Gale Tree Consultancy

Tree Condition Report

St John the Baptist, Westbourne

Ref: TCR/449/23

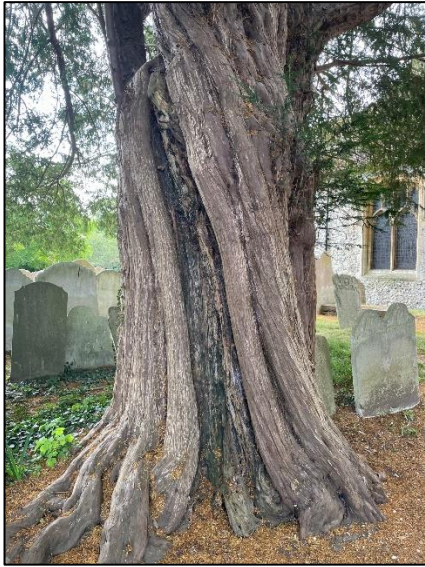
Tree No	Tag No.	Species	Stem Dia.	Height	Crown Spread	Age Class	Phy. Cond.	Comments	Recommendations	Priority
T1	533	Yew	1000+	10-15	10-15	VET	FAIR	Open vertical wound/cavity on the south and west side of the stem, dull tone associated Numerous other wounds in mid to high crown	None at this time Consider detailed decay evaluations using PiCUS sonic tomography to better understand the extent of decay/hollowing	NA
T3	534	Yew	1000+	10-15	10-15	VET	FAIR	Crack in west side of stem 7cm deep, dull tone around that immediate area Cubical brown rot in central column decay in open cavity Multiple cavities and through wounds noted within mid stem area Stem bias east	None at this time Consider detailed decay evaluations using PiCUS sonic tomography to better understand the extent of decay/hollowing	NA
T8	535	Yew	1000+	10-15	10-15	VET	FAIR	Column of decay on north east side of stem from ground level up to c.5m	None at this time Consider detailed decay evaluations using PiCUS sonic tomography to better understand the extent of decay/hollowing	NA

T1/533 note the open wound T3/534 showing the crack and steel ruler c.7cm deep

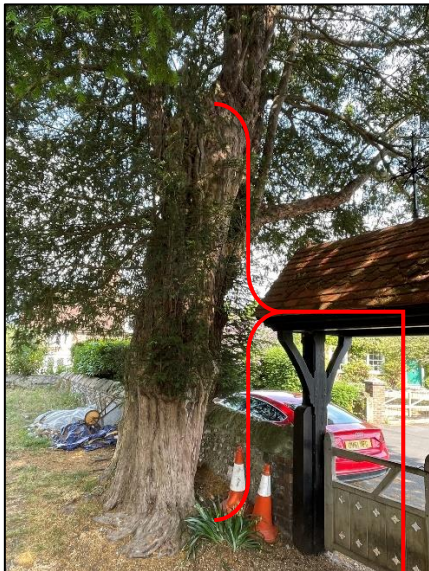
T8/535 location and extent of dull tone

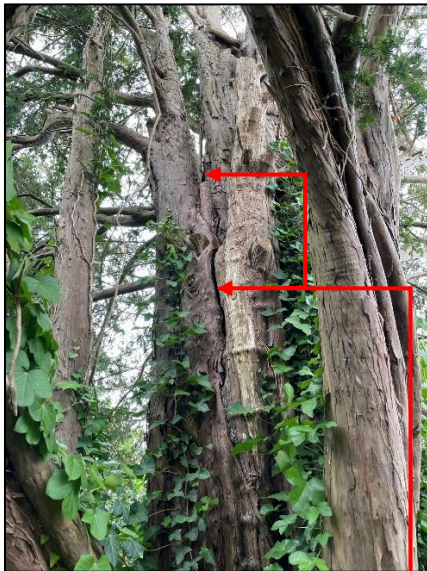
- T9/536 Yew has a number of failing included unions² which were opening and closing due to wind gusts whilst the tree was being assessed
- No immediate action is required at this time. However, a recommendation to inspect the tree after extreme weather events, such as wind gusts in excess of Force 8 on the Beaufort Scale has been made to assess whether the unions have opened further

² Included unions - develops when two or more stems grow closely together causing weak, under supported branch angles. This results in a weakness due to the lack of a woody union and subsequently, any increase in lateral movement can result in the union failing

T9/536 failed included unions

T9	536	Yew	751-1000	10-15	5-10	M	FAIR	Three PSS with failing included unions, creaking noises heard during light wind gusts during assessment	None at this time Reassess after extreme wind events such as wind gusts in excess of Force 8 on the Beaufort Scale	GM
T10	537	Yew	751-1000	10-15	5-10	M	FAIR	Thick ivy c.90% of crown restricts thorough assessment	Sever ivy at ground level and again at 1m, removing the severed band	HS2

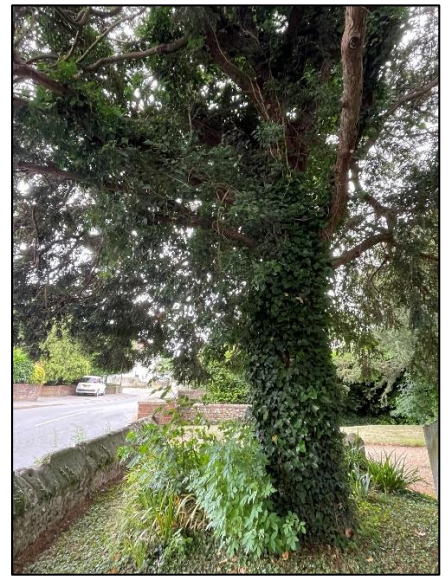
- T10/537 Yew has ivy advancing high into the tree covering c.90% of the stem and crown structure which restricted the assessment process
- Ivy serves as valuable habitat for wildlife and wherever possible should be retained for this purpose

- However, where it obscures the main stem, major branch attachment points and the upper crown structure, it can cover anomalies that would otherwise be evident

- It will also increase the sail and 'mass' of the crown and in extreme cases can increase the risk of branch failure and where trees are located adjacent to areas of high footfall or vehicular access/movement this can increase the risk of injury or harm occurring

T10/537 dense ivy restricting thorough assessment

- Where it has been recommended, the ivy should be severed as close to the ground as possible and again at c.1m with the severed band being removed. This will allow the ivy ascending into the tree to die off naturally whilst the gap generated will mean any new ivy can be severed if/when it appears

- Undertake the severance of the ivy to T10/537 in the time period specified
- Reassess in three years from the reports date
- This time frame should be shortened in the event:
 - The trees local environment changes significantly
 - Fruiting bodies emerge from anywhere on the tree
 - After extreme weather events such as:
 - Wind gusts in excess of Force 8 on the Beaufort Scale
 - After named extreme weather events such as Storm Eunice of February 2022
