## **Westbourne Parish Council, 10 September 2026**

## Operational Inspection

Westbourne Parish Council

## Inspection Scope for RPII Annual Inspectors

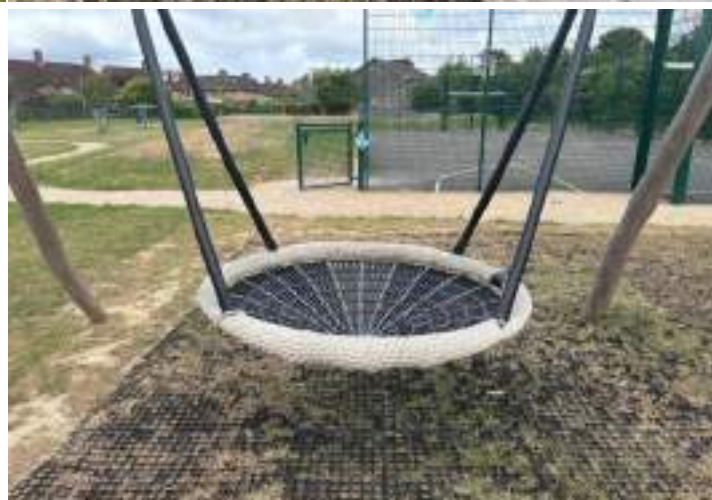
**Finding:** The seat connection cannot be inspected fully as the chain cover cannot be lifted

**Action:** Cut the cover to allow access to the shackle and assess the wear

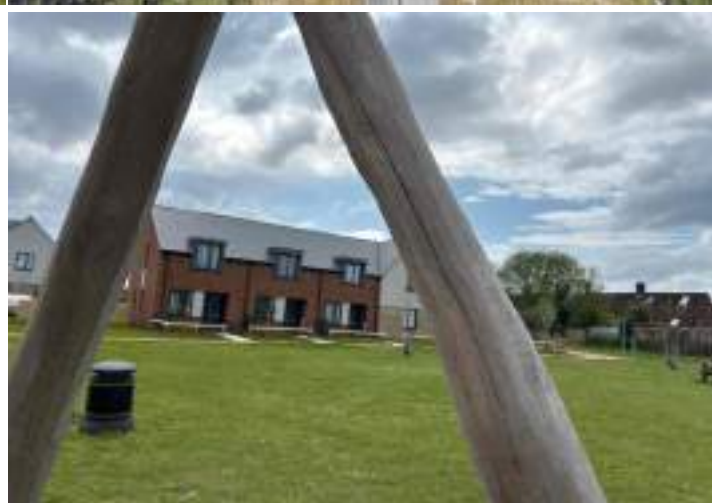
**Finding:** The timber has a number of splits/shakes or air cracks and this may affect the stability or allow water ingress which will accelerate the rotting process

**Action:** Monitor to ensure the splits do not cross through fixing points of the structure and/or cause any instability

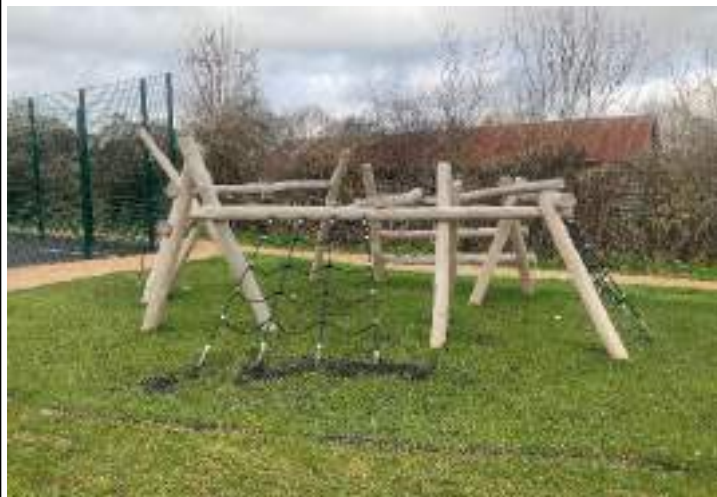
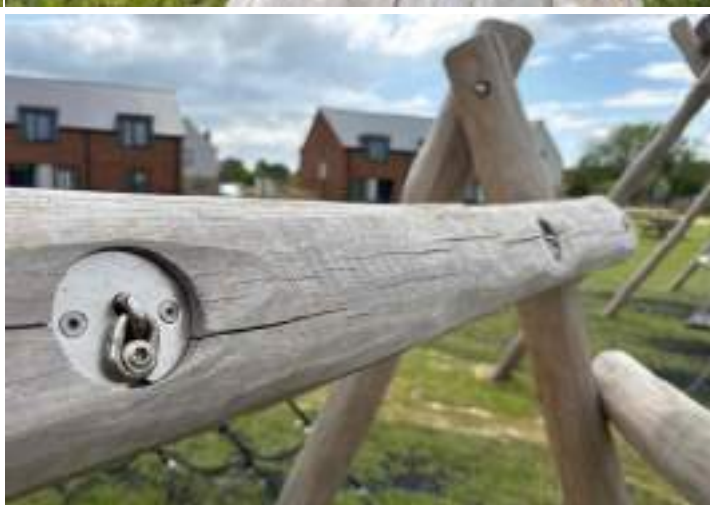
**Finding:** The timber has a number of splits/shakes or air cracks and this may affect the stability or allow water ingress which will accelerate the rotting process

**Action:** Monitor to ensure the splits do not cross through fixing points of the structure and/or cause any instability

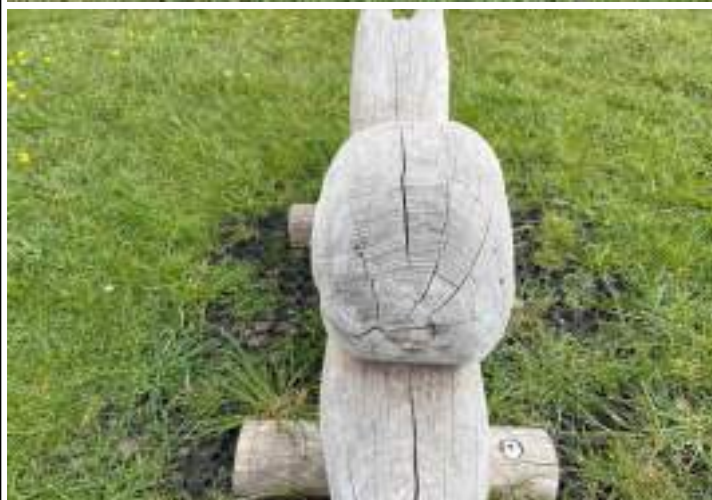
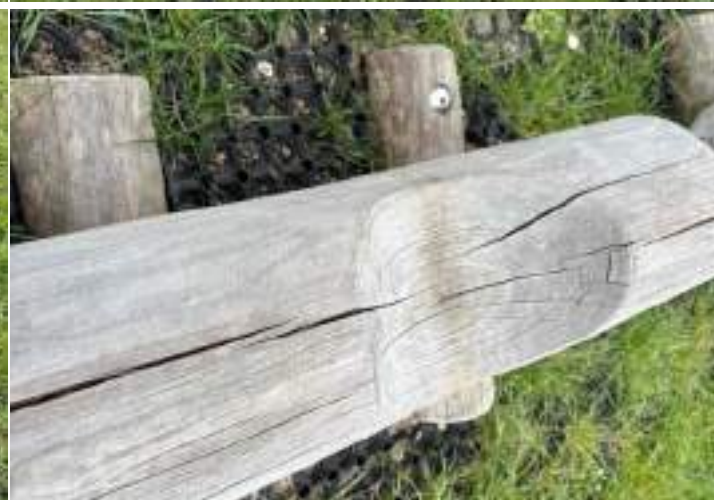
**Finding:** The timber has a number of splits/shakes or air cracks and this may affect the stability or allow water ingress which will accelerate the rotting process

**Action:** Monitor to ensure the splits do not cross through fixing points of the structure and/or cause any instability

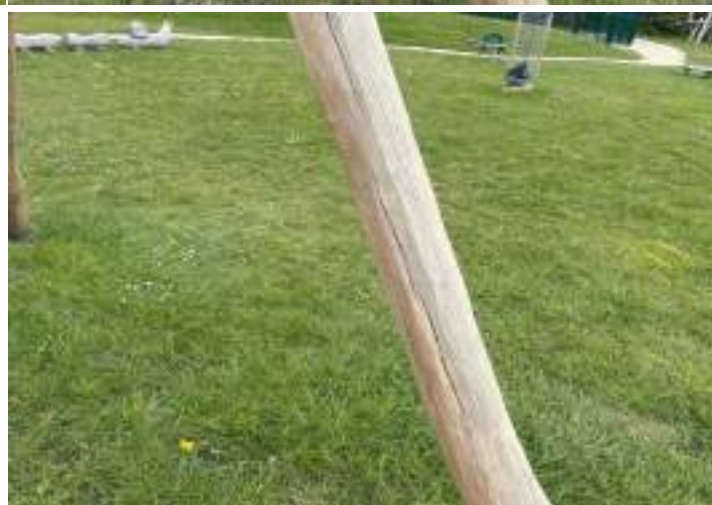
**Finding:** The timber has a number of splits/shakes or air cracks and this may affect the stability or allow water ingress which will accelerate the rotting process

**Action:** Monitor to ensure the splits do not cross through fixing points of the structure and/or cause any instability

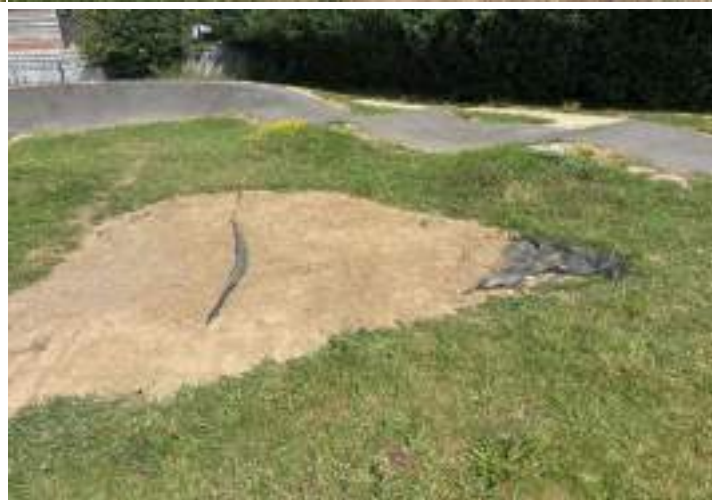
**Finding:** Surface has eroded and the membrane is exposed causing trip hazards  
**Action:** Infill as required

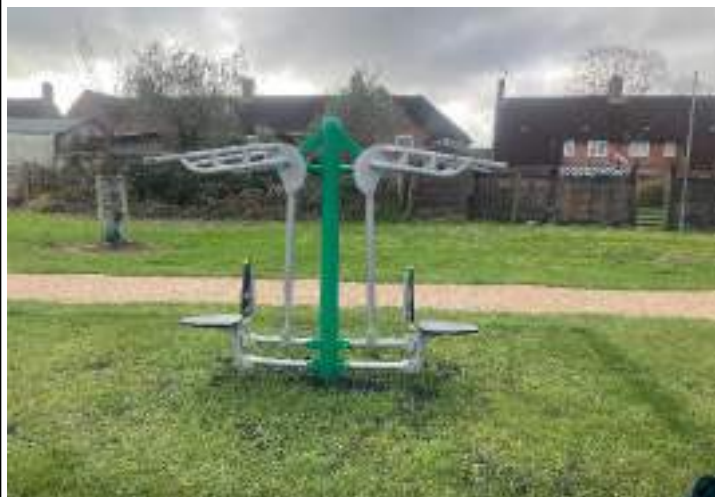
**Finding:** There is some damage to the item

**Action:** Monitor for any further deterioration and repair as required

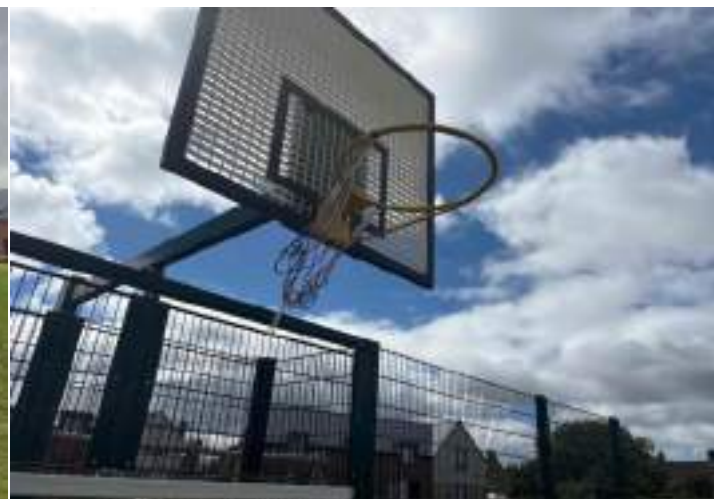
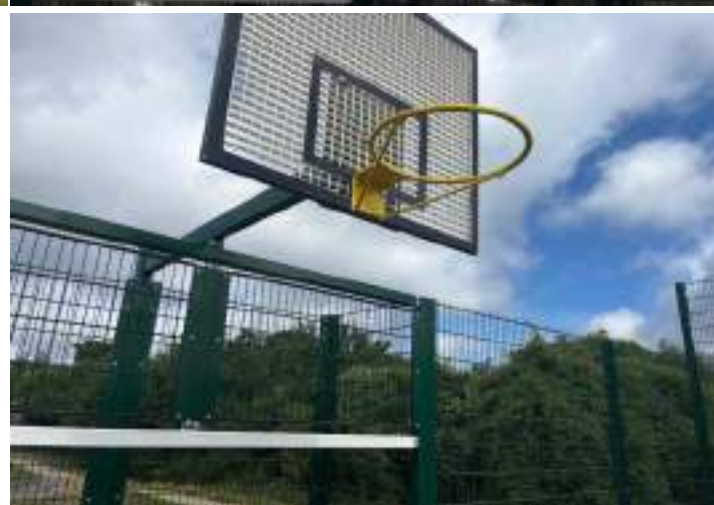
**Finding:** The goal hoops have been damaged or are missing from the equipment

**Action:** Repair or replace as required

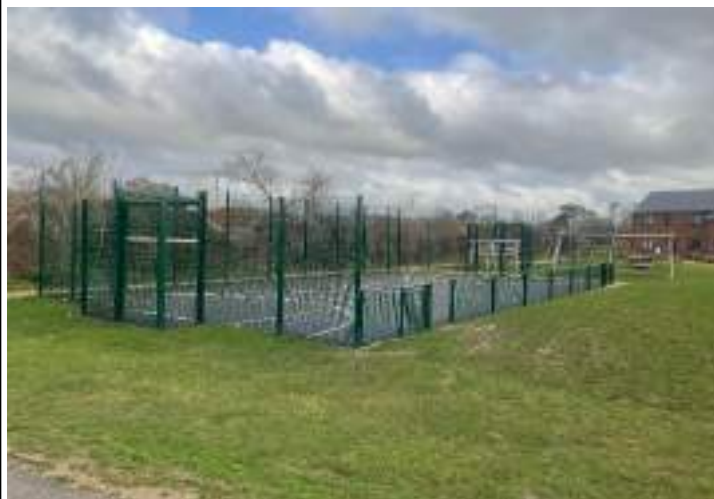
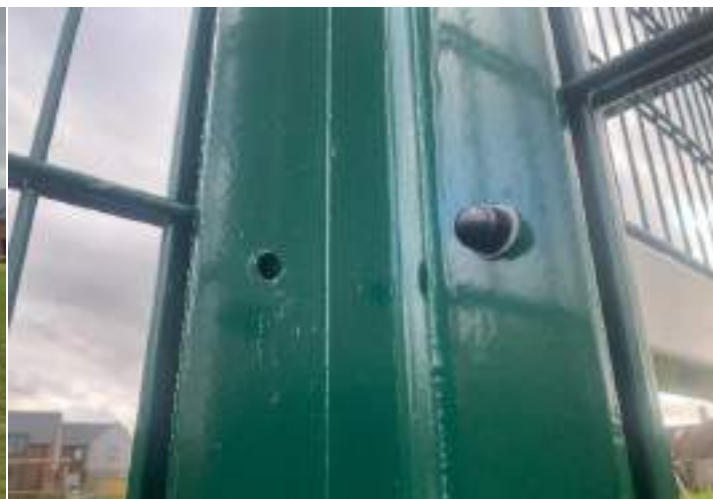
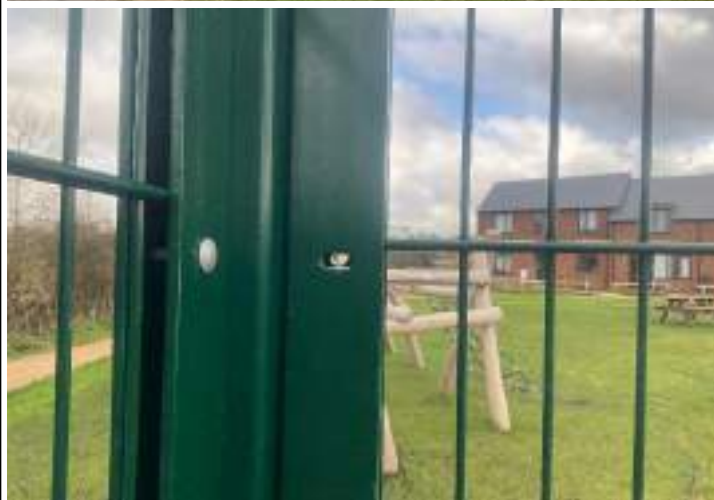
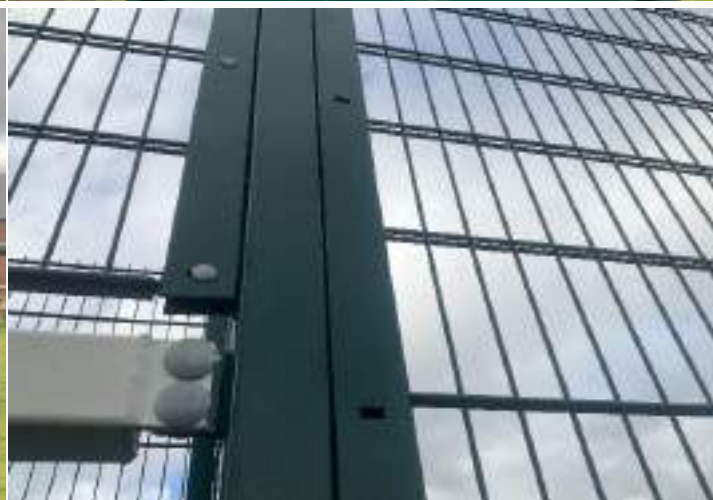
**Finding:** There is or are fixings missing on the item

**Action:** Replace all missing fixings x 5-7 m8 coach bolts

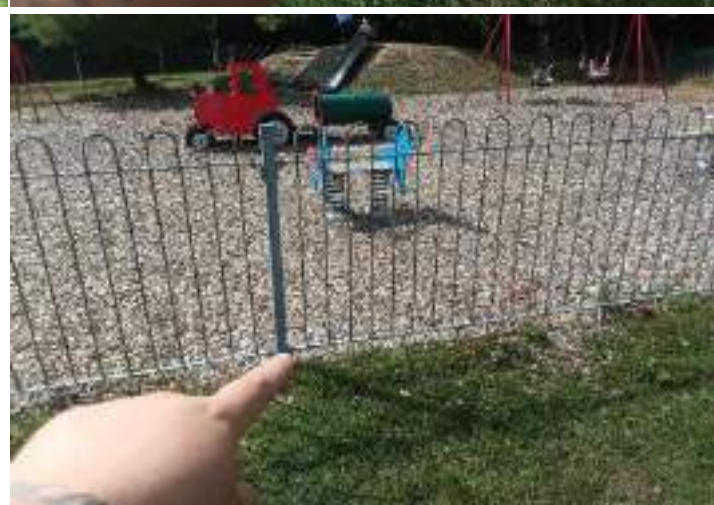
**Finding:** A number of fixings have worked loose around the fencing-inaccessible  
**Action:** Secure all loose fixings

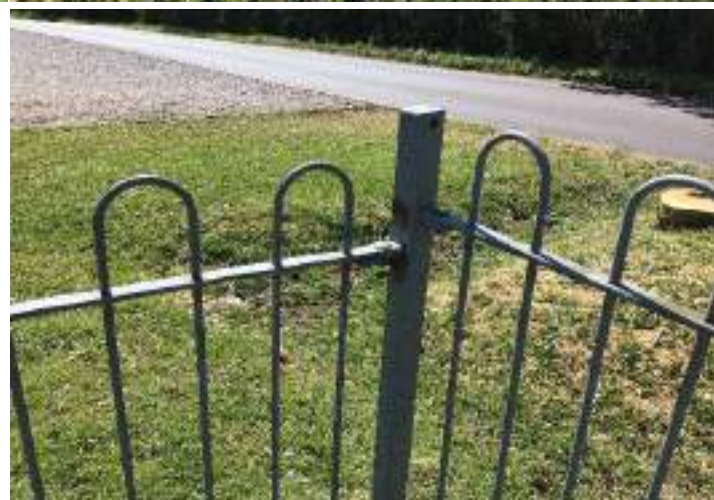
**Finding:** The paintwork on this item has been damaged or worn exposing the metal underneath which is rusting

**Action:** Treat any rusting components and repaint

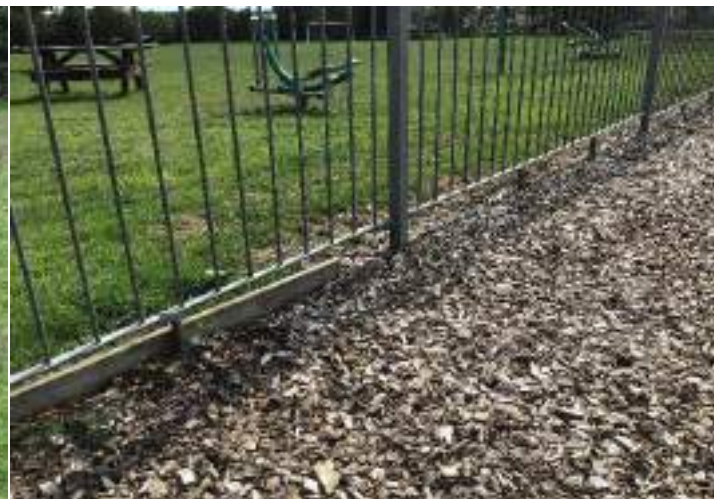
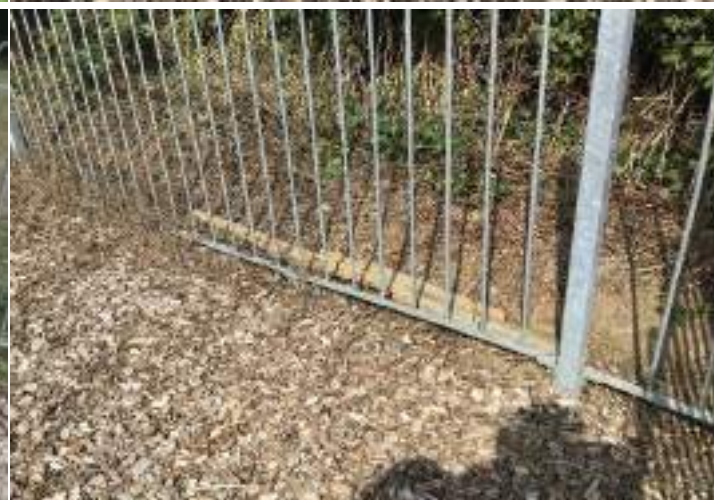
**Finding:** Majority of the kick boards/retaining boards are missing

**Action:** Replace

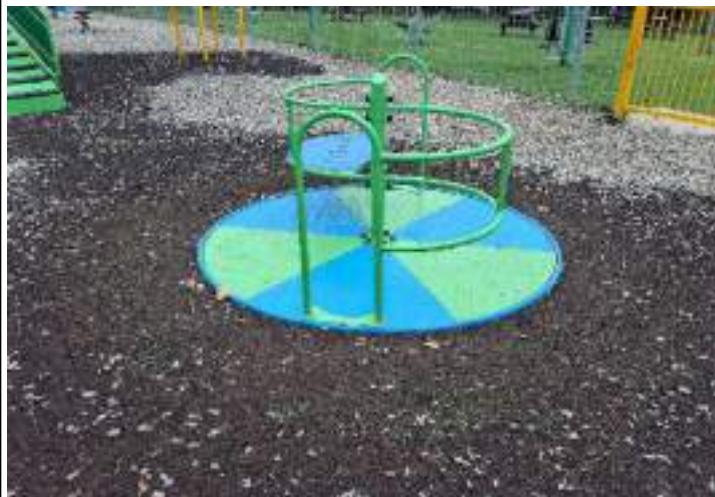
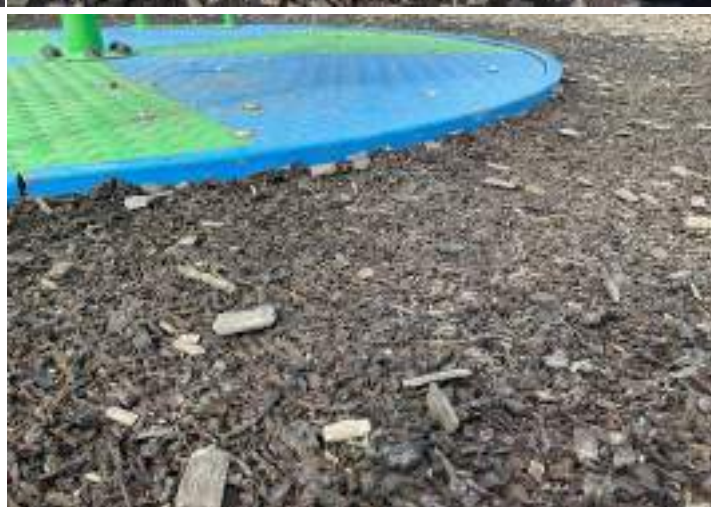
**Finding:** There are trip hazards present

**Action:** Reinstate surrounding surfaces to level to remove the trip points

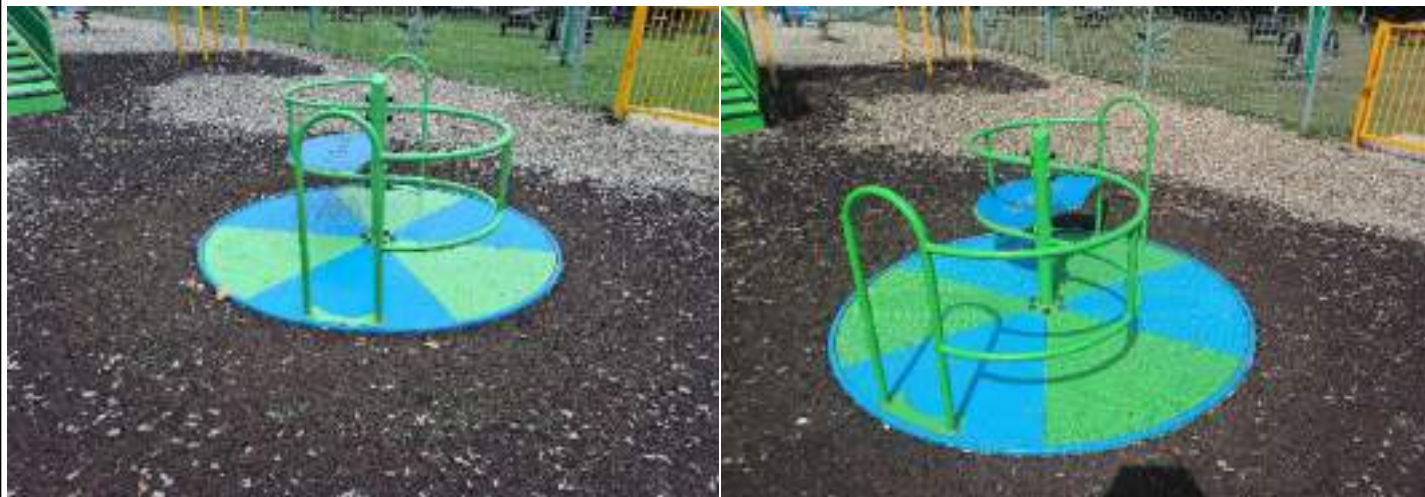
**Finding:** The bearing is worn / damaged and the item is not operating correctly  
**Action:** Repair / replace

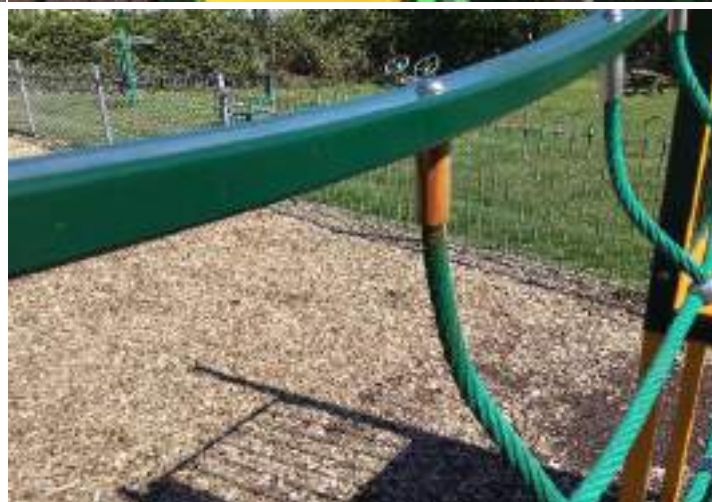
**Finding:** There is surface corrosion present on the item

**Action:** Consider treating and repainting the item

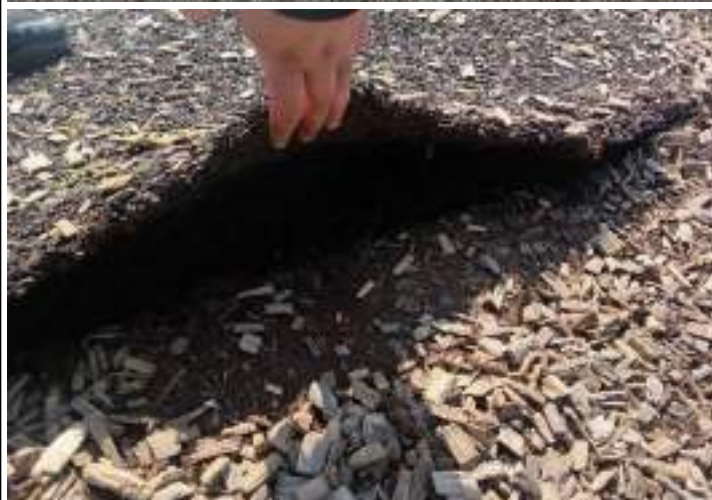
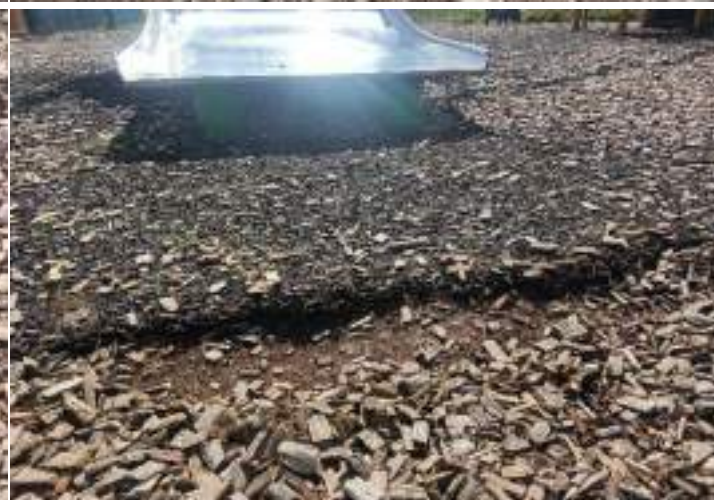
**Finding:** The surface is lifting at the edges and creating trip points  
**Action:** Repair perimeter of surfacing to remove trip points

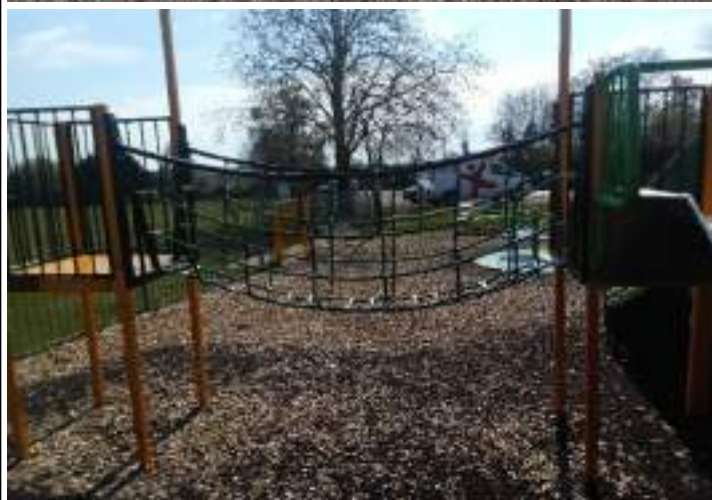
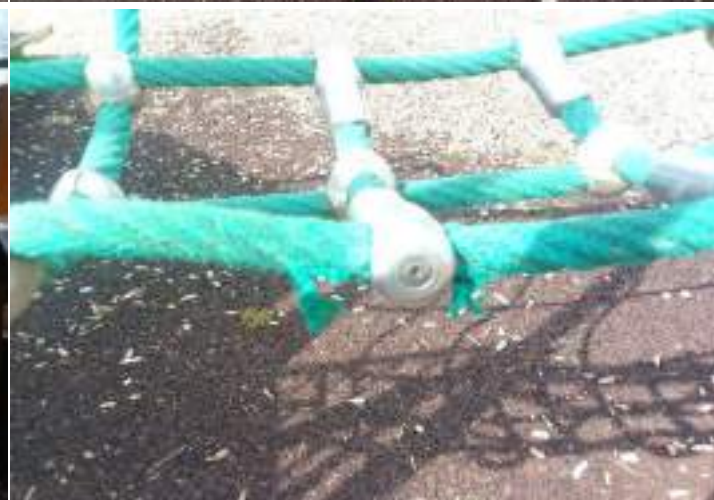
**Finding:** The ropes/nets are worn/damaged in places

**Action:** Monitor for any further deterioration and repair or replace as required

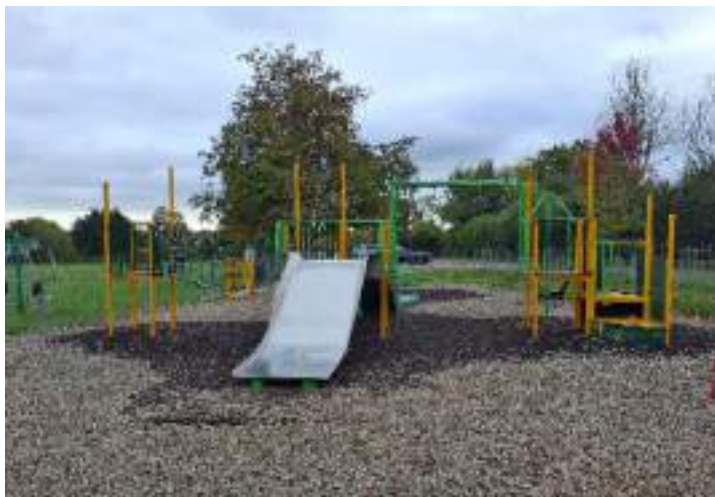
**Finding:** There are a number of dents in the slide surface

**Action:** Monitor for any further deterioration and repair as required

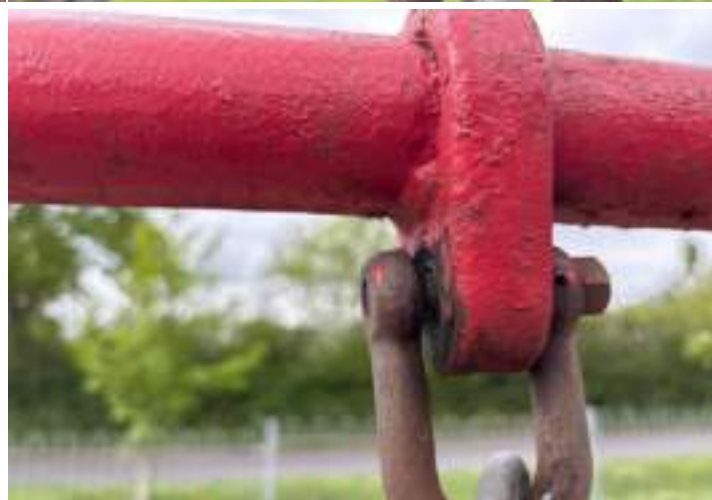
**Finding:** The bushes are worn or missing x 4

**Action:** Replace worn or missing bushes

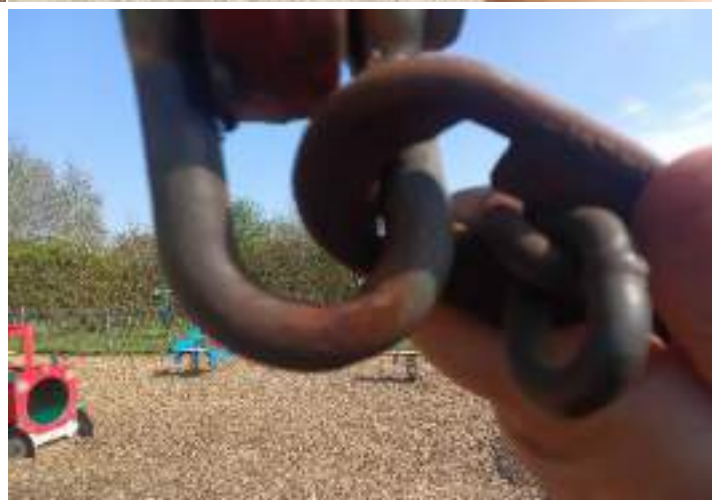
**Finding:** There is some wear to the shackles.

**Action:** Monitor for any further deterioration and replace when 40% worn

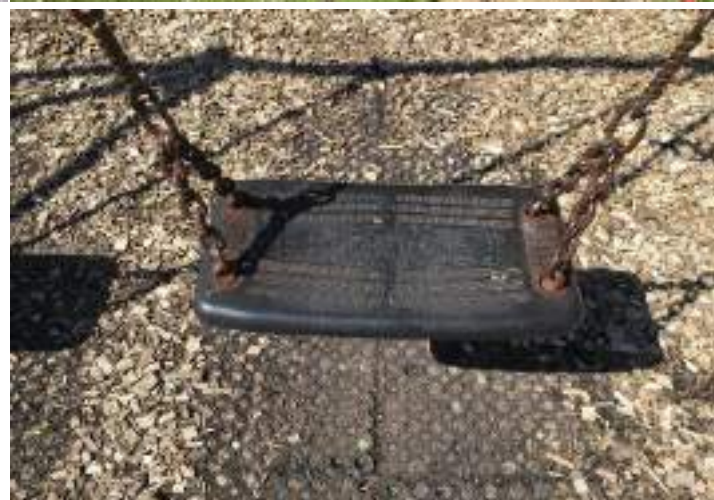
**Finding:** There is surface corrosion present on the item

**Action:** Consider treating and repainting the item

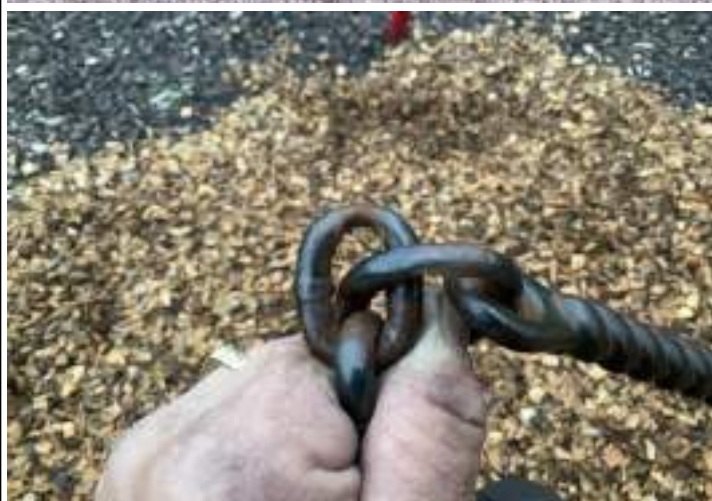
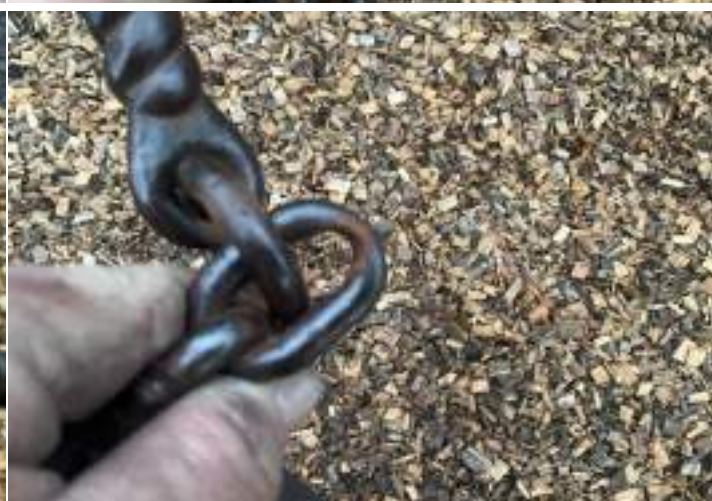
**Finding:** The chain links are worn in excess of 50% and require renewing on both swings

**Action:** Replace worn chains 2x sets of chains

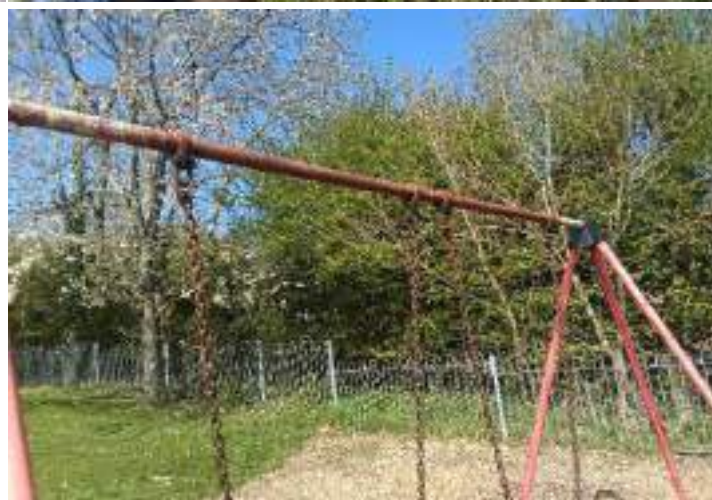
**Finding:** The bushes are worn or missing

**Action:** Replace worn or missing bushes

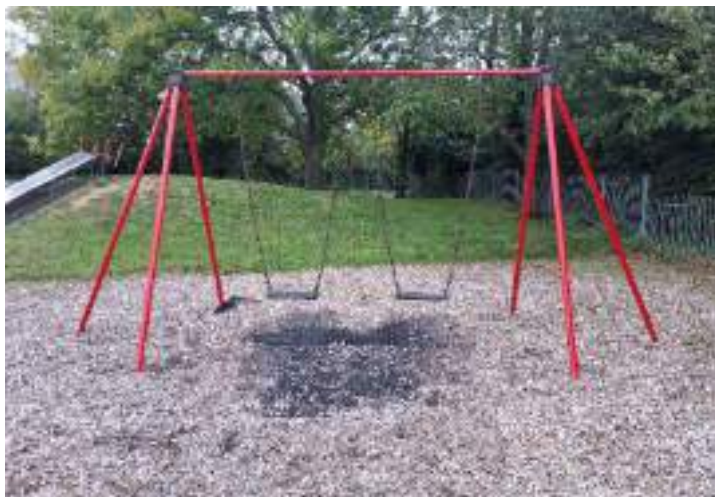
**Finding:** There is some wear to the shackles.

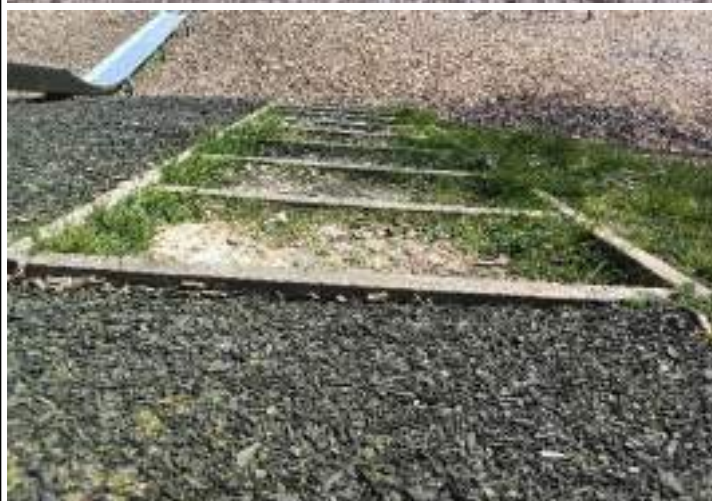
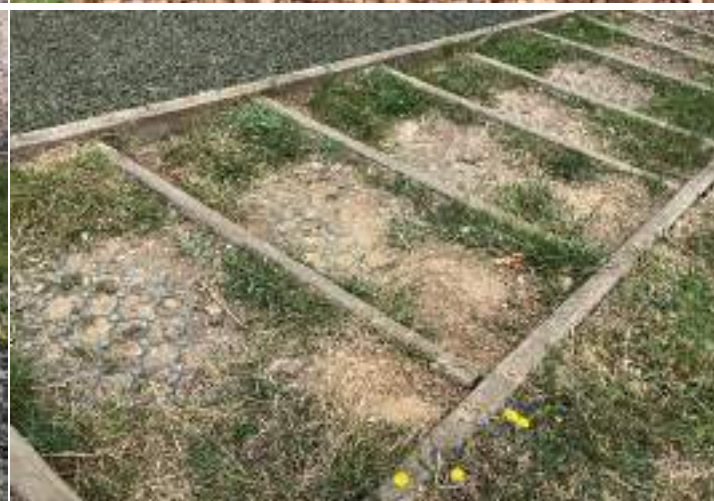
**Finding:** The area around the item has eroded / trip hazards **Action:** Reinstate eroded area on the steps which can lead to falls down bank/steps

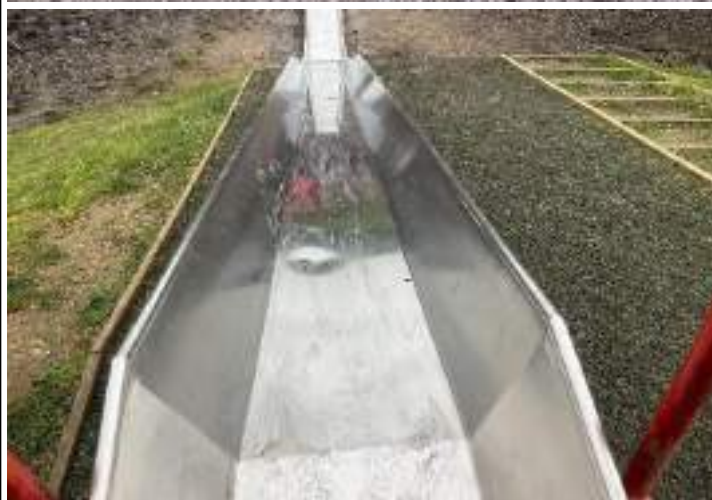
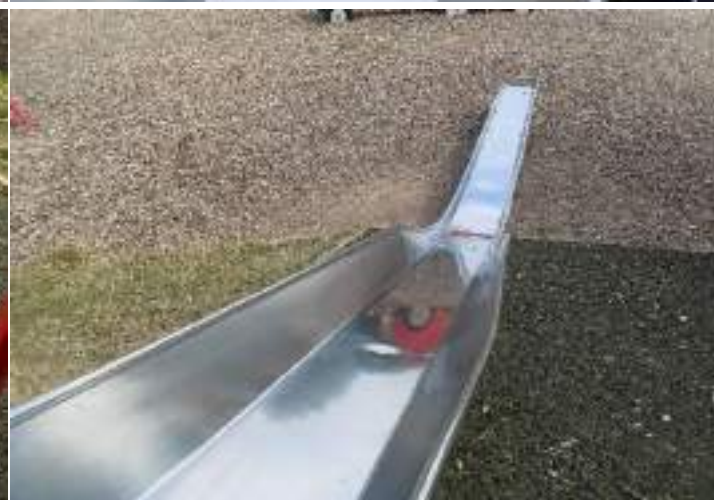
**Finding:** There are a number of dents in the slide surface

**Action:** Monitor for any further deterioration and repair as required

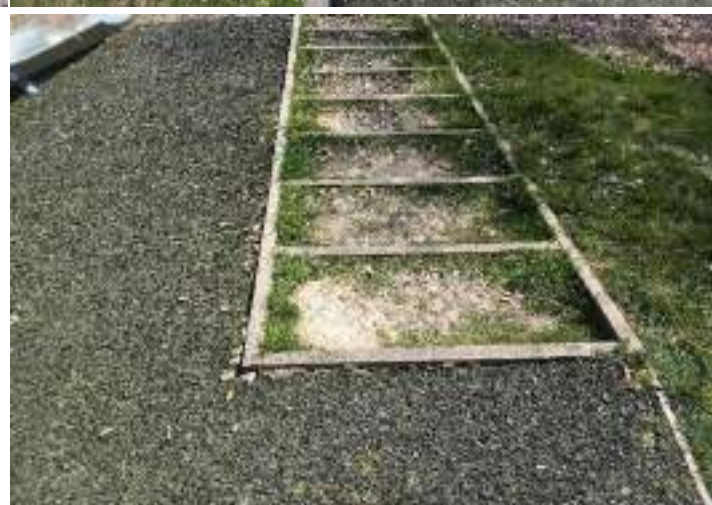
**Finding:** There are gaps opening between the surfacing and the edging surround or between the joints in the surfacing- approximately 6 lin m  
**Action:** Monitor for any further deterioration and repair as required

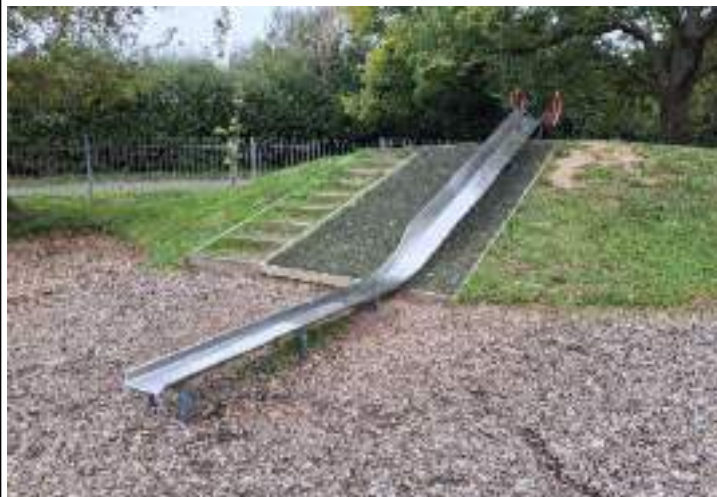
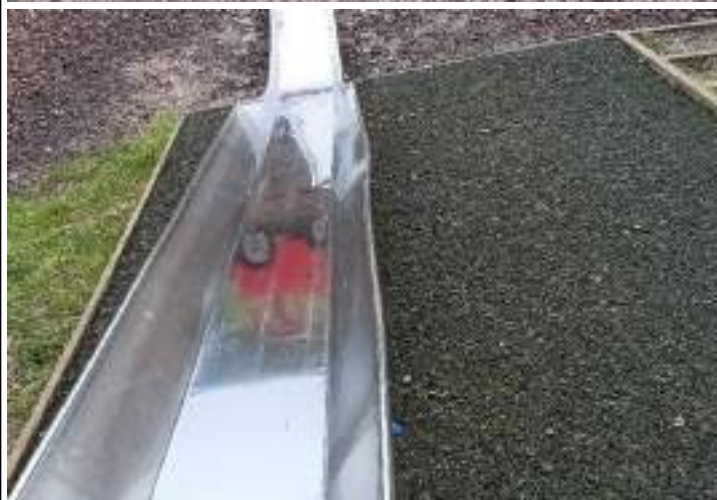
**Finding:** The side of the slide is damaged

**Action:** Monitor for any further deterioration and repair as required

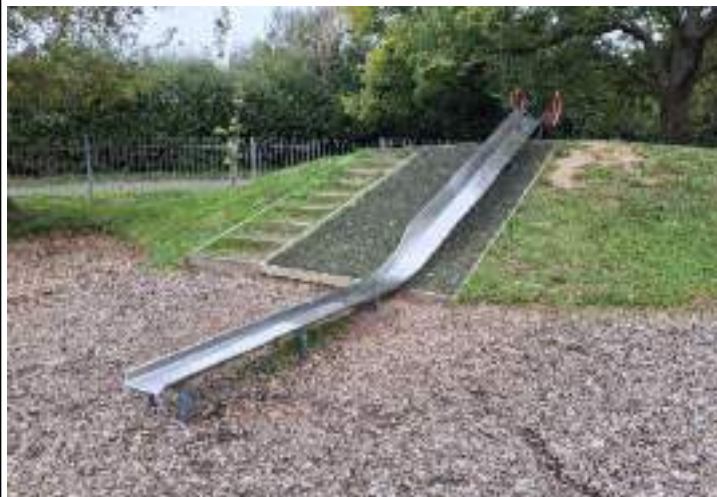
**Finding:** There is surface corrosion / rust present on the item

**Action:** Consider treating the item

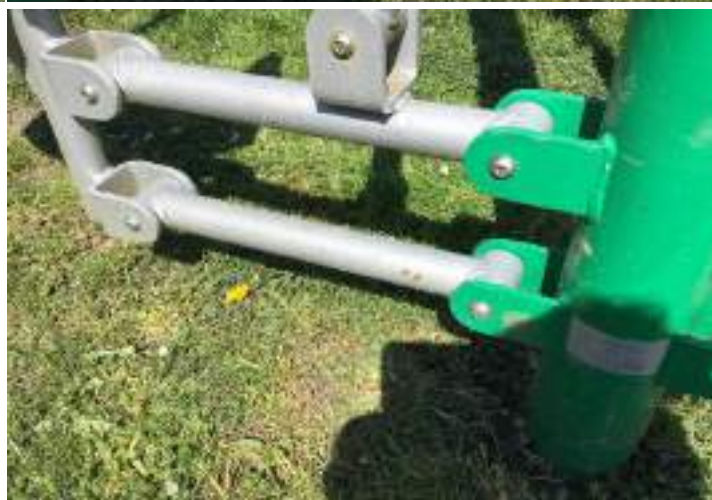
**Finding:** The paintwork on this item has been damaged or worn exposing the metal underneath which is rusting

**Action:** Treat any rusting components and repaint

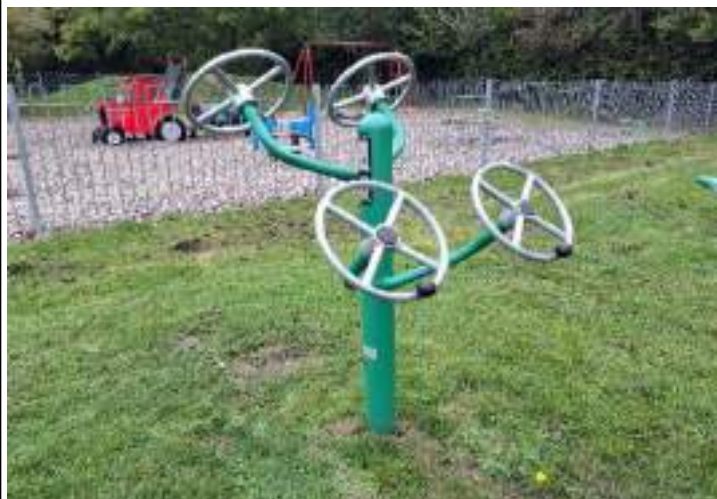
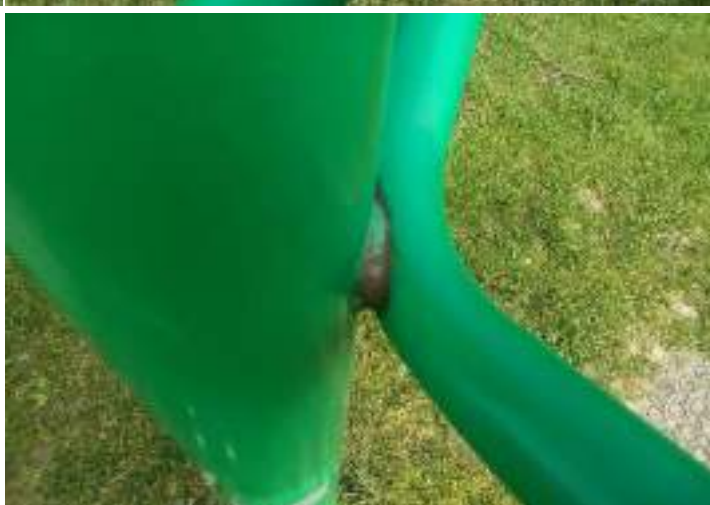
**Finding:** The paintwork on this item has been damaged or worn exposing the metal underneath which is rusting

**Action:** Treat any rusting components and repaint

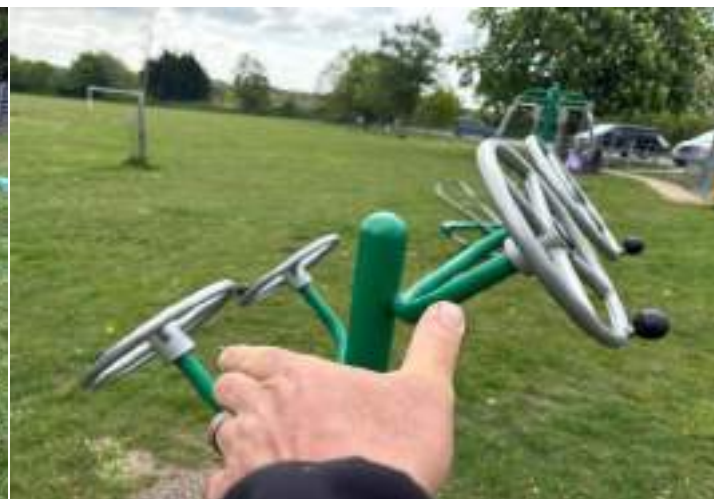
**Finding:** The bearing is showing signs of wear

**Action:** Monitor for any further deterioration and replace as required

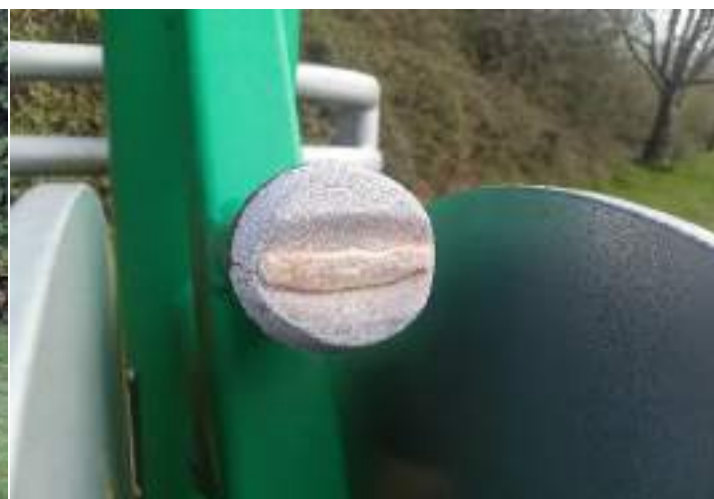
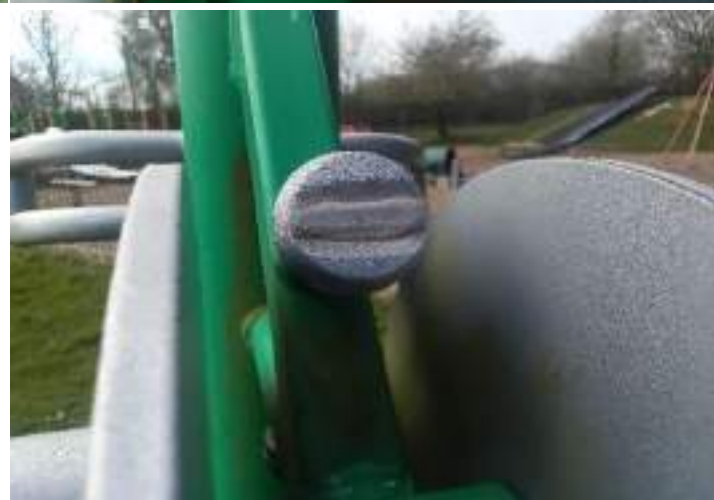
**Finding:** The buffers are wearing

**Action:** Monitor for any further deterioration and replace as required

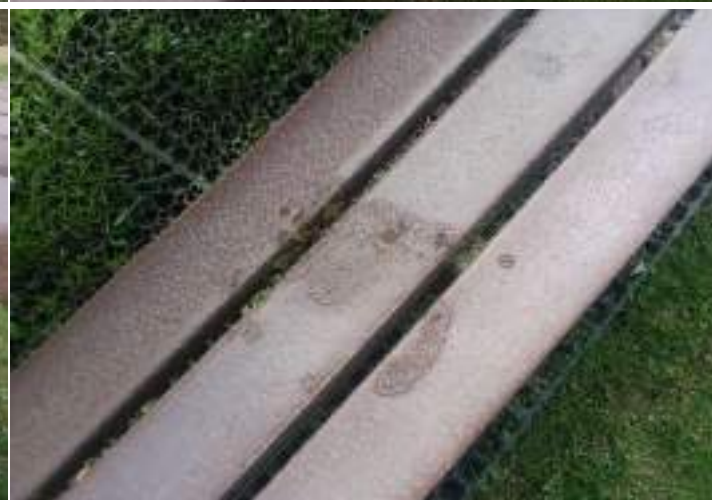
**Finding:** There is some evidence of fire damage to the item **Action:** Monitor for any further deterioration and repair as required

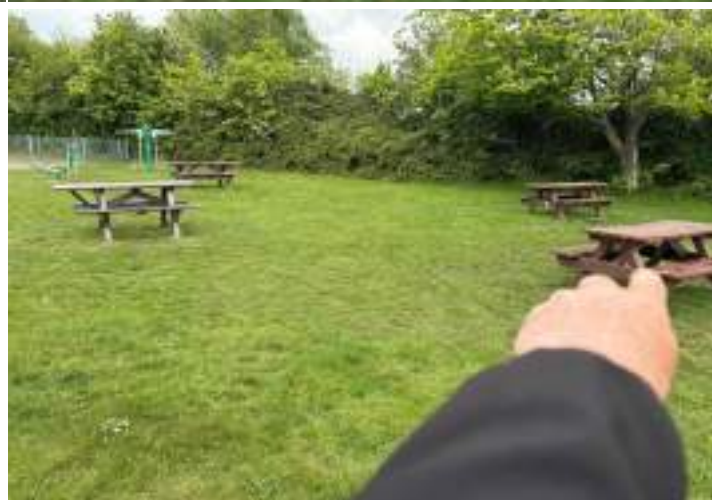
**Finding:** There is some damage to the item

**Action:** Monitor for any further deterioration and repair as required

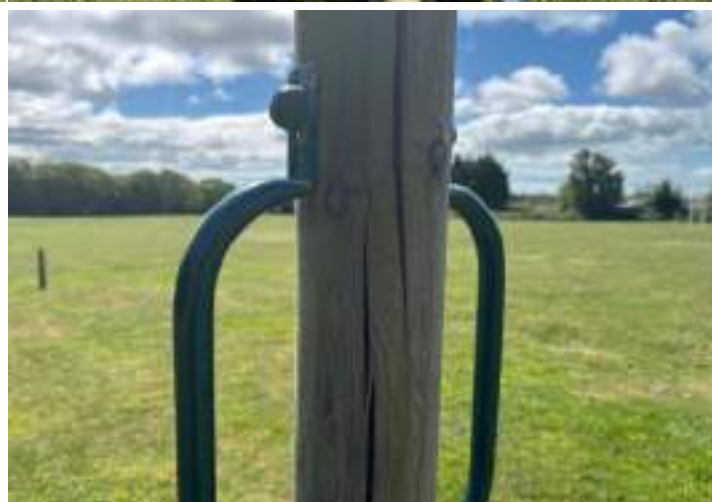
**Finding:** The timber has a number of splits/shakes or air cracks and this may affect the stability or allow water ingress which will accelerate the rotting process

**Action:** Monitor to ensure the splits do not cross through fixing points of the structure and/or cause any instability

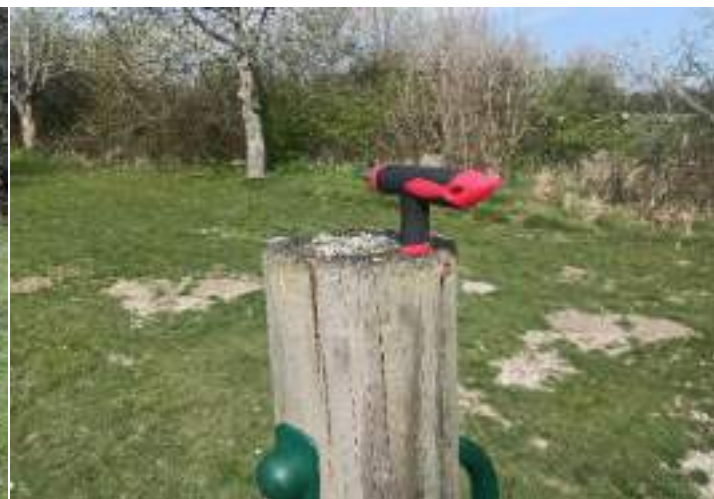
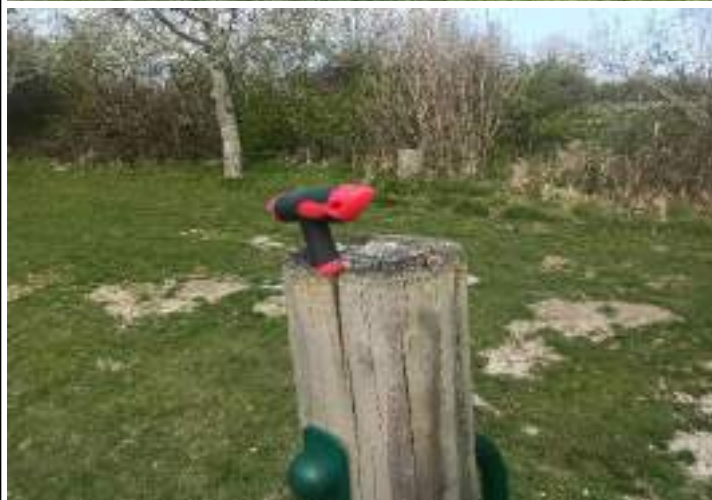
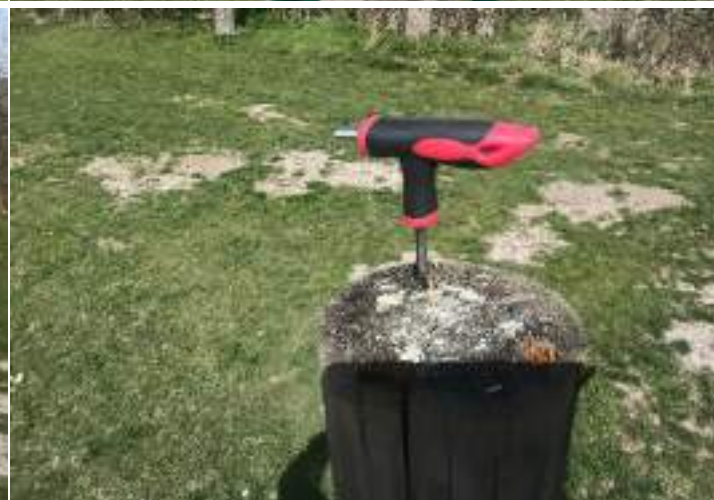
**Finding:** There are areas or parts of the timber on the structure that have rotted

**Action:** Replace all affected timbers

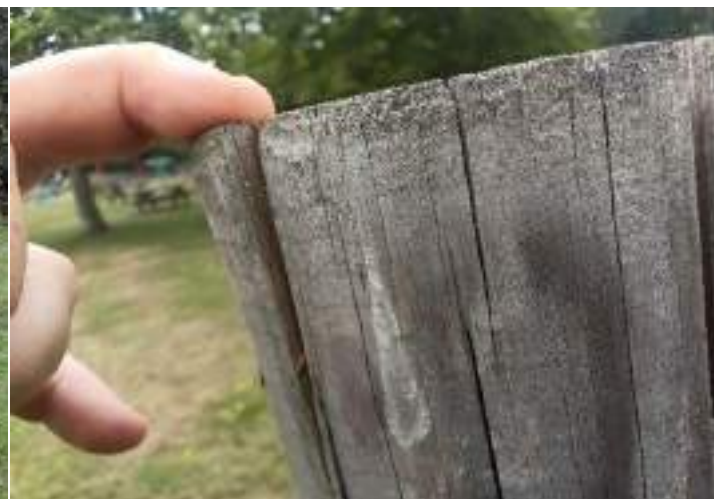
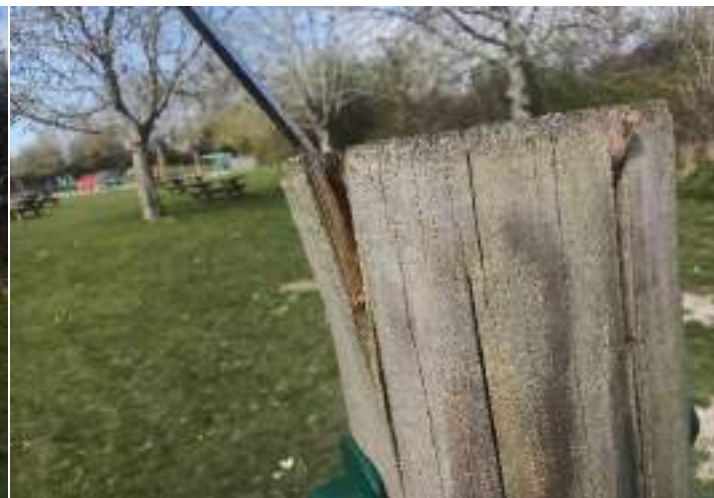
**Finding:** There is some damage to the item

**Action:** Monitor for any further deterioration and repair as required

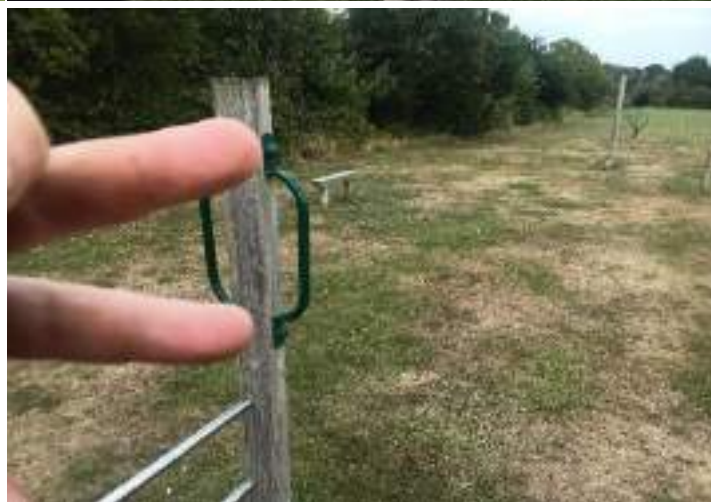
**Finding:** A number of fixing(s) have worked loose-inaccessible

**Action:** Secure all loose fixings

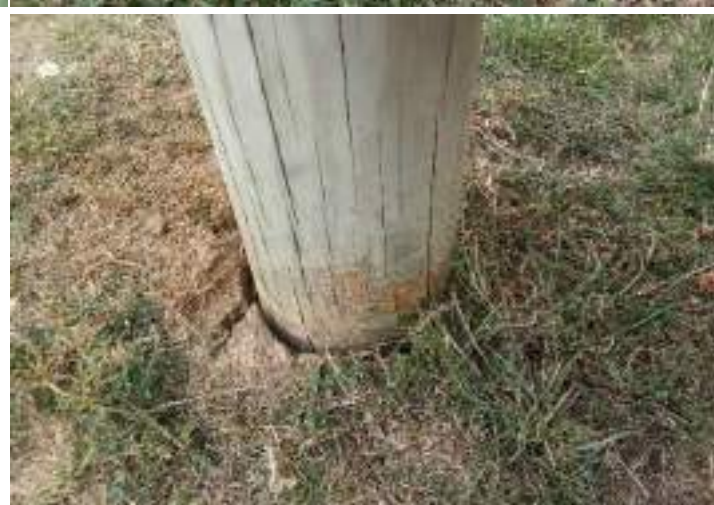
**Finding:** There is some strimmer / machinery damage apparent on the posts, this can penetrate the preservative applied to the timber and accelerate the rotting process

**Action:** Monitor for any deterioration (rot) and replace as required
