## **Westbourne Parish Council, 10 September 2026**

## Operational Inspection

Westbourne Parish Council

## Inspection Scope for RPII Annual Inspectors

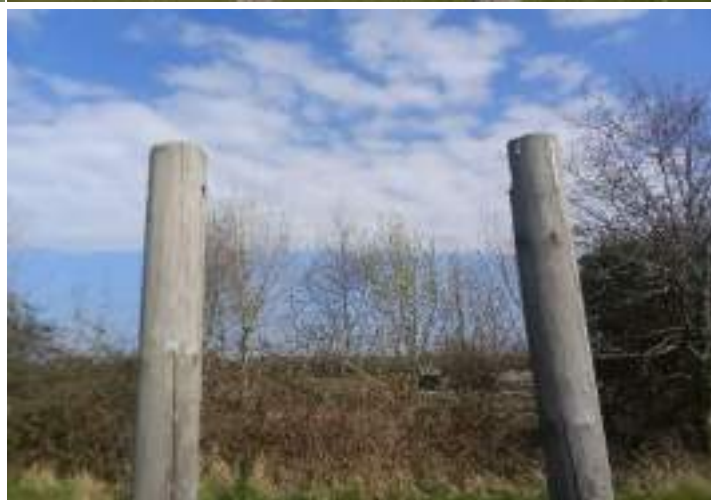
**Finding:** The item has missing component(s) - top bar missing

**Action:** Consider replacing missing components

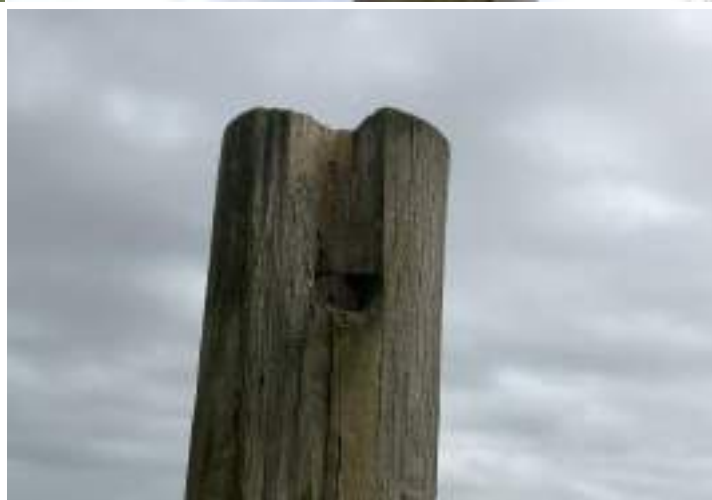
**Finding:** The item has been severely damaged

**Action:** Replace item

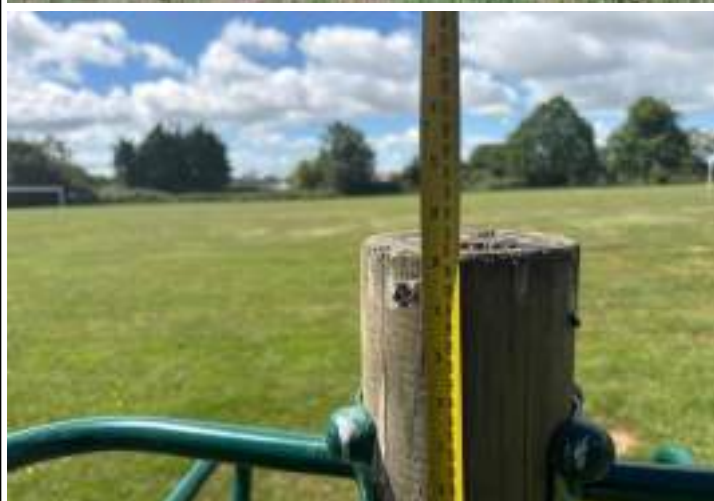
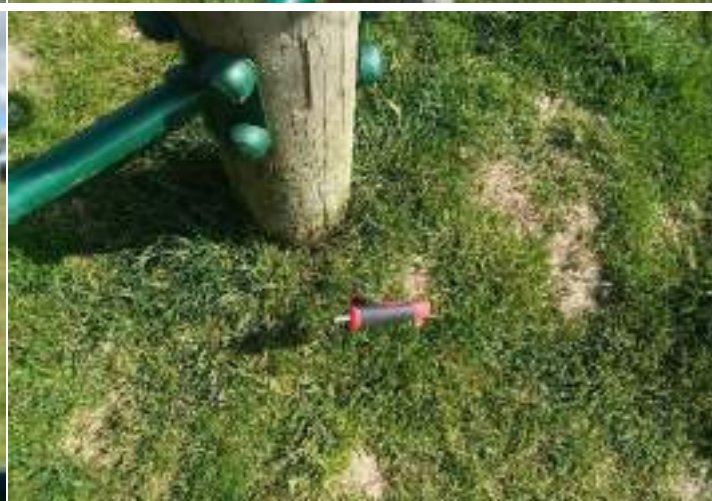
**Finding:** There are areas or parts of the timber on the structure that have rotted above ground measurement approximately 1.4 m

**Action:** Replace all affected timbers

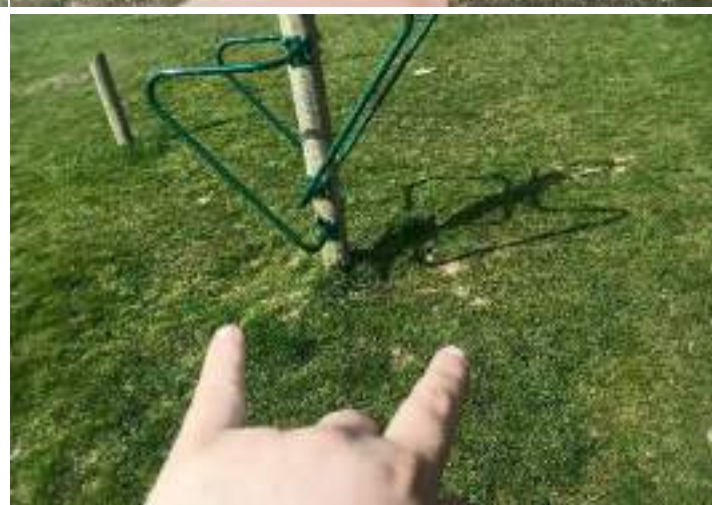
**Finding:** The surface has subsided in some areas

**Action:** Monitor for any further deterioration and repair as required

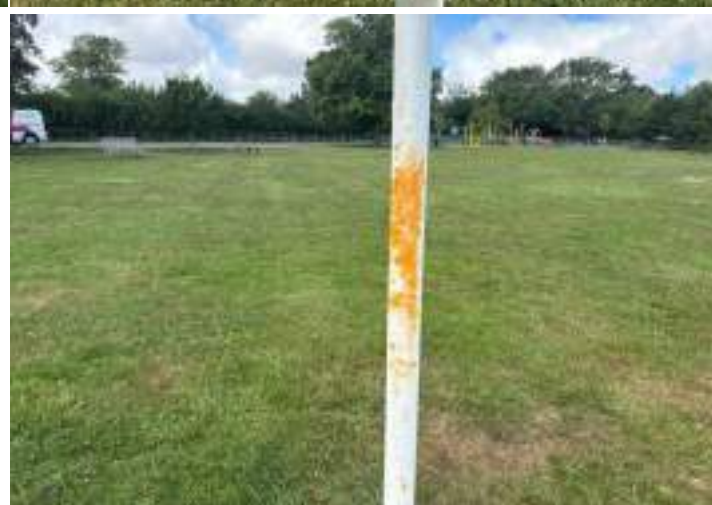
**Finding:** There is surface corrosion / rust present on the item

**Action:** Consider treating the item

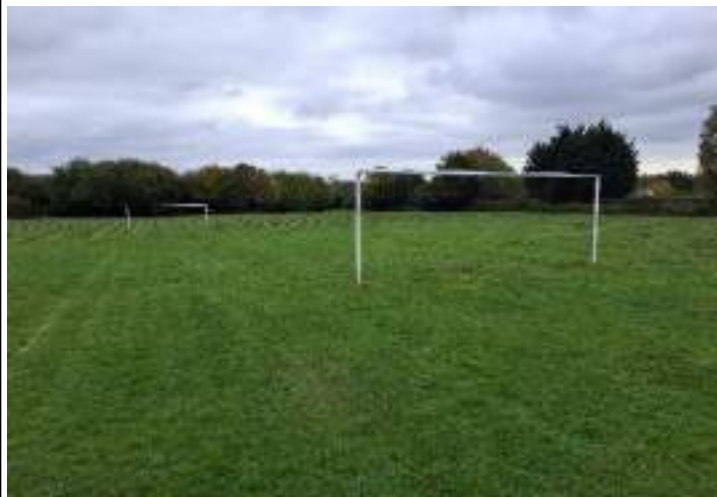
**Finding:** The item is loose in its foundations

**Action:** Reinstall item to secure

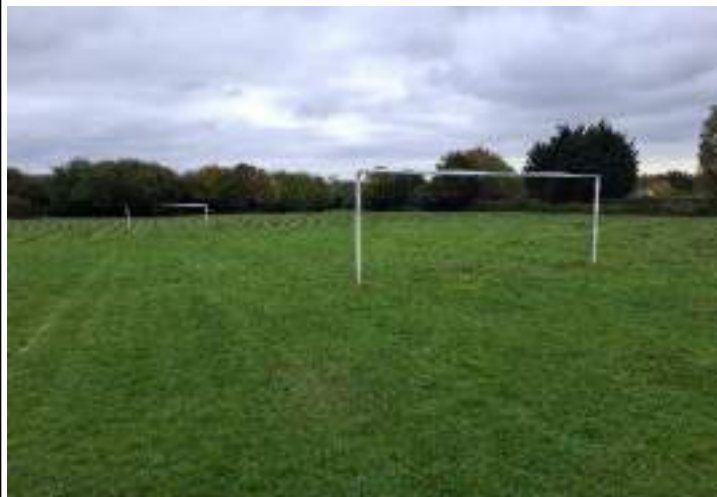
**Finding:** The paintwork on this item has been damaged or worn exposing the metal underneath which is rusting / corroding

**Action:** Treat affected areas and repaint
