Gale Tree Consultancy

Tree Condition Report

St John the Baptist, Westbourne

Ref: TCR/449/23

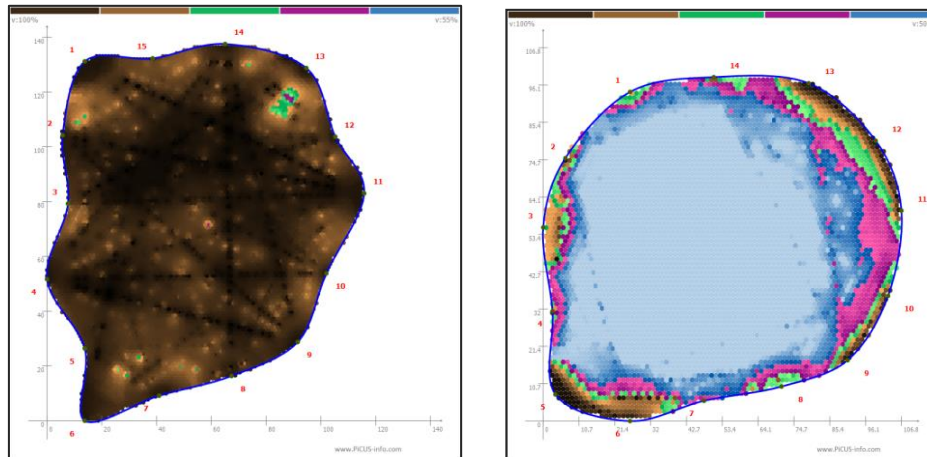
Decay or hollowing results in lower sound speeds and a shift to lighter colours with maroon and blue/white indicating more significant decay.

An example of a sound tree is on the left below and one with significant decay/hollowing on the right:

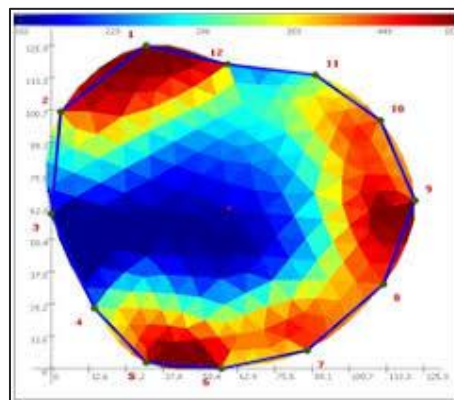
The blue colouration in the tomogram indicates an area of high conductivity suggesting advancing decay

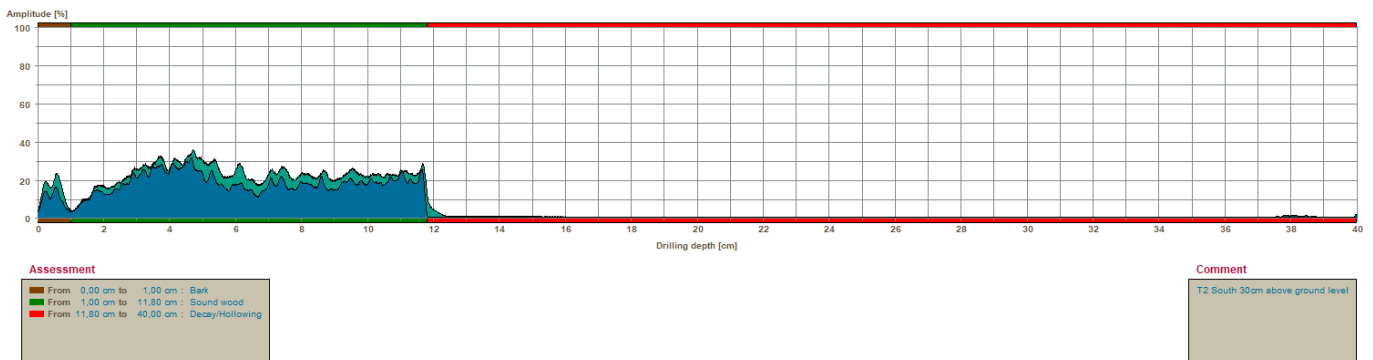
On the example below, extensive decay is indicated from a depth of 11.8cm through to the end of the assessment

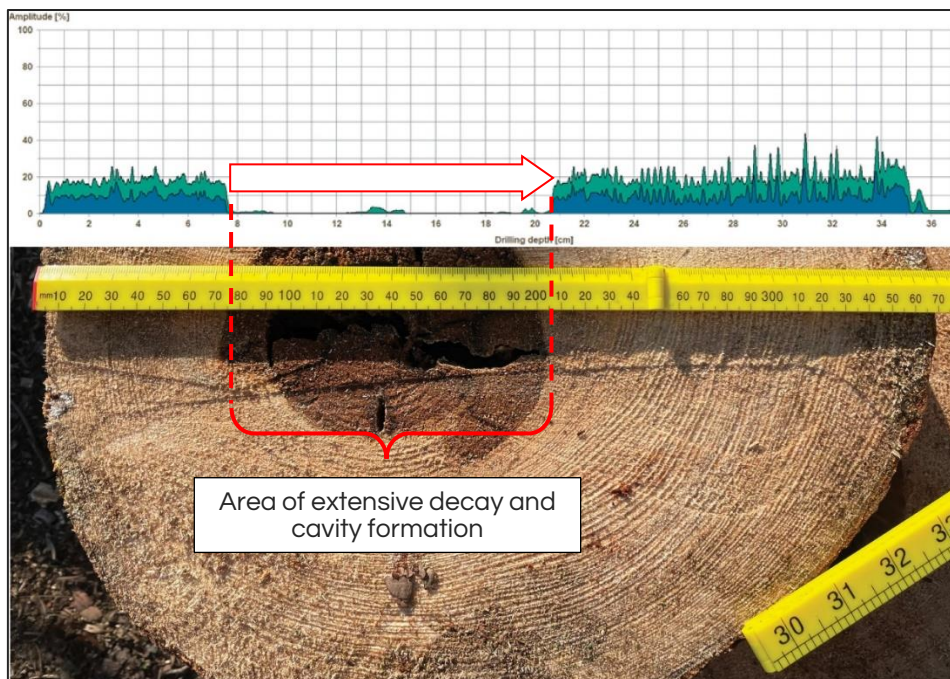
On the image below, you can see where the drill entered the area of extensive decay and cavity at c.7.5cm and re-entered the sound wood at c.20.8cm; the drill exited the stem at c.35.4cm
