## **Westbourne Parish Council, 10 September 2026**

## Operational Inspection

Westbourne Parish Council

## Inspection Scope for RPII Annual Inspectors

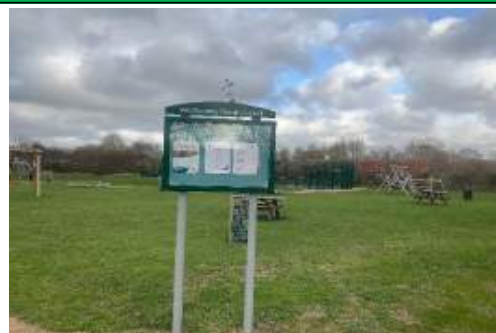
**Item:** Notice Board  
**Manufacturer:** Unknown  
**Surface Type:** Grass  
**Item Quantity:** 1

The item is slightly loose in its foundations - Monitor for any further deterioration and repair as required

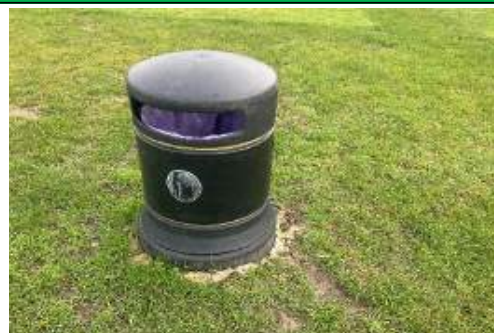
**Item:** Litter Bin  
**Manufacturer:** Unknown  
**Surface Type:** Concrete  
**Item Quantity:** 1

There is some damage to the item - Monitor for any further deterioration and repair as required

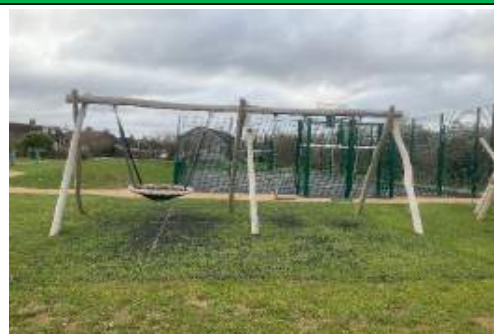
**Item:** 2 Bay 2 Flat 1 Basket Seat  
**Manufacturer:** Eibe Play Ltd  
**Surface Type:** Grass  
**Item Quantity:** 1

The seat connection cannot be inspected fully as the chain cover cannot be lifted - Cut the cover to allow access to the shackle and assess the wear

The timber has a number of splits/shakes or air cracks and this may affect the stability or allow water ingress which will accelerate the rotting process - Monitor to ensure the splits do not cross through fixing points of the structure and/or cause any instability

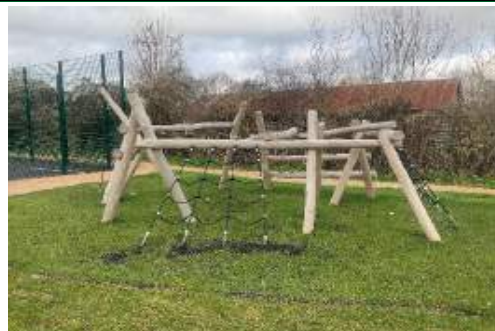
**Item:** Log Climber  
**Manufacturer:** Eibe Play Ltd  
**Surface Type:** Grass  
**Item Quantity:** 1

The timber has a number of splits/shakes or air cracks and this may affect the stability or allow water ingress which will accelerate the rotting process - Monitor to ensure the splits do not cross through fixing points of the structure and/or cause any instability

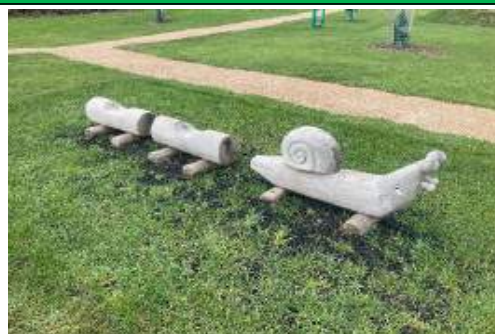
**Item:** Animal Bench  
**Manufacturer:** Eibe Play Ltd  
**Surface Type:** Grass  
**Item Quantity:** 1

The timber has a number of splits/shakes or air cracks and this may affect the stability or allow water ingress which will accelerate the rotting process - Monitor to ensure the splits do not cross through fixing points of the structure and/or cause any instability

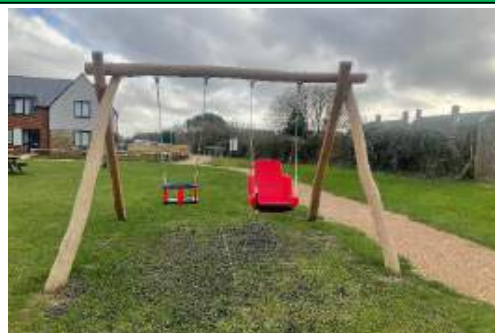
**Item:** 1 Bay 1 Seat (Cradle) - Type 1  
**Manufacturer:** Eibe Play Ltd  
**Surface Type:** Grass  
**Item Quantity:** 1

The timber has a number of splits/shakes or air cracks and this may affect the stability or allow water ingress which will accelerate the rotting process - Monitor to ensure the splits do not cross through fixing points of the structure and/or cause any instability

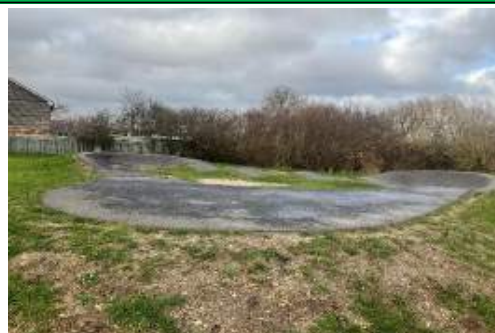
**Item:** Scooter Park  
**Manufacturer:** Unknown  
**Surface Type:** Bitmac  
**Item Quantity:** 1

Surface has eroded and the membrane is exposed causing trip hazards - Infill as required

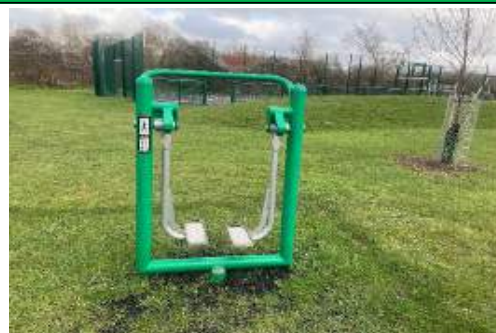
**Item:** Air Walker  
**Manufacturer:** Hags  
**Surface Type:** Grass  
**Item Quantity:** 1

The paint is flaking off the metalwork - Rub down and re-paint

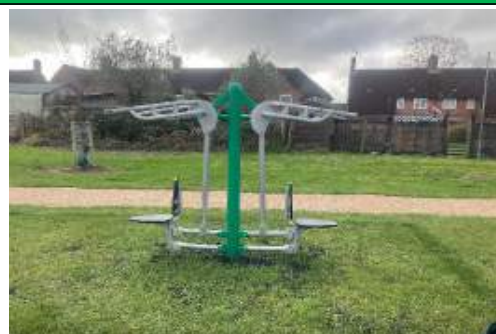
**Item:** Double Fitness Station  
**Manufacturer:** Hags  
**Surface Type:** Grass  
**Item Quantity:** 1

There is some damage to the item - Monitor for any further deterioration and repair as required

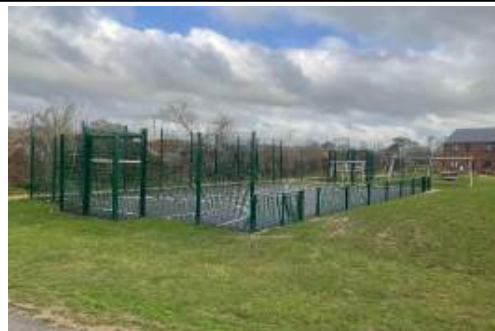
**Item:** Multi Use Games Area (MUGA)  
**Manufacturer:** Eibe Play Ltd  
**Surface Type:** Bitmac  
**Item Quantity:** 1

The goal hoops have been damaged or are missing from the equipment - Repair or replace as required

There is or are fixings missing on the item - Replace all missing fixings x 5-7 m8 coach bolts

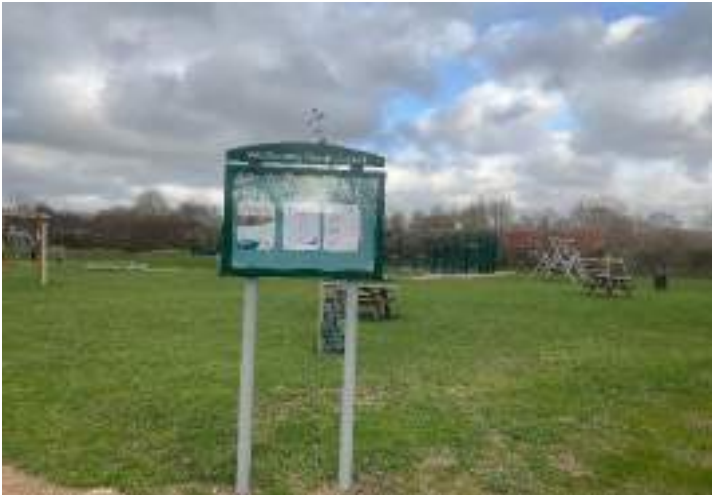
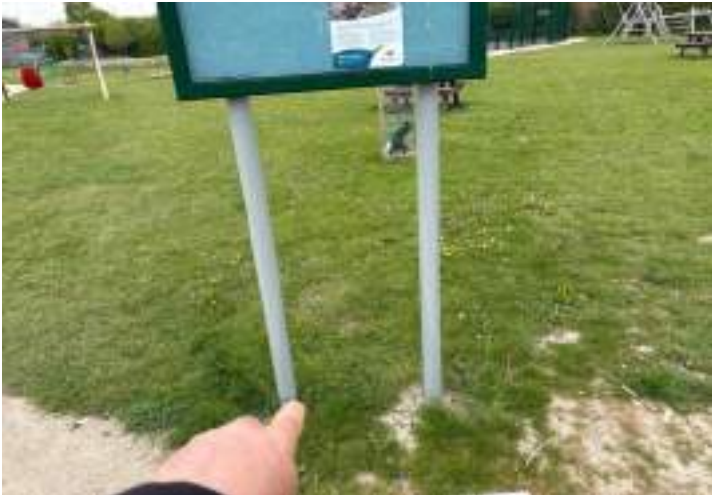
| 6 - Low Risk (Finding 1) | | | |
|---|---|---|---|
| <b>Item:</b> | Signs - Notice Board | <b>Risk Level:</b> | L - Low Risk |

| 6 - Low Risk (Finding 1) | | | |
|---|---|---|---|
| <b>Finding:</b> The item is slightly loose in its foundations | | <b>Action:</b> Monitor for any further deterioration and repair as required | |

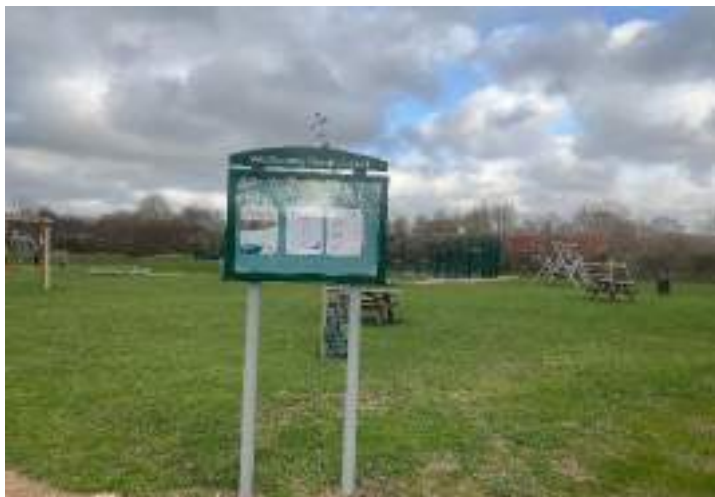
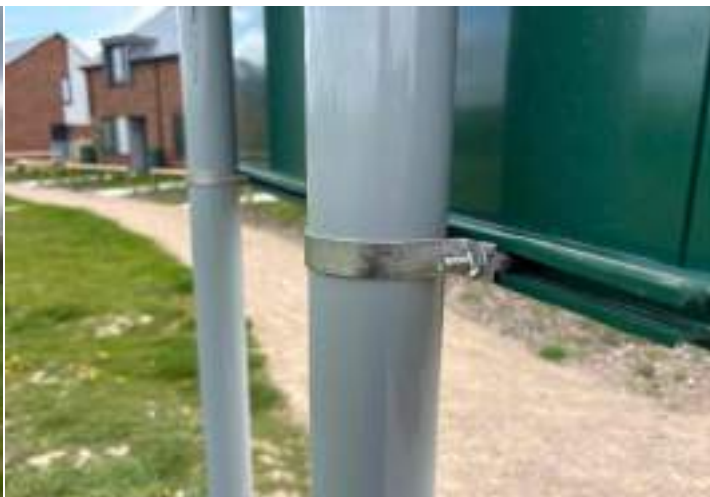
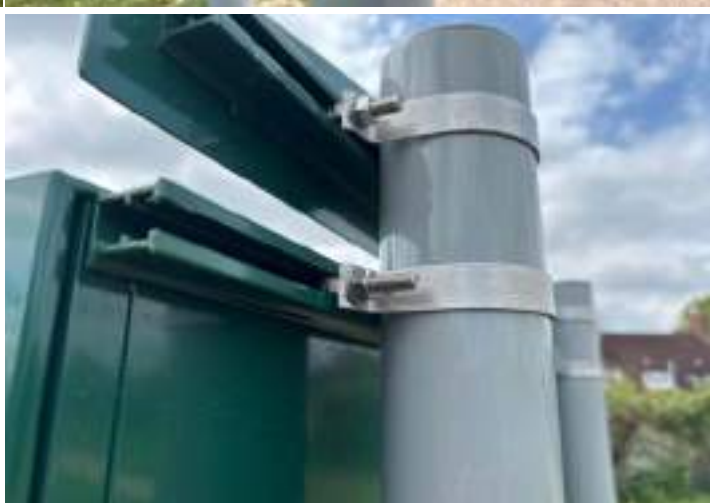
**Item:** Signs - Notice Board  
**Manufacturer:** Unknown

**Finding:** There are projecting bolt thread(s) present

**Action:** Remove excess thread length and deburr or provide cap

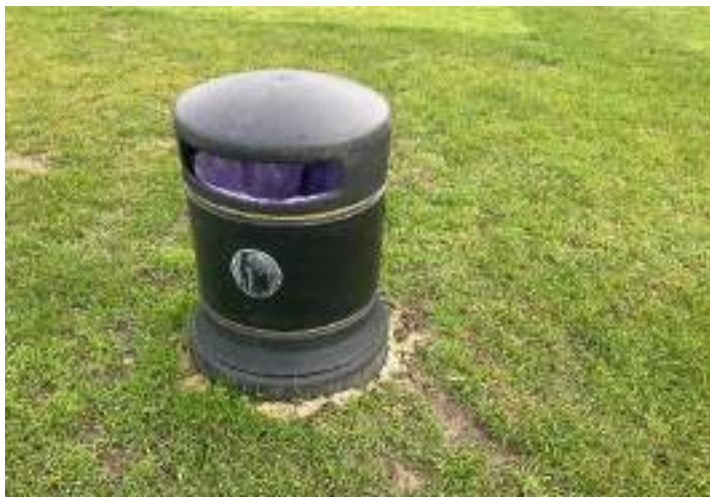
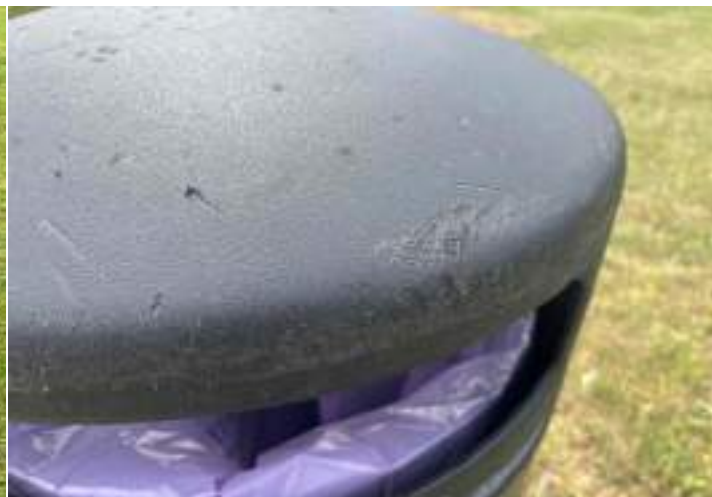
**Item:** Ancillary Items - Litter Bin  
**Manufacturer:** Unknown

**Finding:** There is some damage to the item

**Action:** Monitor for any further deterioration and repair as required

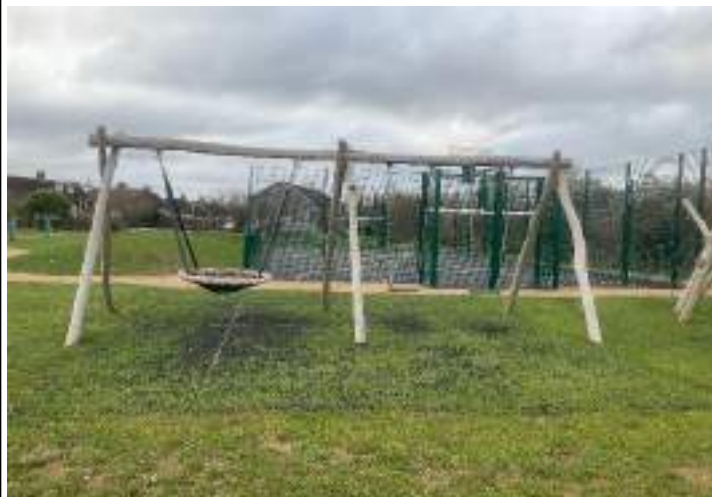
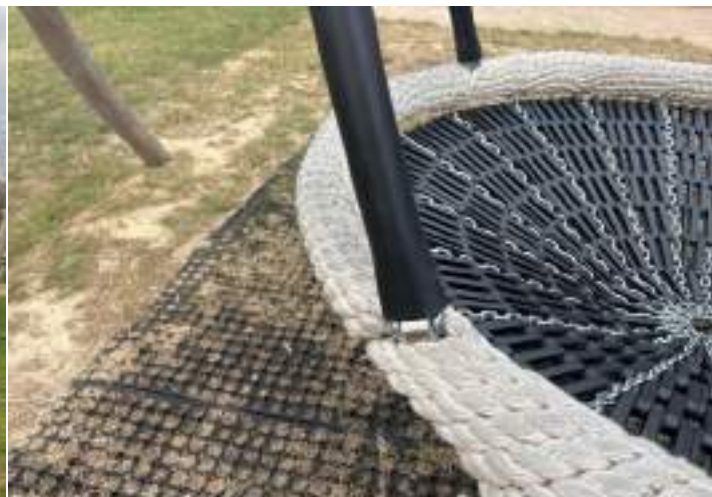
**Item:** Swings - 2 Bay 2 Flat 1 Basket Seat  
**Manufacturer:** Eibe Play Ltd

**Finding:** The seat connection cannot be inspected fully as the chain cover cannot be lifted

**Action:** Cut the cover to allow access to the shackle and assess the wear

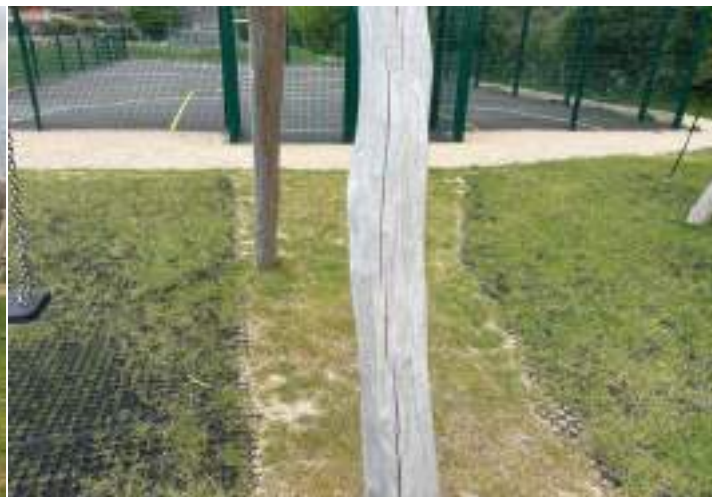
**Item:** Swings - 2 Bay 2 Flat 1 Basket Seat  
**Manufacturer:** Eibe Play Ltd

**Finding:** The timber has a number of splits/shakes or air cracks and this may affect the stability or allow water ingress which will accelerate the rotting process

**Action:** Monitor to ensure the splits do not cross through fixing points of the structure and/or cause any instability

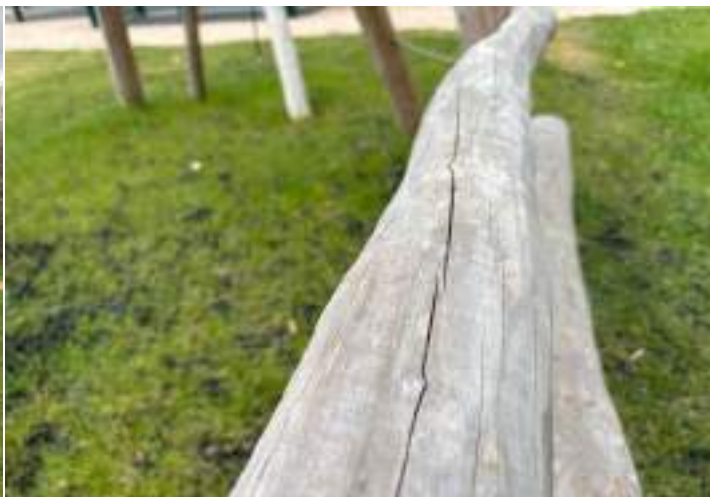
**Item:** Activity Equipment - Log Climber  
**Manufacturer:** Eibe Play Ltd

**Finding:** The timber has a number of splits/shakes or air cracks and this may affect the stability or allow water ingress which will accelerate the rotting process

**Action:** Monitor to ensure the splits do not cross through fixing points of the structure and/or cause any instability

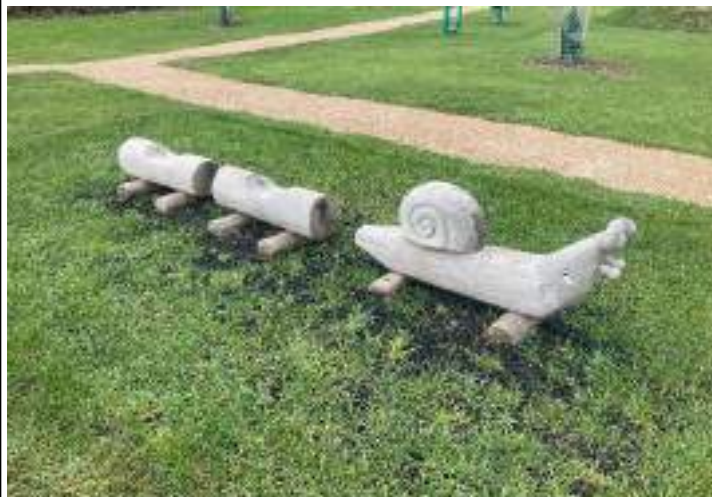
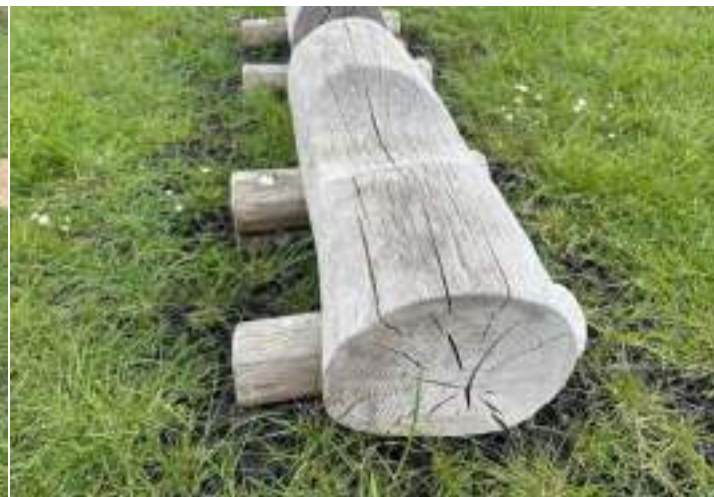
**Item:** Other - Animal Bench  
**Manufacturer:** Eibe Play Ltd

**Finding:** The timber has a number of splits/shakes or air cracks and this may affect the stability or allow water ingress which will accelerate the rotting process

**Action:** Monitor to ensure the splits do not cross through fixing points of the structure and/or cause any instability

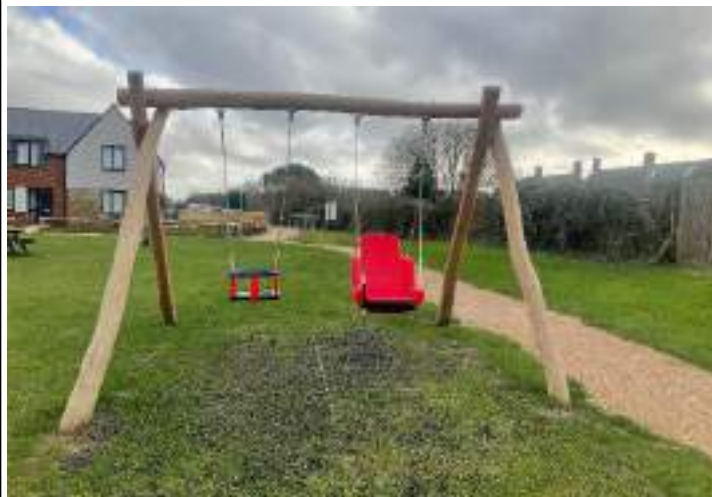
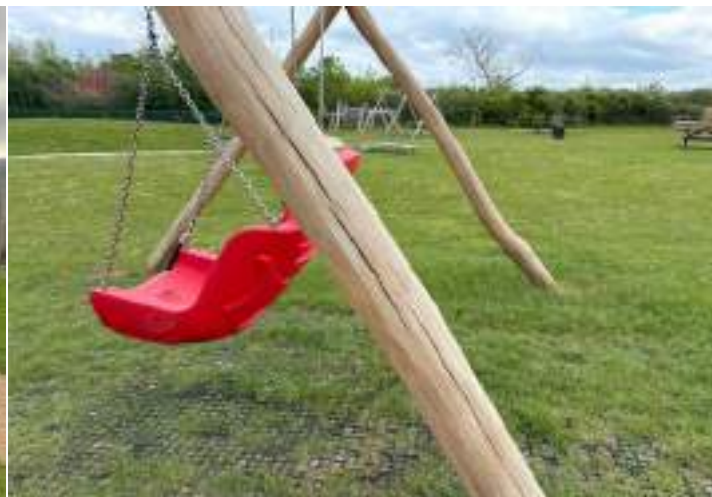
**Item:** Swings - 1 Bay 1 Seat (Cradle) - Type 1  
**Manufacturer:** Eibe Play Ltd

**Finding:** The timber has a number of splits/shakes or air cracks and this may affect the stability or allow water ingress which will accelerate the rotting process

**Action:** Monitor to ensure the splits do not cross through fixing points of the structure and/or cause any instability

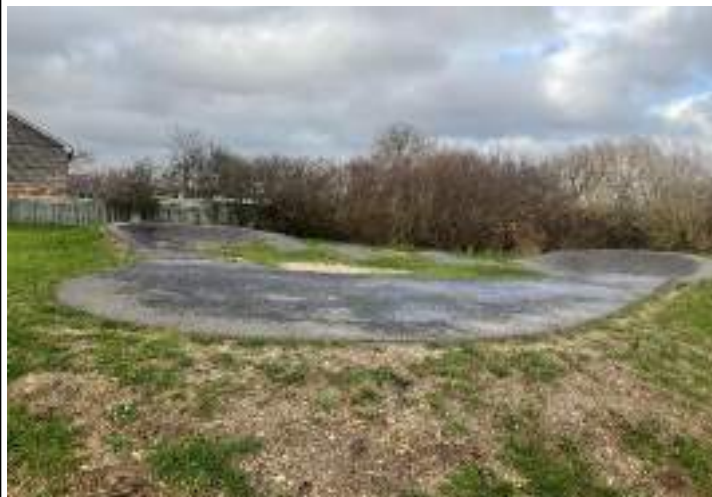
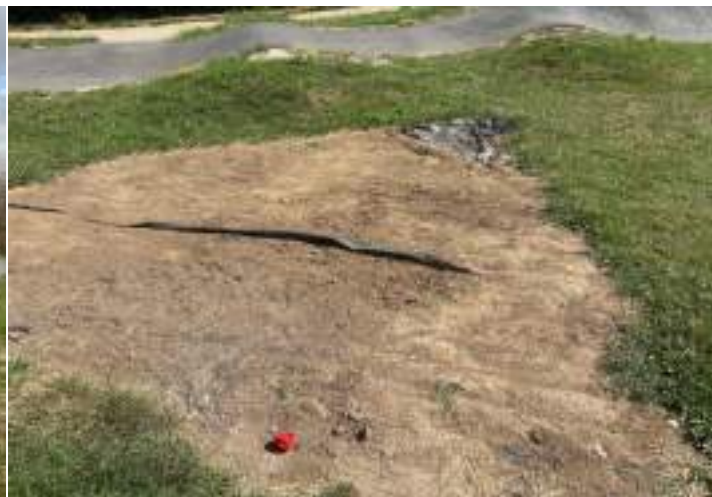
**Item:** Wheeled Sports - Scooter Park  
**Manufacturer:** Unknown

**Finding:** Surface has eroded and the membrane is exposed causing trip hazards  
**Action:** Infill as required

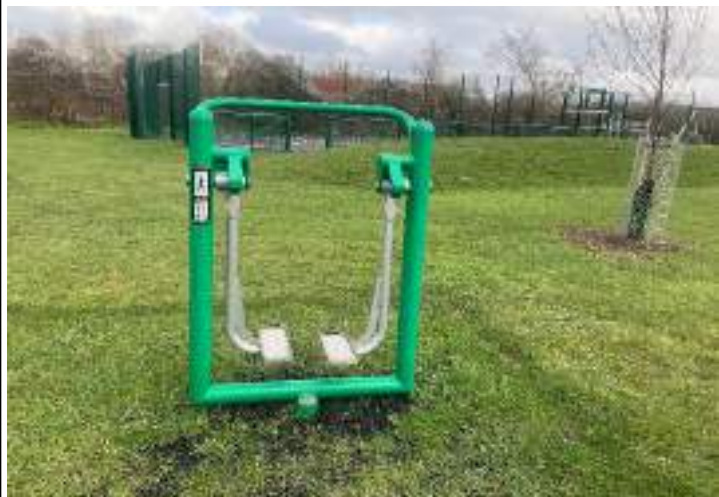
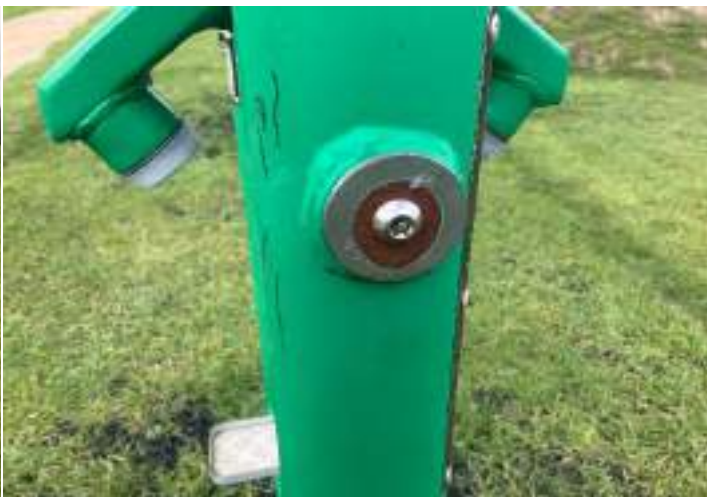
**Item:** Outdoor Fitness Equipment - Air Walker  
**Manufacturer:** Hags

**Finding:** The paint is flaking off the metalwork

**Action:** Rub down and re-paint

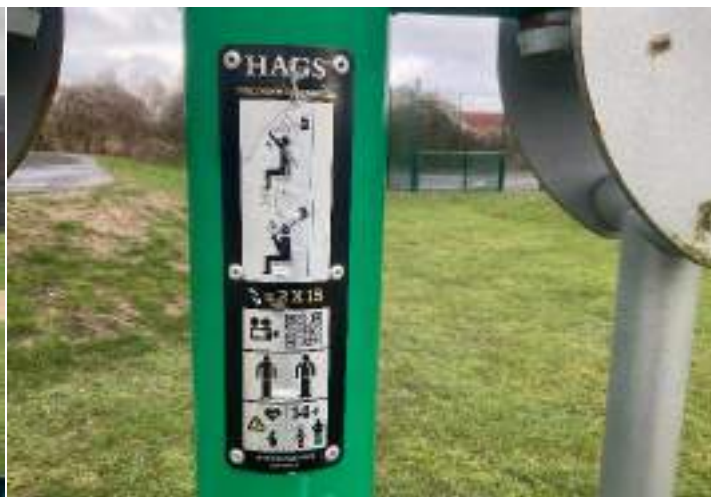
**Finding:** There is some damage to the item

**Action:** Monitor for any further deterioration and repair as required

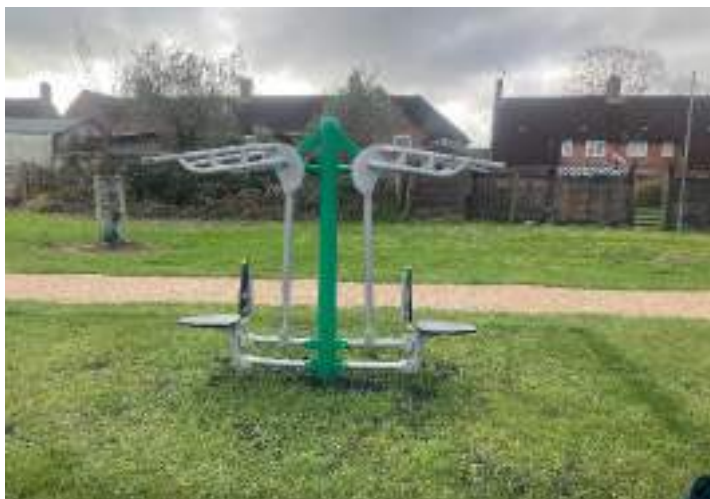
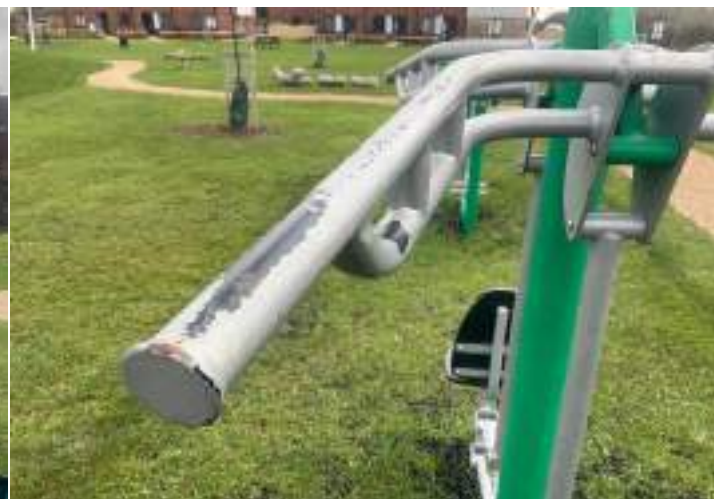
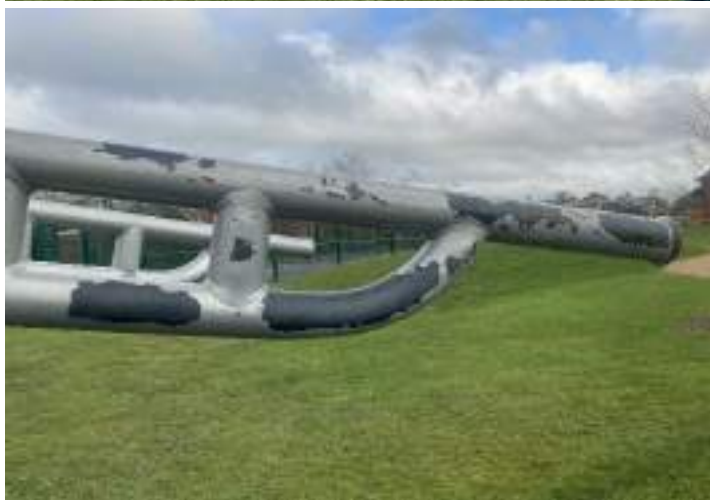
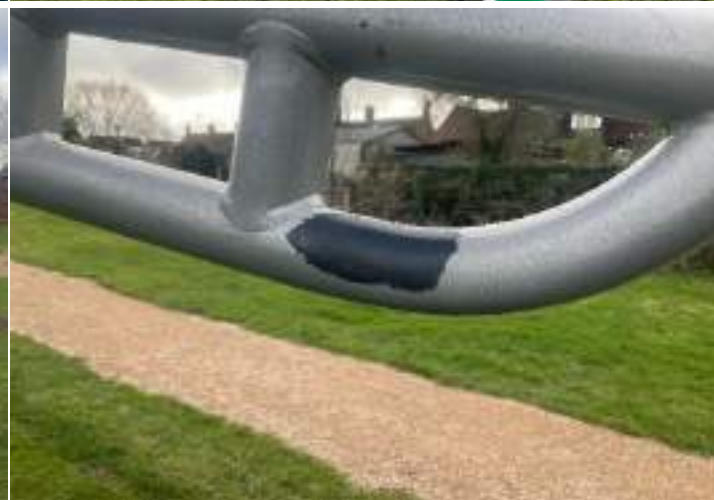
**Finding:** The paint is flaking off the metalwork

**Action:** Rub down and re-paint

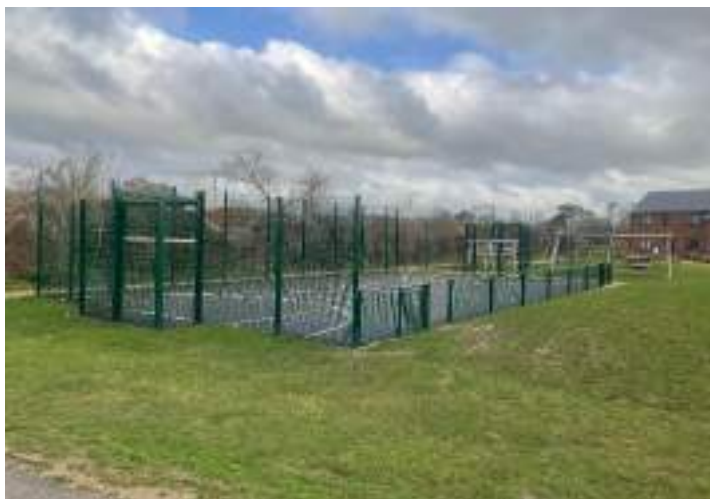
**Finding:** The goal hoops have been damaged or are missing from the equipment

**Action:** Repair or replace as required

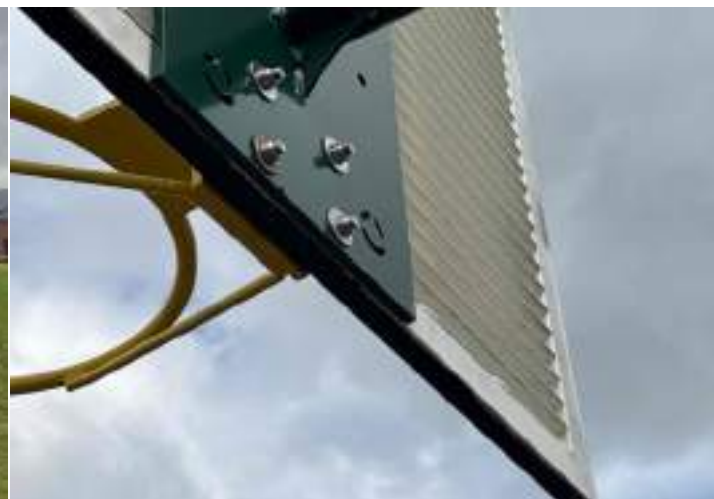
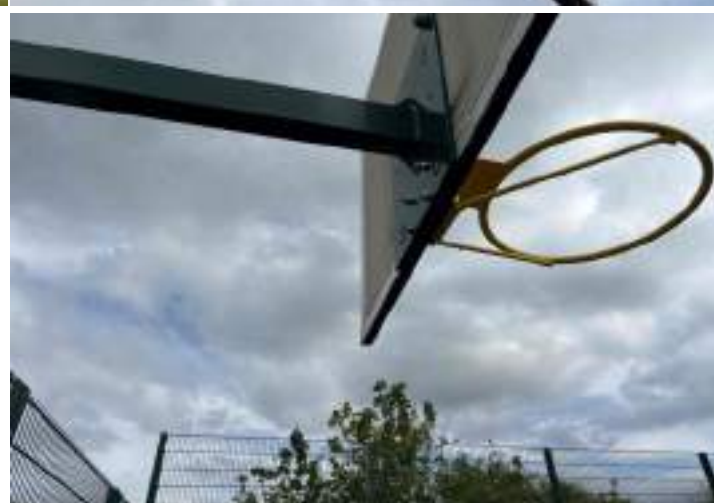
**Finding:** There are projecting bolt thread(s) present

**Action:** Remove excess thread length and deburr or provide cap

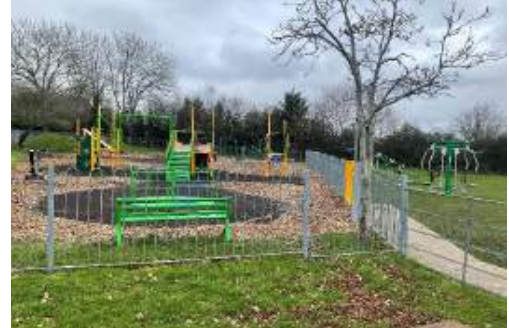
**Item:** Site General  
**Manufacturer:** Owner/Operator  
**Surface Type:** N/A  
**Item Quantity:** 1

The surface has eroded and the foundations are exposed - Reinstate surrounding surfaces to cover the foundations

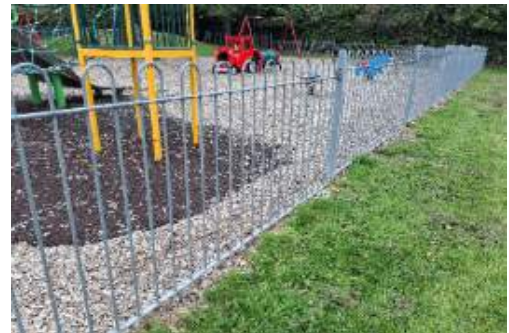
**Item:** Fence - Bow Top  
**Manufacturer:** Not Identified  
**Surface Type:** Grass  
**Item Quantity:** 1

A number of fixings have worked loose around the fencing - inaccessible - Secure all loose fixings

There are a number of fixings missing from the fence - Replace 2 missing fixings

The paintwork on this item has been damaged or worn exposing the metal underneath which is rusting - Treat any rusting components and repaint

There are loose posts around the fence x 26 in total, around the whole fencing - Monitor for any further deterioration and reset as required

Majority of the kick boards/retaining boards are missing - Replace

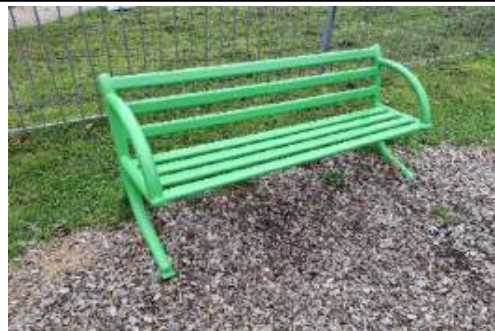
**Item:** Bench  
**Manufacturer:** Wicksteed Playgrounds  
**Surface Type:** Woodchip  
**Item Quantity:** 2

A number of ground fixing(s) have worked loose which is covered by surfacing - Secure all loose fixings

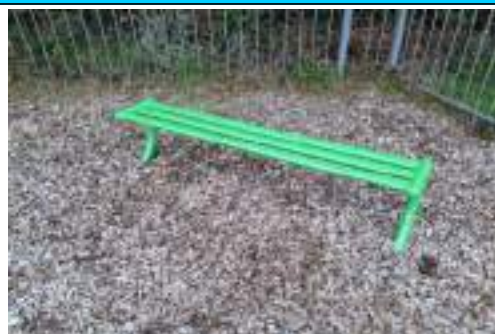
**Item:** Bench  
**Manufacturer:** Not Identified  
**Surface Type:** Woodchip  
**Item Quantity:** 1

This item is satisfactory - no work required -

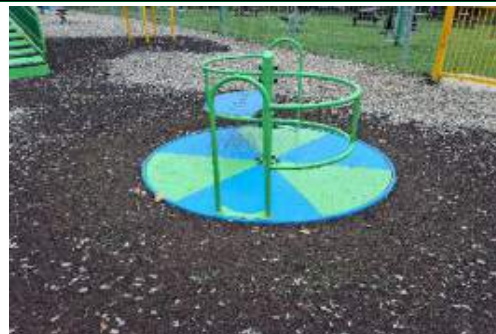
**Item:** Inclusive Roundabout  
**Manufacturer:** Wicksteed Playgrounds  
**Surface Type:** Bonded Rubber Mulch  
**Item Quantity:** 1

There is or are fixings missing on the item- corner of the platform can now be lifted | - Replace 1 missing fixings

The bearing is worn / damaged and the item is not operating correctly - Repair / replace

There are trip hazards present - Reinstate surrounding surfaces to level to remove the trip points

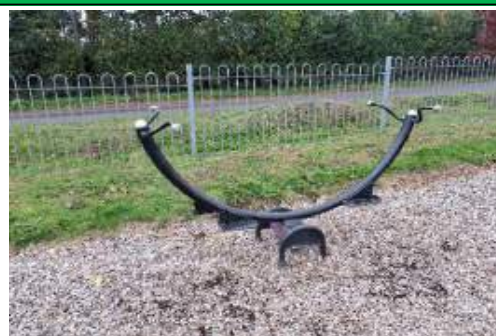
**Item:** See Saw  
**Manufacturer:** Wicksteed Playgrounds  
**Surface Type:** Bark Mulch  
**Item Quantity:** 1

The paint is flaking off the metalwork - Rub down and re-paint

There is some minor damage to the surface of the item - Monitor for any further deterioration and repair as required

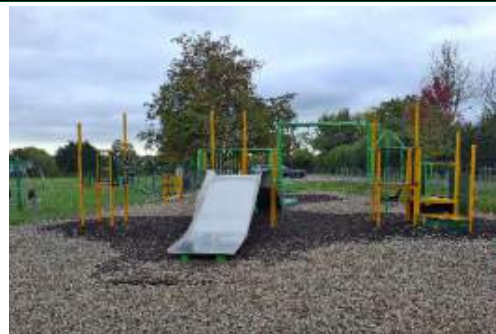
**Item:** Multi Play (Junior)  
**Manufacturer:** Wicksteed Playgrounds  
**Surface Type:** Bonded Rubber Mulch  
**Item Quantity:** 1

There is some wear to the shackles. - Monitor for any further deterioration and replace when 40% worn

The surface is lifting at the edges and creating trip points - Repair perimeter of surfacing to remove trip points

There are a number of dents in the slide surface - Monitor for any further deterioration and repair as required

A number of fixing(s) have worked loose - due to style of fixing and barriers unable to reach both male and female part at the same time to tighten - Secure all loose fixings

There is surface corrosion present on the item - Consider treating and repainting the item

There is some notable evidence of chain wear - Monitor for any further deterioration and replace when 40% worn

The ropes/nets are worn/damaged in places - Monitor for any further deterioration and repair or replace as required

There is/are several inserts missing approx 60 - Replace missing inserts

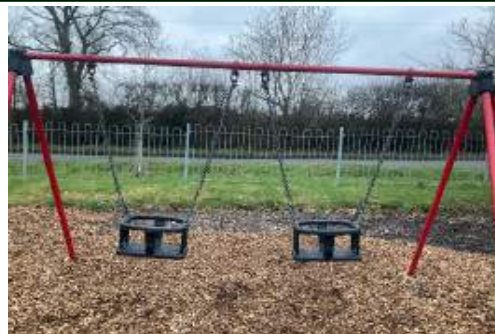
**Item:** 1 Bay 2 Seat (Cradle)  
**Manufacturer:** Wicksteed Playgrounds  
**Surface Type:** Mixed Surface  
**Item Quantity:** 1

The bushes are worn or missing x 4 - Replace worn or missing bushes

There is some wear to the shackles. - Monitor for any further deterioration and replace when 40% worn

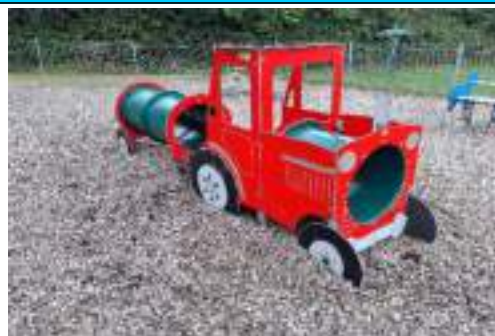
**Item:** Tractor  
**Manufacturer:** Playdale Playgrounds Ltd  
**Surface Type:** Woodchip  
**Item Quantity:** 1

This item is satisfactory - no work required -

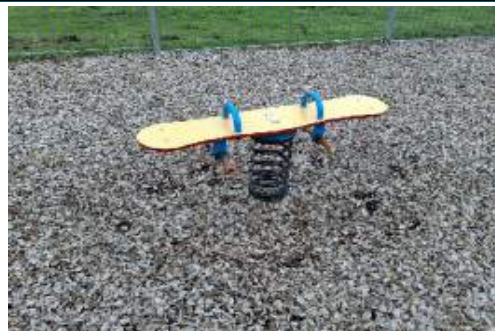
**Item:** Spring See-Saw  
**Manufacturer:** Wicksteed Playgrounds  
**Surface Type:** Woodchip  
**Item Quantity:** 1

There is/are bolt cap covers missing or damaged on the item - Replace 1 missing or damaged bolt cap covers

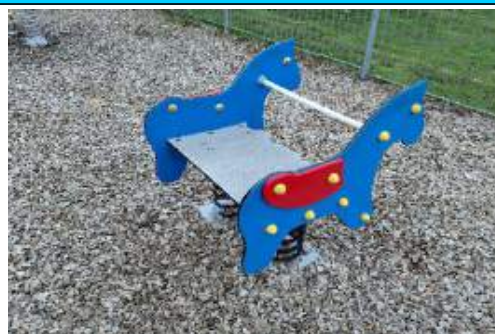
**Item:** Spring Horse  
**Manufacturer:** Ledon  
**Surface Type:** Woodchip  
**Item Quantity:** 1

There is algae or moss on the surface of the equipment - Clean and treat appropriately

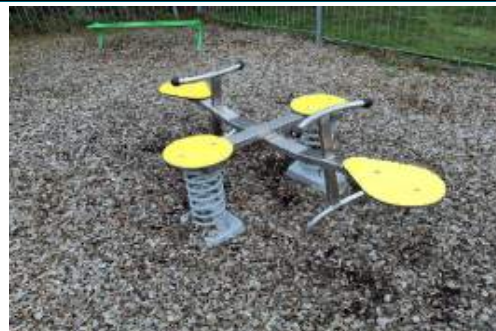
**Item:** Spring See-Saw  
**Manufacturer:** Playdale Playgrounds Ltd  
**Surface Type:** Woodchip  
**Item Quantity:** 1

There is/are bolt cap covers missing or damaged on the item - Replace 8 missing or damaged bolt cap covers

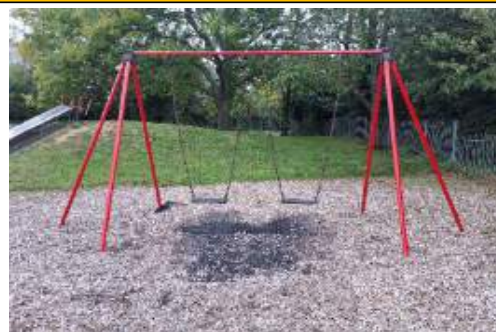
**Item:** 1 Bay 2 Seat (Flat)  
**Manufacturer:** Wicksteed Playgrounds  
**Surface Type:** Mixed Surface  
**Item Quantity:** 1

The chain links are worn in excess of 50% and require renewing on both swings - Replace worn chains 2x sets of chains

There is some wear to the shackles. - Monitor for any further deterioration and replace when 40% worn

There is surface corrosion present on the item - Consider treating and repainting the item

The bushes are worn or missing - Replace worn or missing bushes

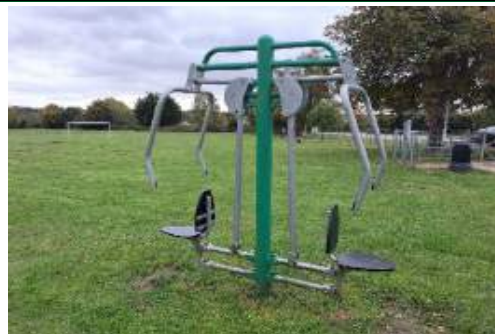
**Item:** Chest Press  
**Manufacturer:** Hags  
**Surface Type:** Grass Matrix Tiles  
**Item Quantity:** 1

The paintwork on this item has been damaged or worn exposing the metal underneath which is rusting - Treat any rusting components and repaint

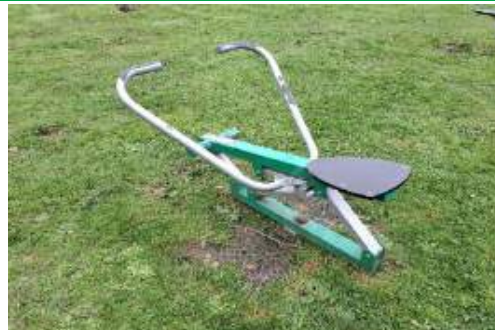
**Item:** Handle Boat  
**Manufacturer:** Hags  
**Surface Type:** Grass Matrix Tiles  
**Item Quantity:** 1

The paint is flaking off the metalwork - Rub down and repaint

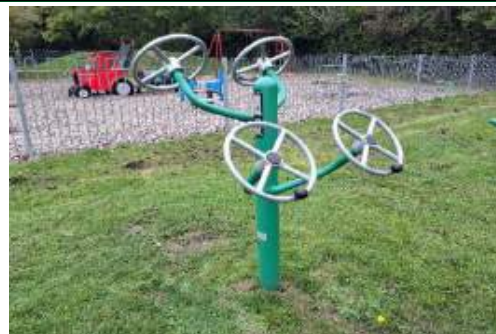
**Item:** Tai Chi Wheels  
**Manufacturer:** Hags  
**Surface Type:** Grass Matrix Tiles  
**Item Quantity:** 1

The paintwork on this item has been damaged or worn exposing the metal underneath which is rusting - Treat any rusting components and repaint

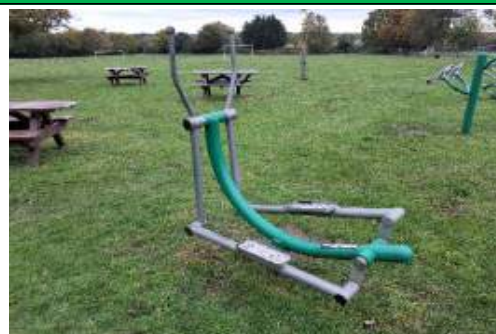
**Item:** Cross Trainer  
**Manufacturer:** Hags  
**Surface Type:** Grass Matrix Tiles  
**Item Quantity:** 1

The grass mats are silted up, the soil is compacted and the area will become very slippery when the soil is wet. - Reinstatement as required

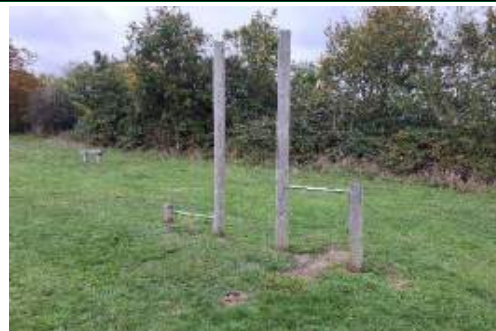
**Item:** Fit Point  
**Manufacturer:** Sovereign Leisure  
**Surface Type:** Grass Matrix Tiles  
**Item Quantity:** 1

The timber has a number of splits/shakes or air cracks and this may affect the stability or allow water ingress which will accelerate the rotting process - Monitor to ensure the splits do not cross through fixing points of the structure and/or cause any instability

The item has been severely damaged - Replace item

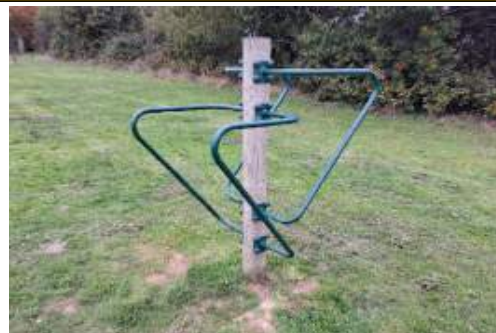
**Item:** Dip Station  
**Manufacturer:** Sovereign Leisure  
**Surface Type:** Grass  
**Item Quantity:** 1

Parts of the timber are rough or splintered - Remove all rough or sharp edges

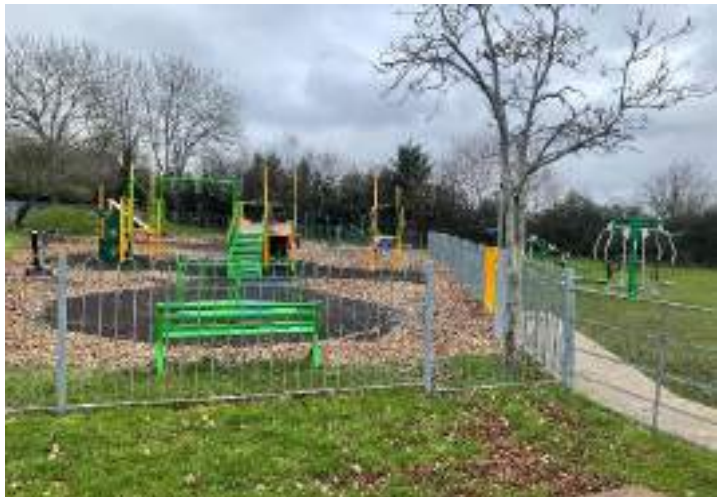
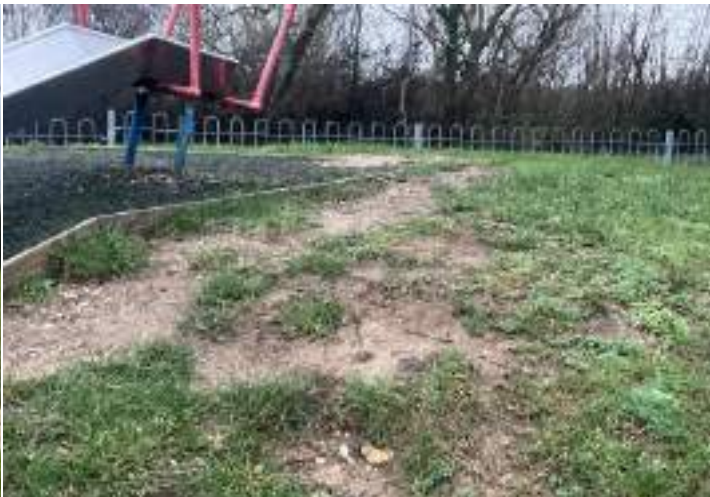
| 8 - Low Risk (Finding 1) | | | |
|---|---|---|---|
| <b>Item:</b> | Ancillary Items - Site General | <b>Risk Level:</b> | L - Low Risk |

| 8 - Low Risk (Finding 1) | | | |
|---|---|---|---|
| <b>Finding:</b> The area around the item has eroded and may become slippery | | <b>Action:</b> Reinstate eroded area | |

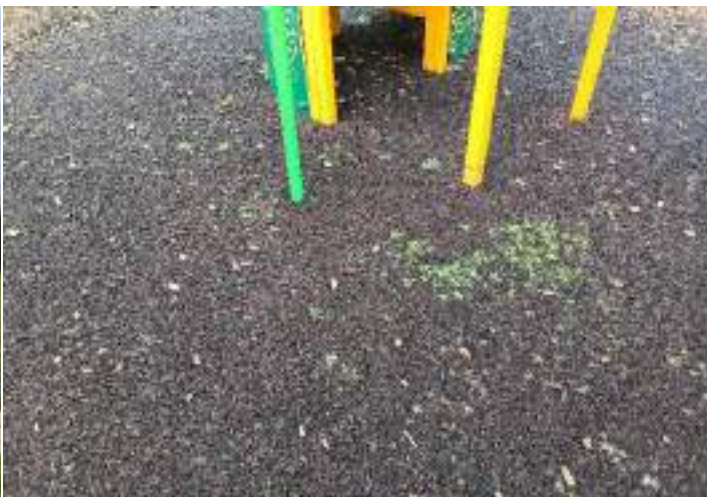
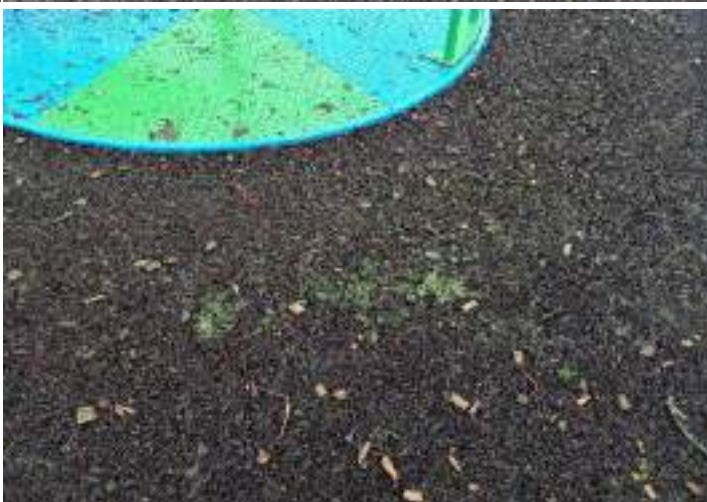
**Finding:** There is weed / vegetation growth on, between, or around the edges of the surfacing  
**Action:** Remove weed / vegetation growth

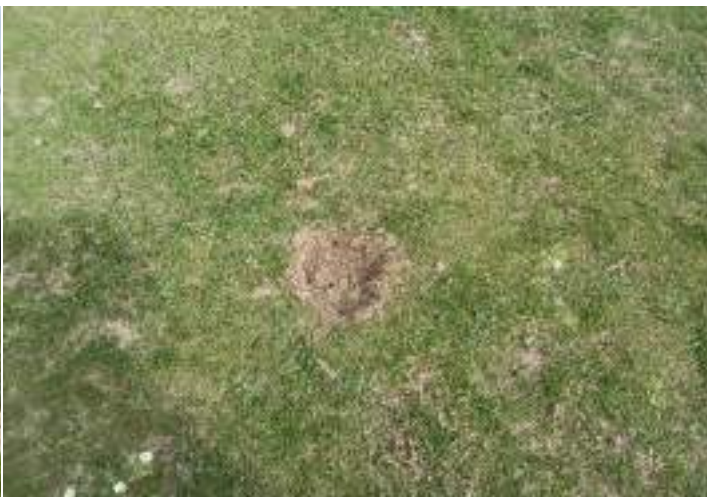
**8 - Low Risk (Finding 3)**

**Finding:** There are holes in surface that may have been created purposely by users.

**Action:** Infill to provide a sound reasonably level surface.

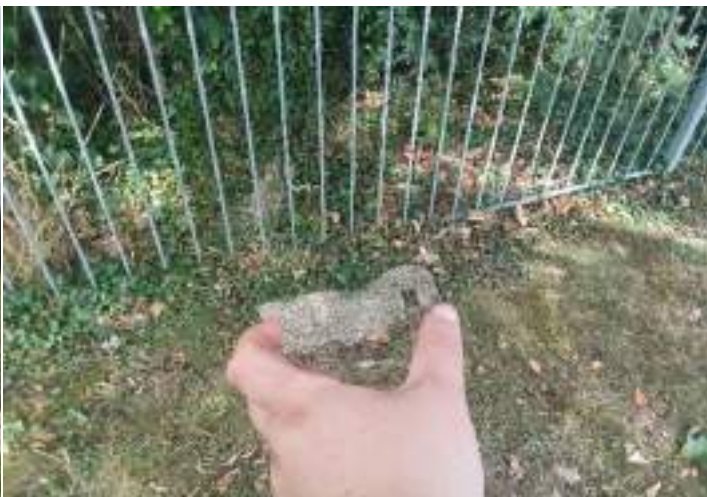
**Finding:** The surface has eroded and the foundations are exposed

**Action:** Reinstate surrounding surfaces to cover the foundations

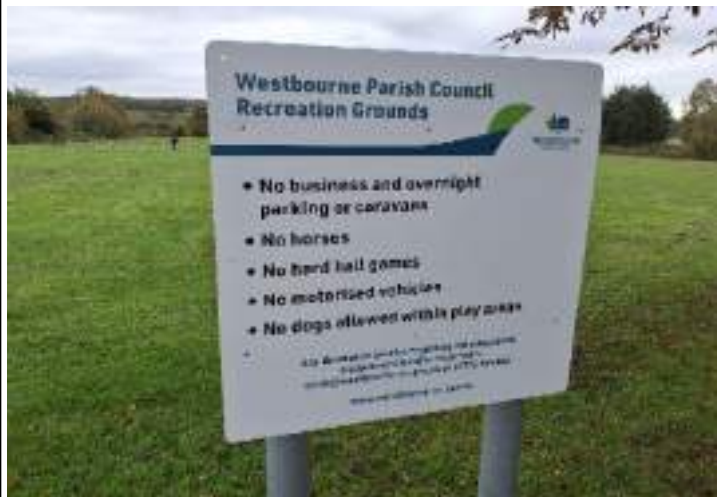
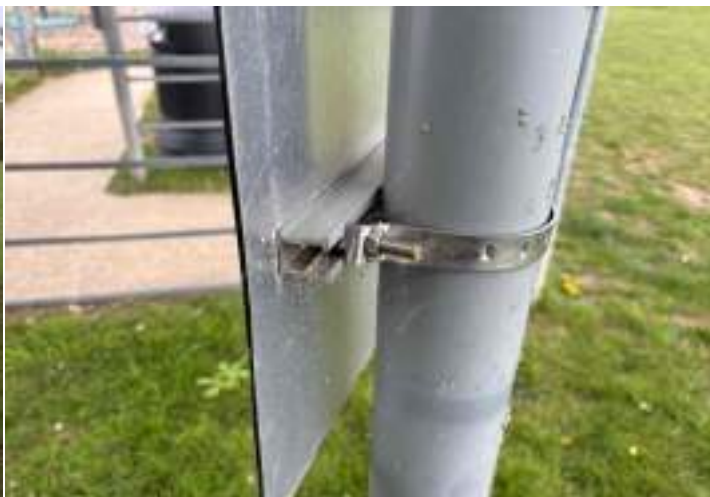
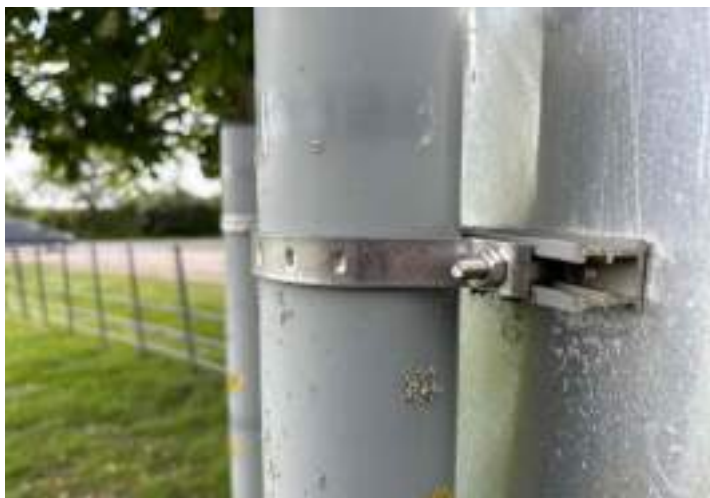
**Finding:** There are projecting bolt thread(s) present

**Action:** Remove excess thread length and deburr or provide cap

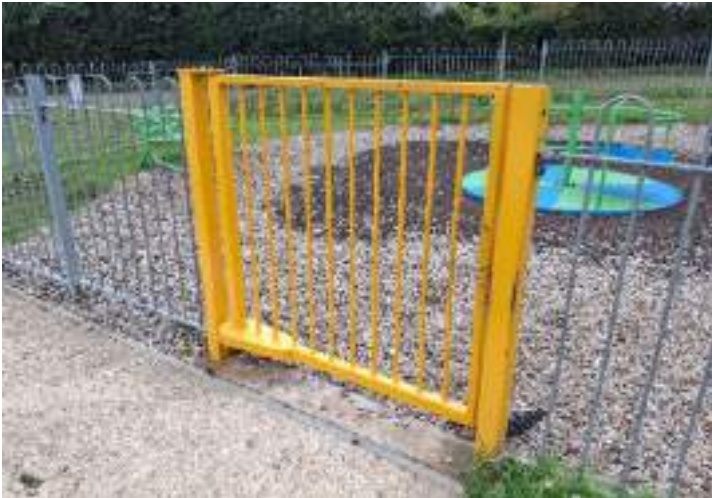
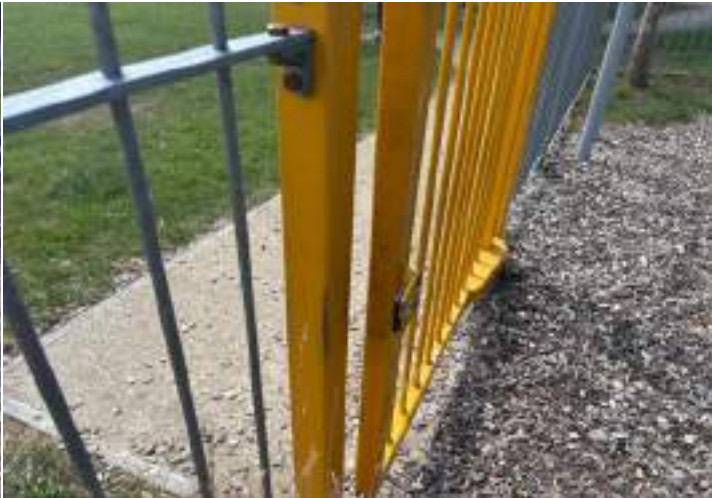
| 5 - Very Low Risk (Finding 1) | | | |
|---|---|---|---|
| <b>Finding:</b> The gate is not operating correctly | | <b>Action:</b> Take effective action to ensure the gate closes between 4 and 8 seconds | |

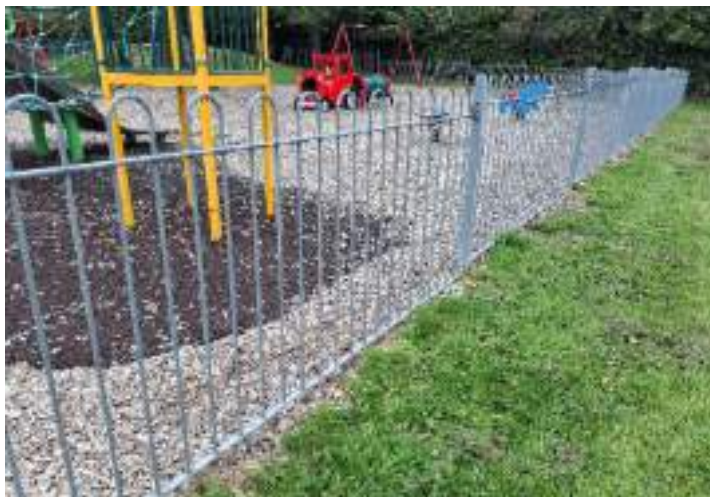
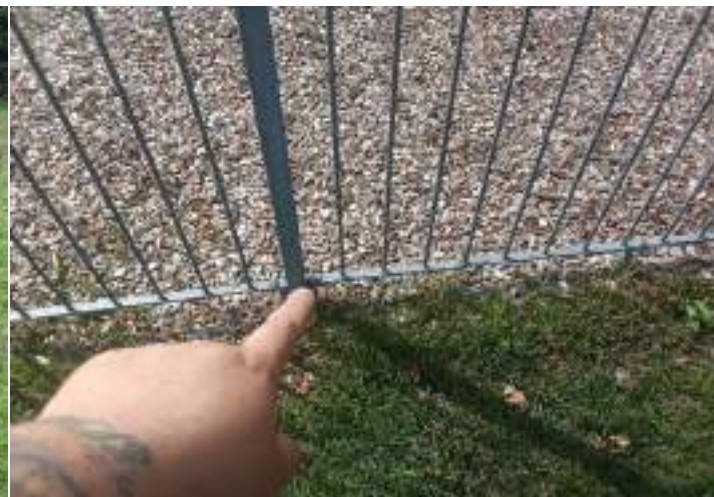
**6 - Low Risk (Finding 1)**

**Finding:** A number of fixings have worked loose around the fencing-inaccessible  
**Action:** Secure all loose fixings
