## **Westbourne Parish Council, 10 September 2026**

## Operational Inspection

Westbourne Parish Council

## Inspection Scope for RPII Annual Inspectors

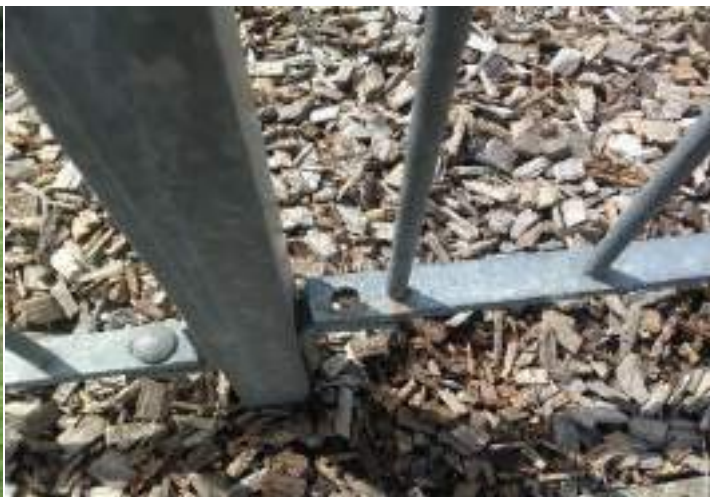
**6 - Low Risk (Finding 2)**

**Finding:** There are a number of fixings missing from the fence

**Action:** Replace 2 missing fixings

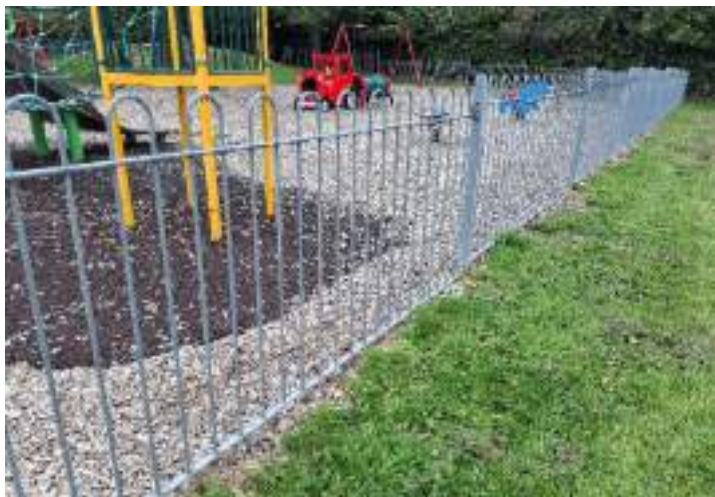
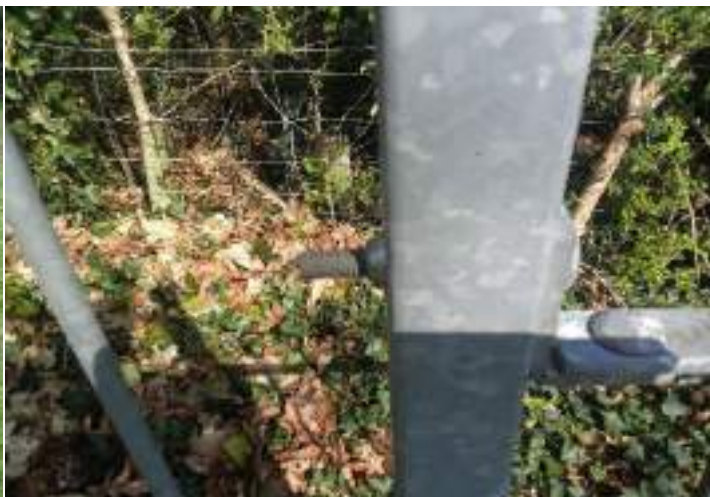
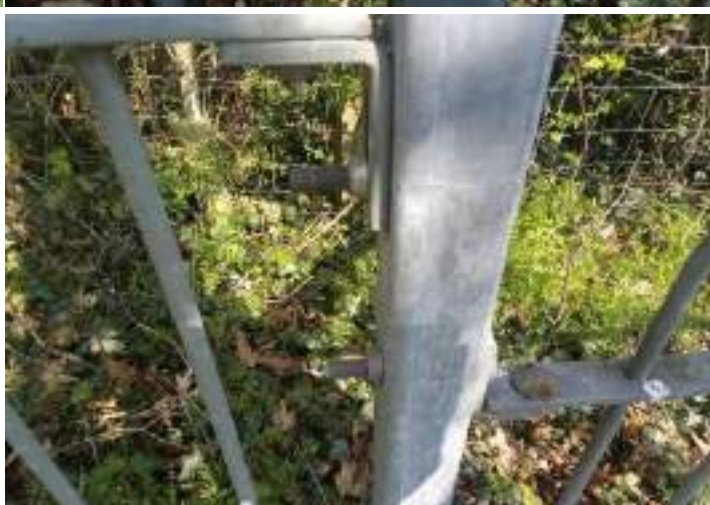
**Finding:** There are projecting bolt thread(s) present

**Action:** Remove excess thread length and deburr or provide cap

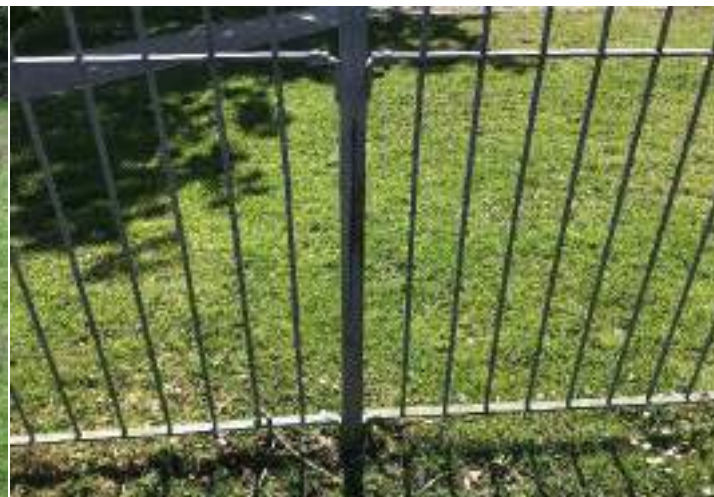
**6 - Low Risk (Finding 4)**

**Finding:** The paintwork on this item has been damaged or worn exposing the metal underneath which is rusting

**Action:** Treat any rusting components and repaint

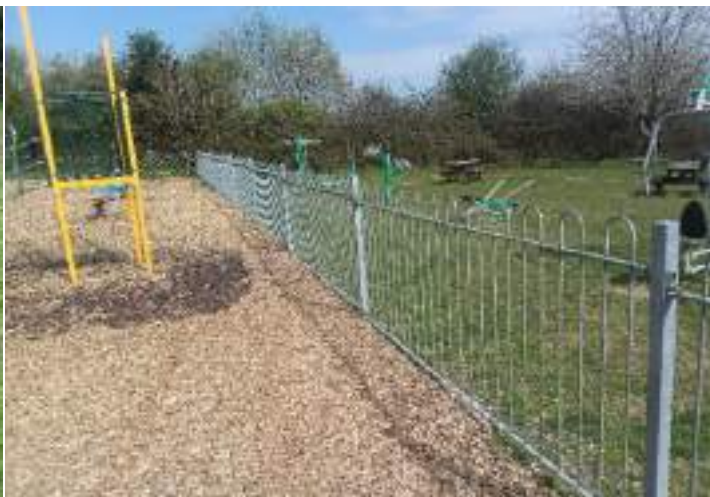
**Finding:** There are loose posts around the fence x 26 in total, around the whole fencing

**Action:** Monitor for any further deterioration and reset as required

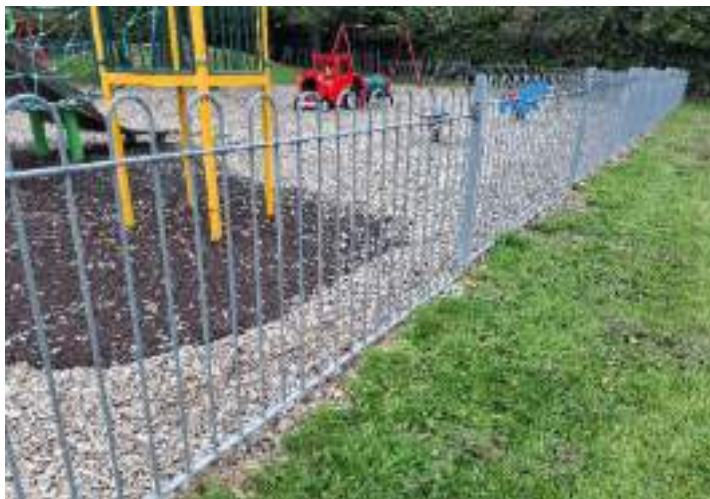
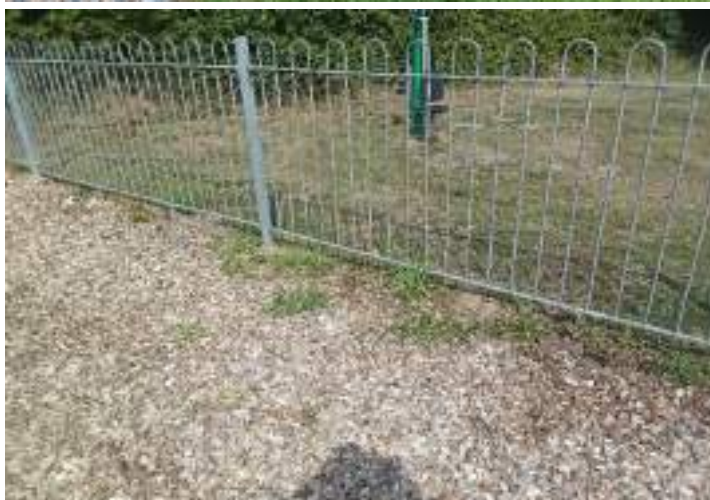
**Finding:** Majority of the kick boards/retaining boards are missing

**Action:** Replace

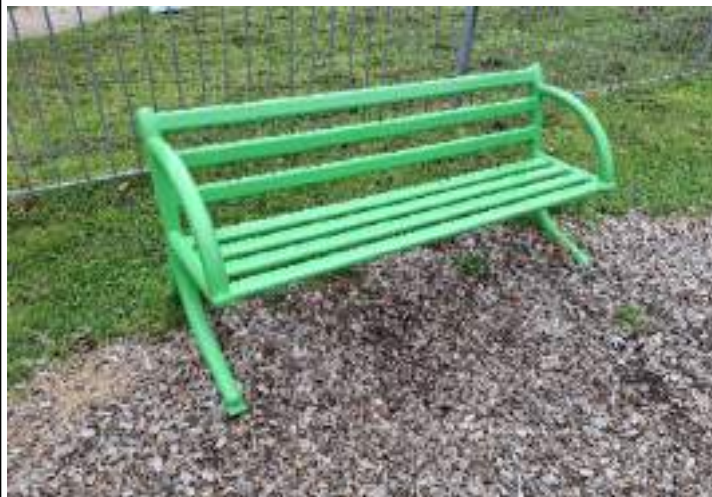
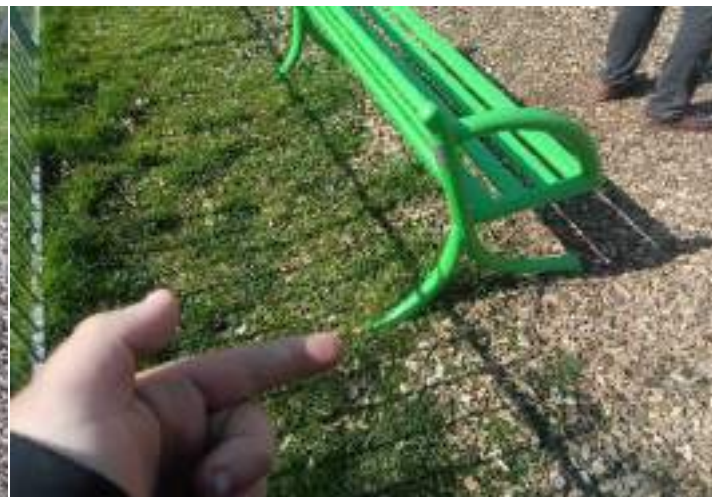
**Finding:** A number of ground fixing(s) have worked loose which is covered by surfacing

**Action:** Secure all loose fixings

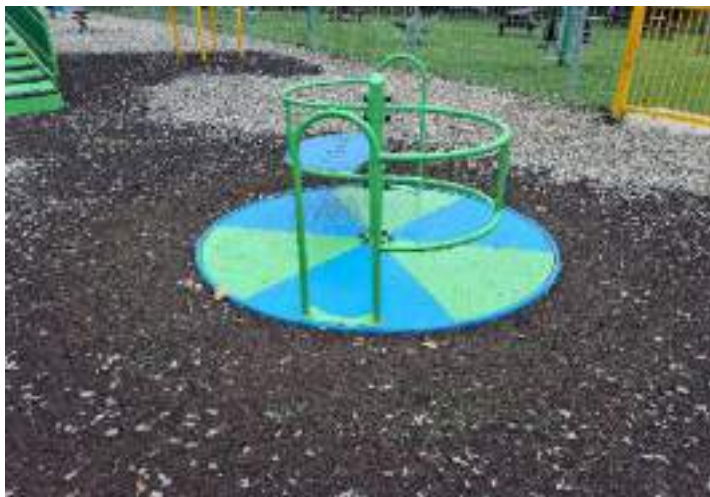
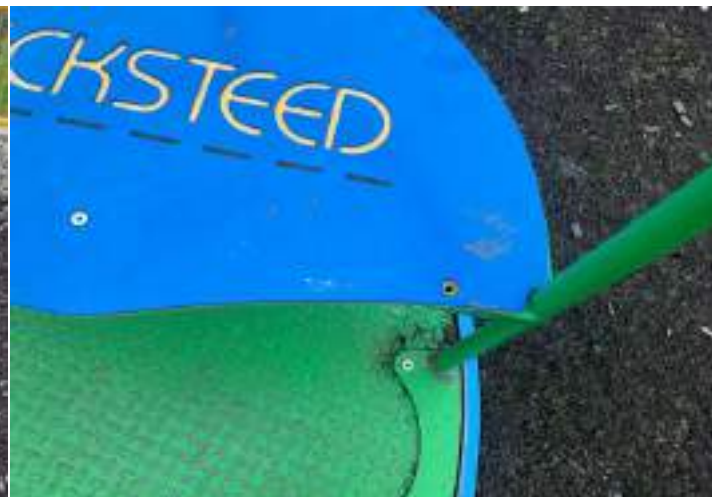
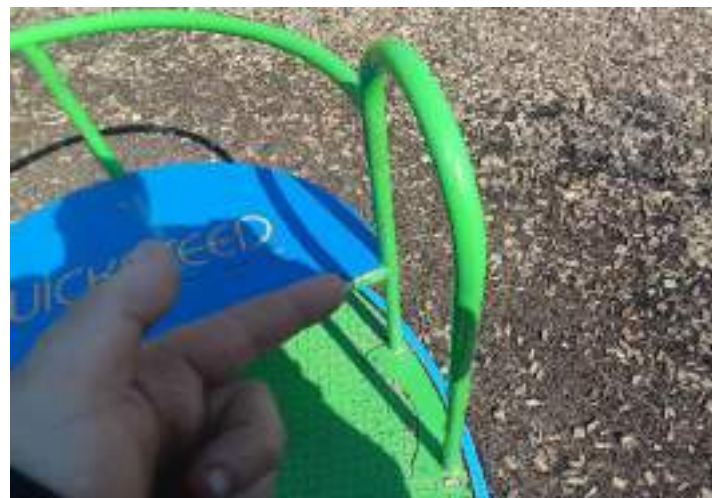
**Finding:** There is or are fixings missing on the item- corner of the platform can now be lifted I

**Action:** Replace 1 missing fixings

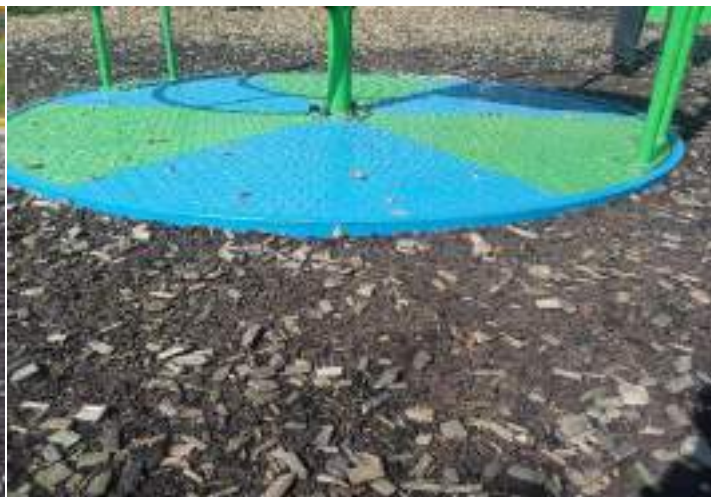
**Finding:** There are trip hazards present

**Action:** Reinstate surrounding surfaces to level to remove the trip points

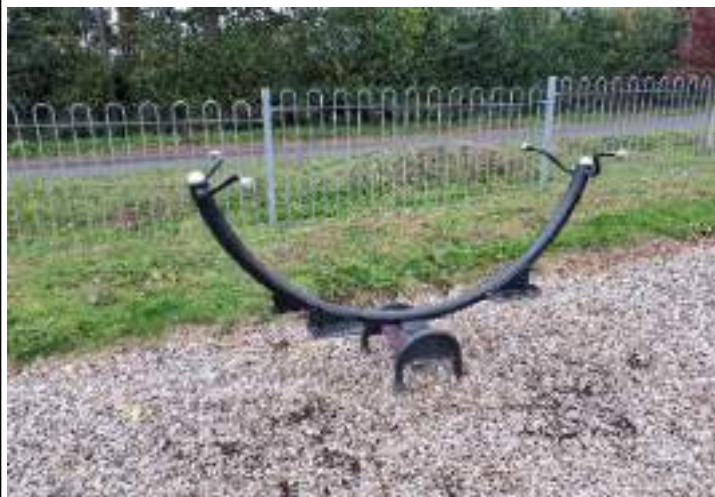
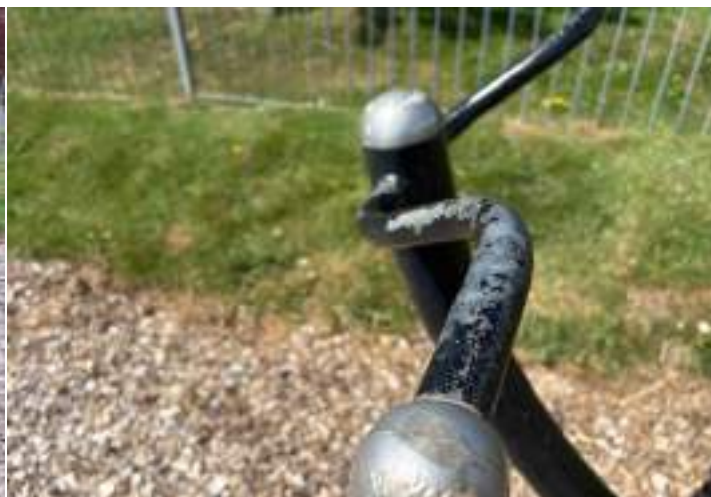
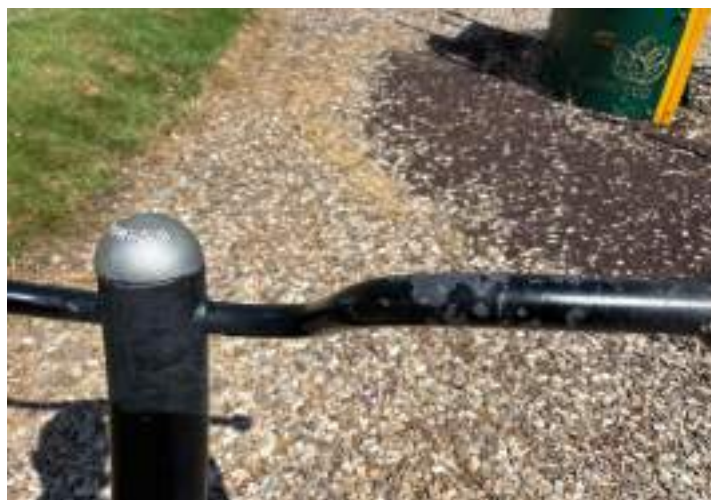
**Finding:** The paint is flaking off the metalwork

**Action:** Rub down and re-paint

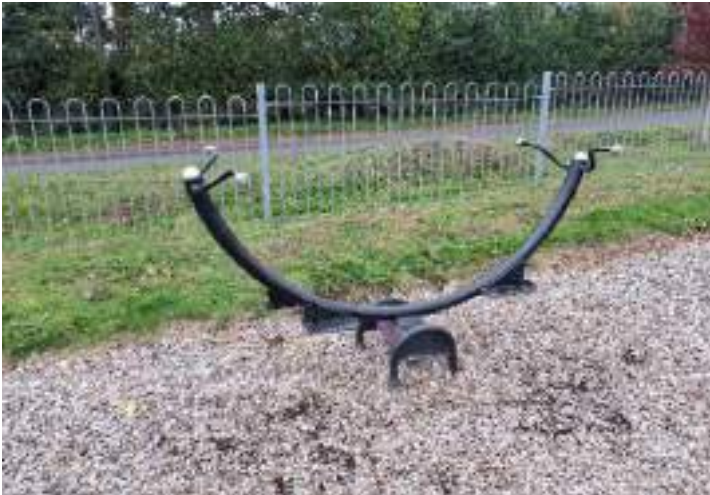
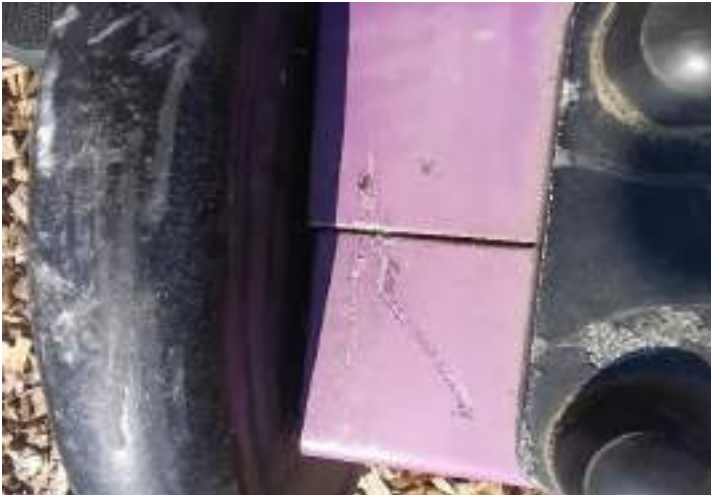
| 4 - Very Low Risk (Finding 2) | | | |
|---|---|---|---|
| <b>Finding:</b> There is some minor damage to the surface of the item | | <b>Action:</b> Monitor for any further deterioration and repair as required | |

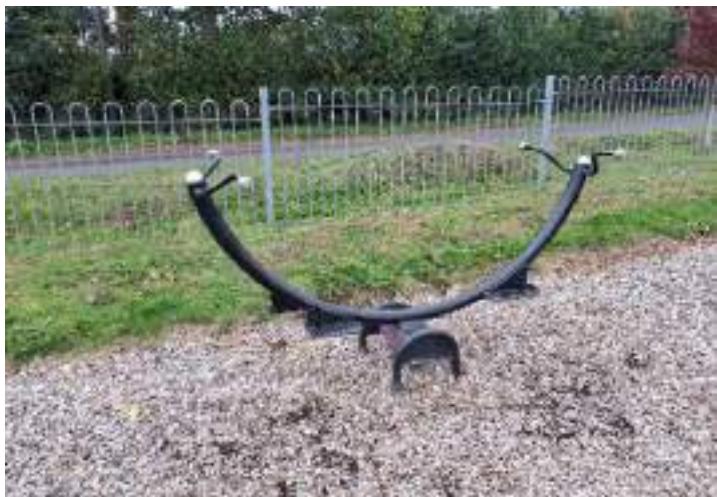
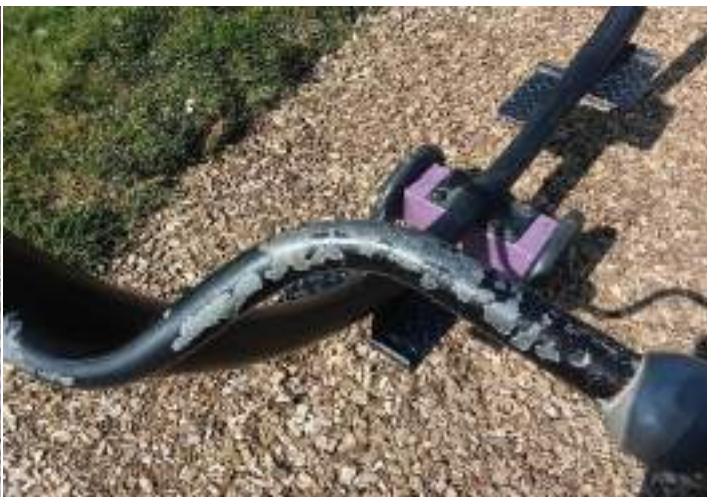
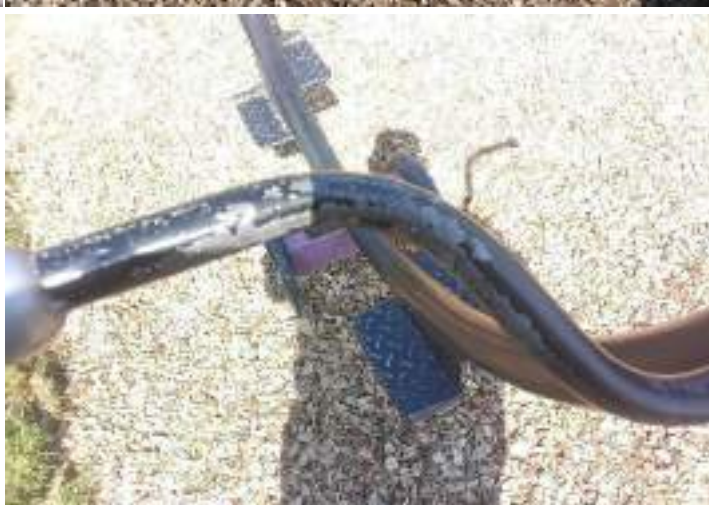
**6 - Low Risk (Finding 3)**

**Finding:** The paint is flaking off the metalwork

**Action:** Rub down and re-paint

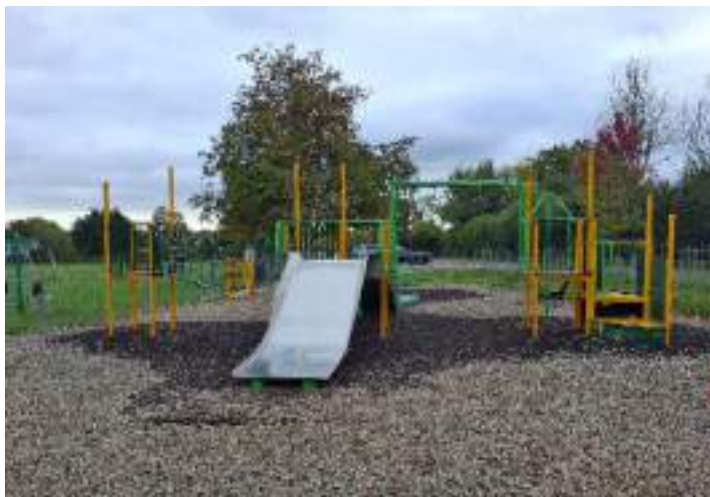
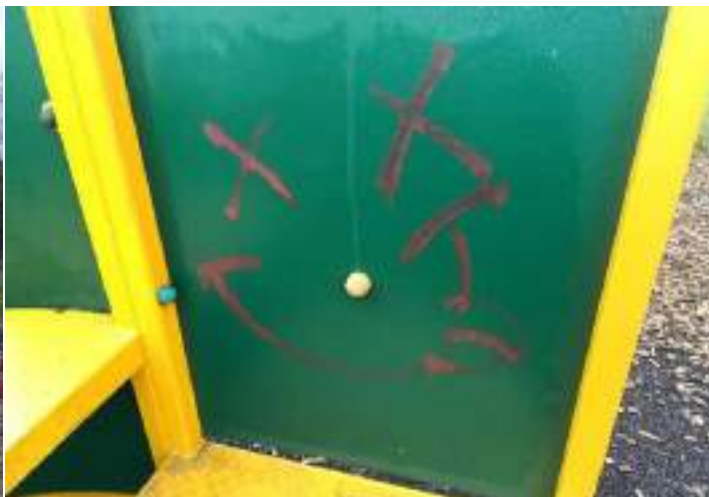
**2 - Very Low Risk (Finding 1)**

**Finding:** There is some graffiti present

**Action:** Remove the graffiti

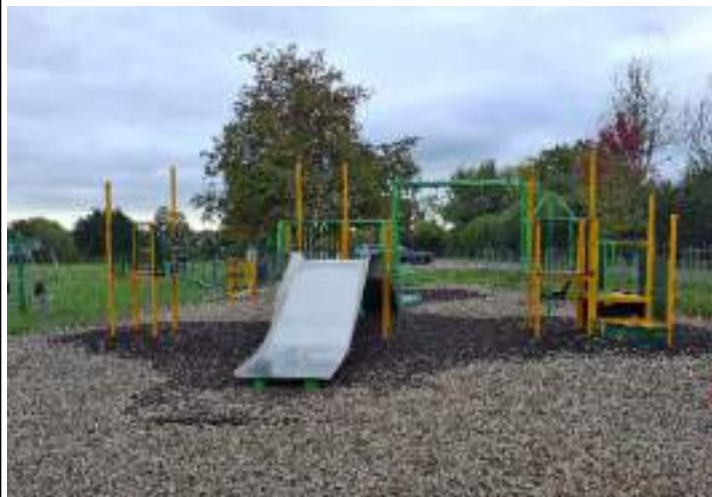
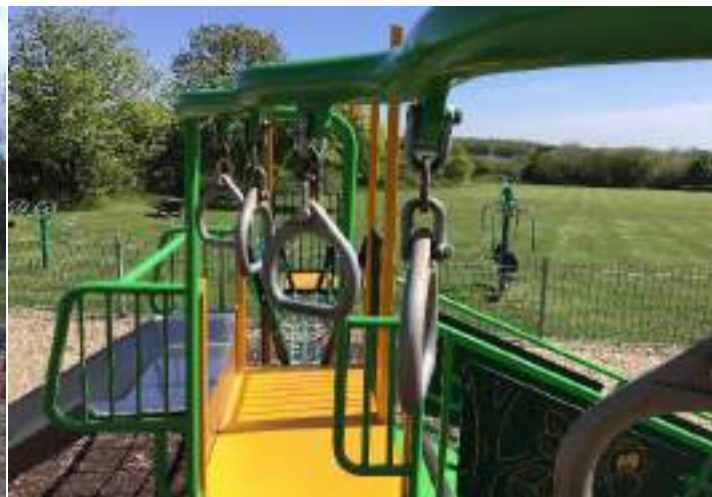
**Finding:** There is surface corrosion present on the item

**Action:** Consider treating and repainting the item

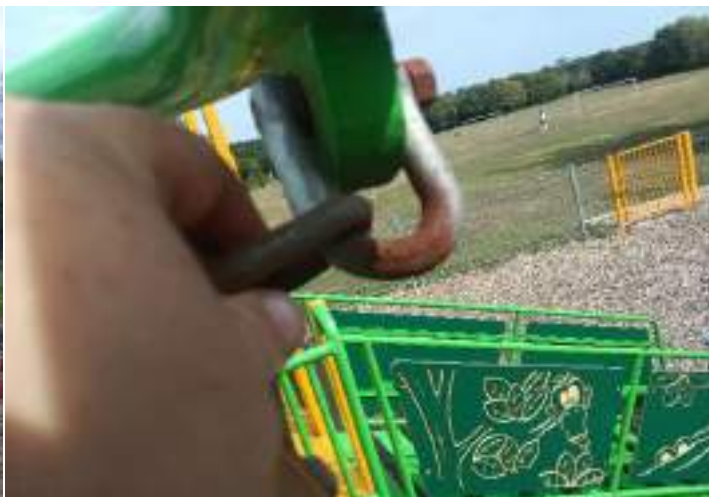
**Finding:** There is some wear to the shackles.

**Action:** Monitor for any further deterioration and replace when 40% worn

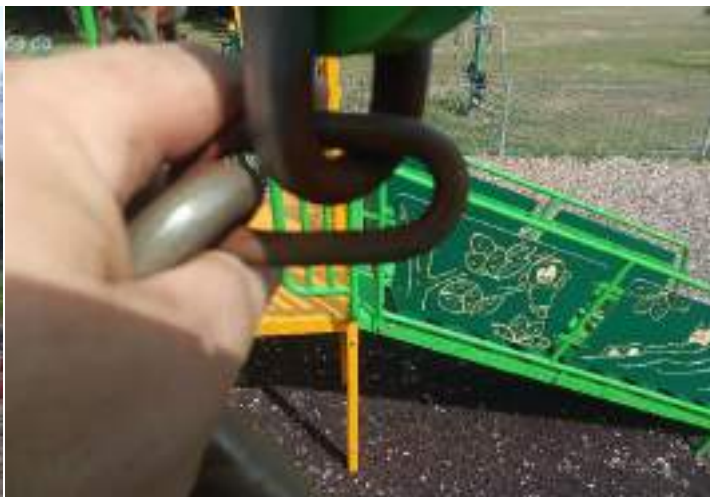
**Finding:** There is some notable evidence of chain wear

**Action:** Monitor for any further deterioration and replace when 40% worn

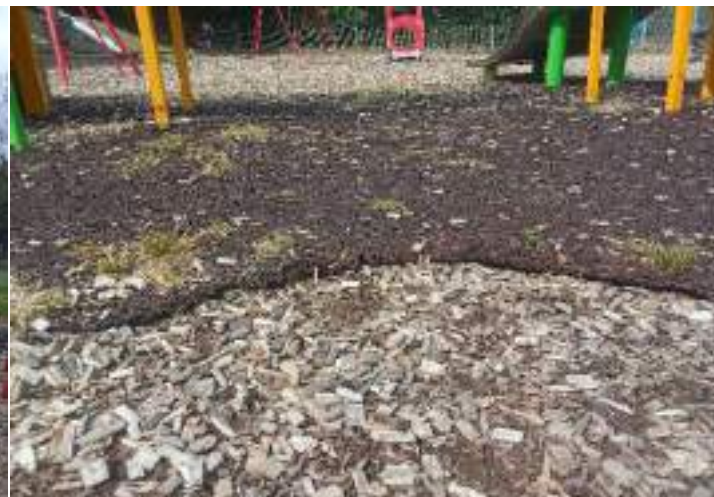
**Finding:** The surface is lifting at the edges and creating trip points  
**Action:** Repair perimeter of surfacing to remove trip points

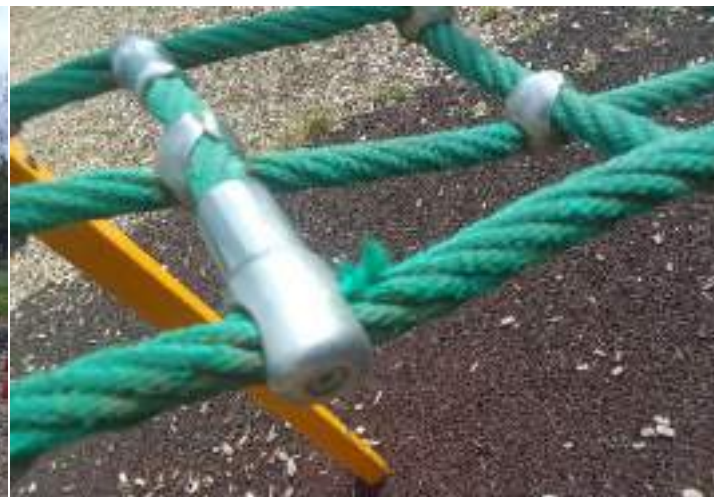
**Finding:** The ropes/nets are worn/damaged in places

**Action:** Monitor for any further deterioration and repair or replace as required

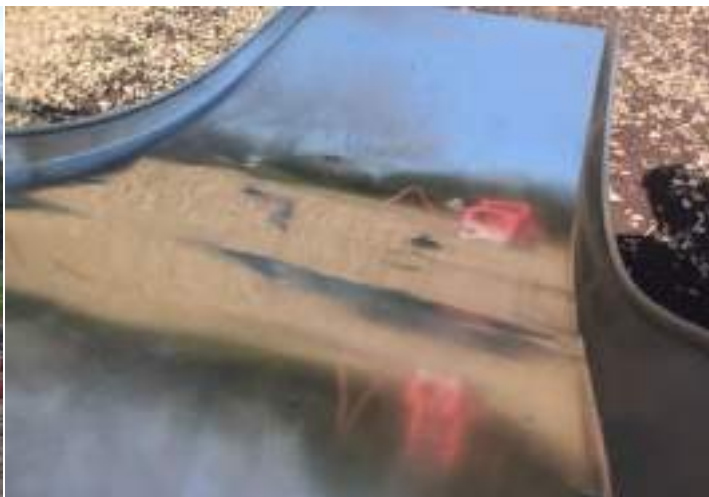
**Finding:** There are a number of dents in the slide surface

**Action:** Monitor for any further deterioration and repair as required

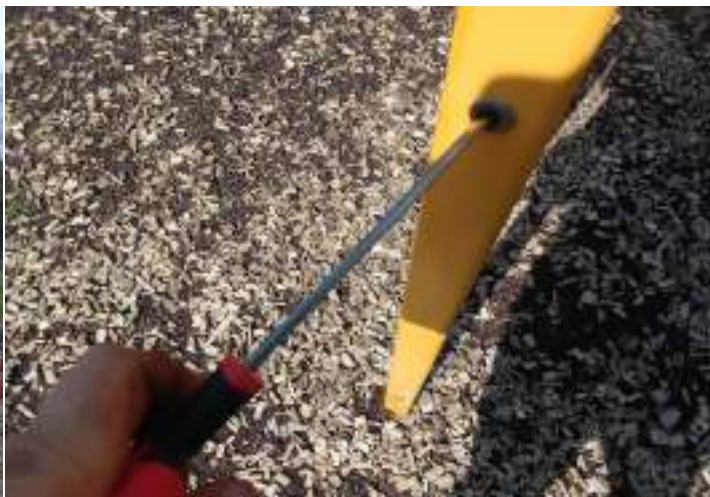
**Finding:** There is/are several inserts missing approx 60

**Action:** Replace missing inserts

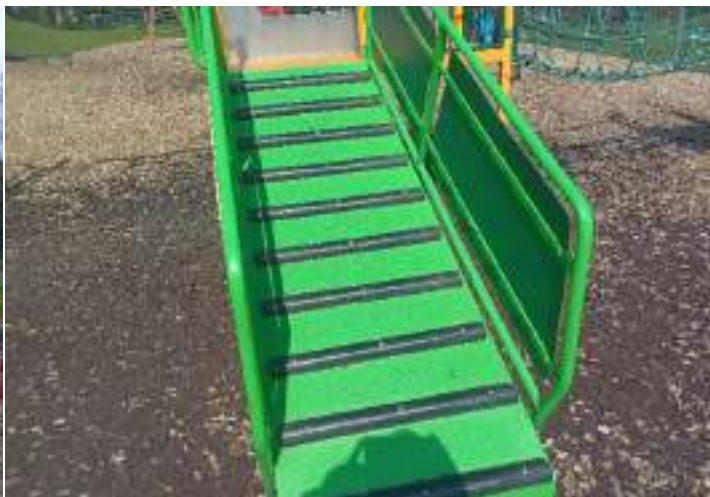
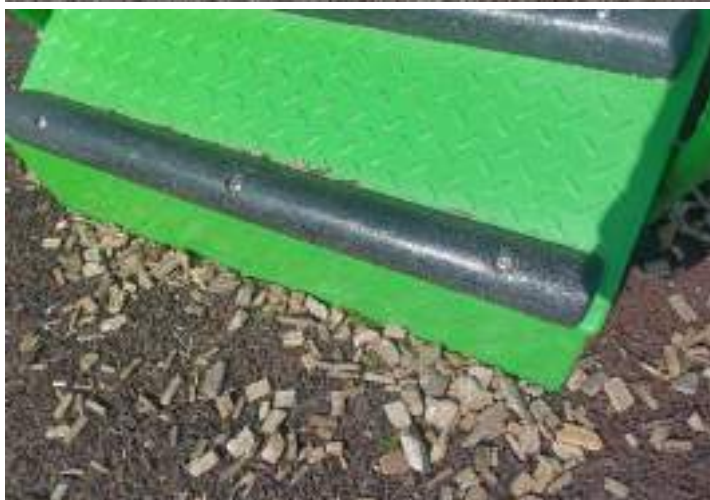
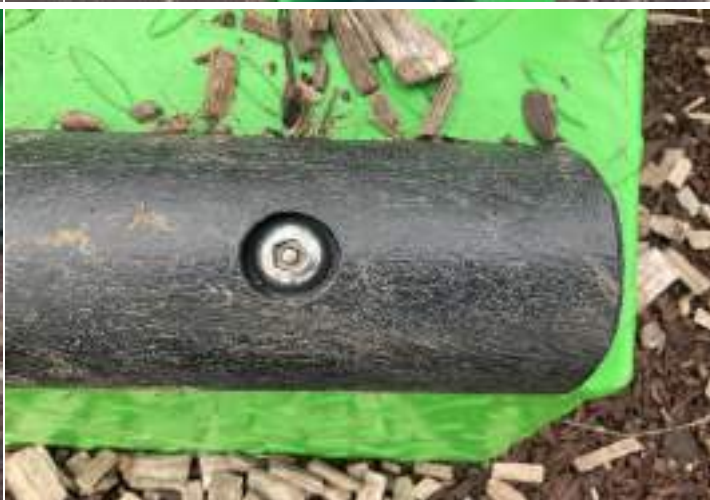
**Finding:** A number of fixing(s) have worked loose - due to style of fixing and barriers unable to reach both male and female part at the same time to tighten

**Action:** Secure all loose fixings

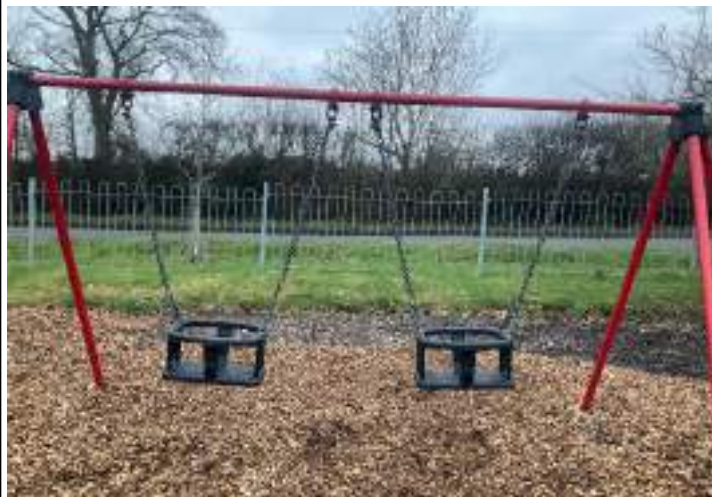
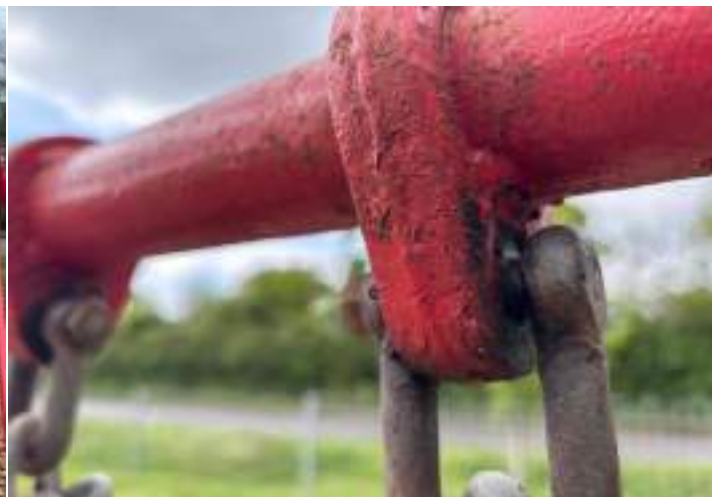
**Finding:** The bushes are worn or missing x 4

**Action:** Replace worn or missing bushes

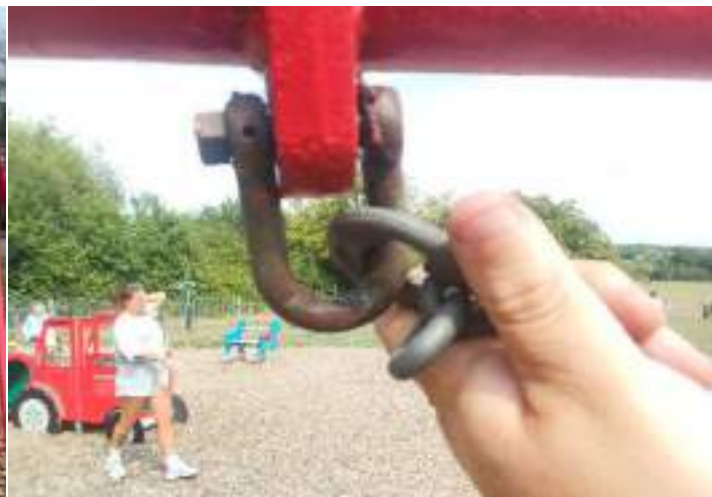
**Finding:** There is some wear to the shackles.

**Action:** Monitor for any further deterioration and replace when 40% worn

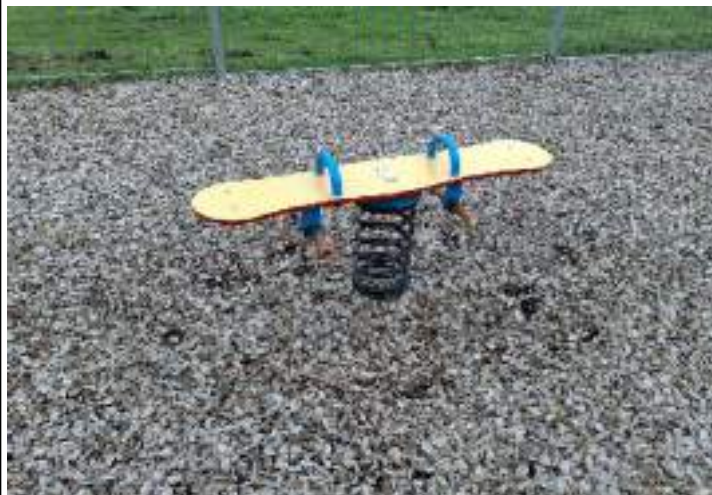
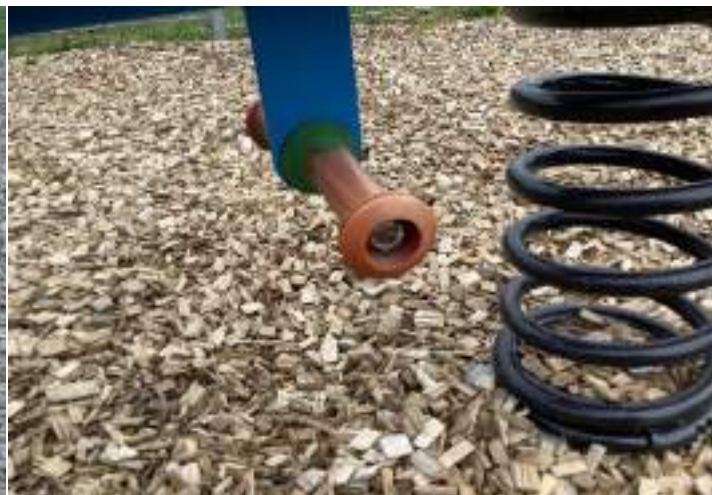
**Finding:** There is/are bolt cap covers missing or damaged on the item

**Action:** Replace 1 missing or damaged bolt cap covers

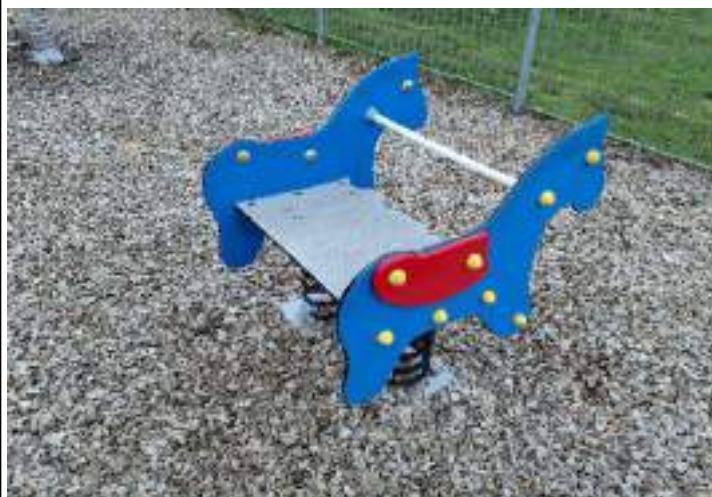
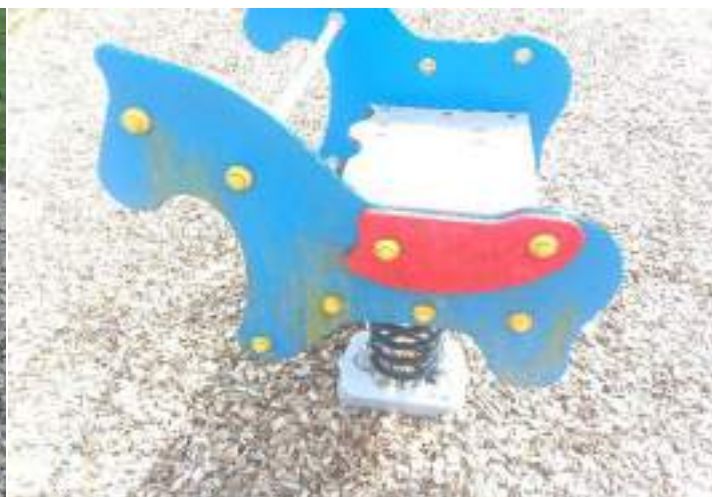
**Finding:** There is algae or moss on the surface of the equipment

**Action:** Clean and treat appropriately

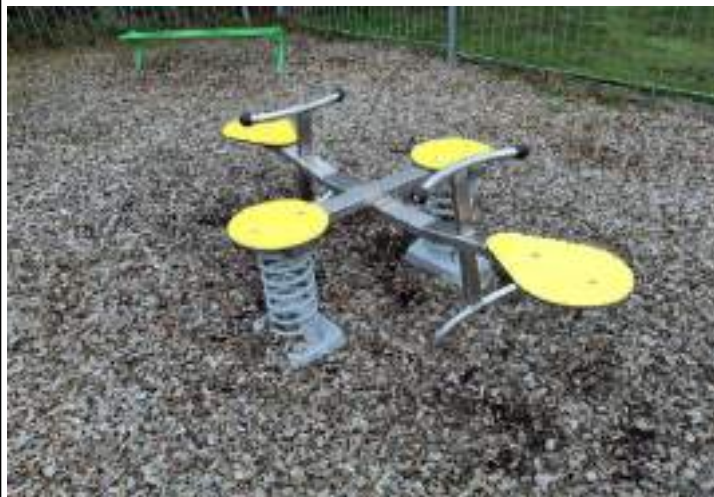
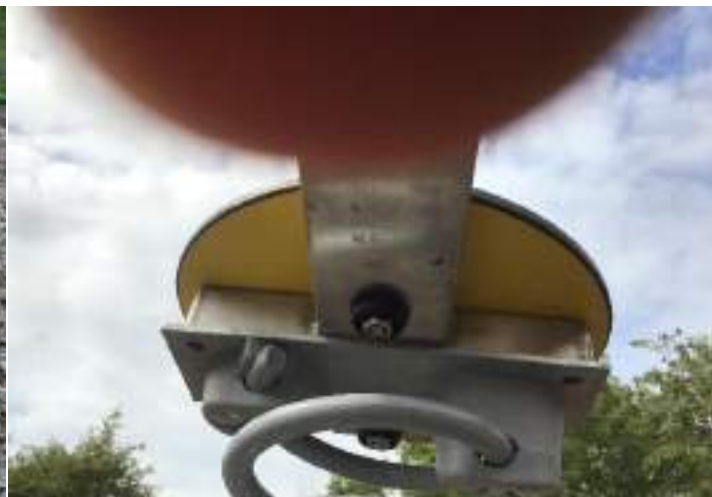
**Finding:** There is/are bolt cap covers missing or damaged on the item

**Action:** Replace 8 missing or damaged bolt cap covers

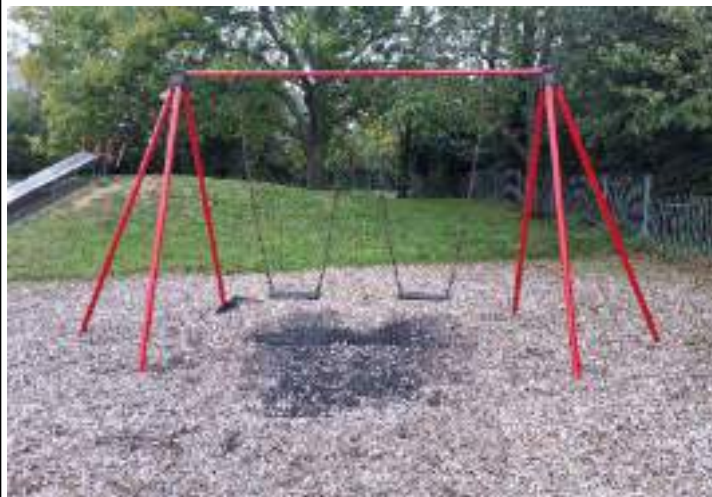
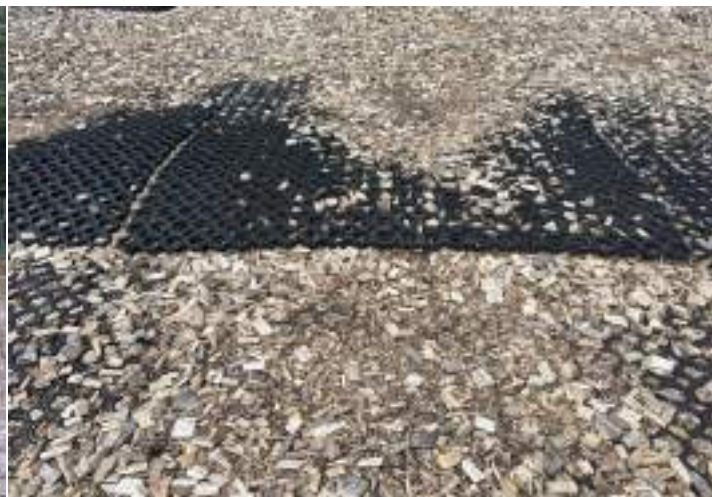
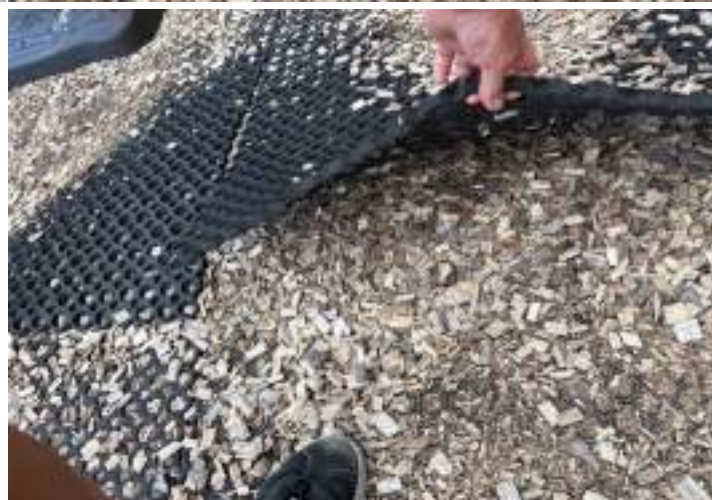
**Finding:** There are gaps opening between the grass mat tiles

**Action:** Provide additional ties or secure / reinstate surface

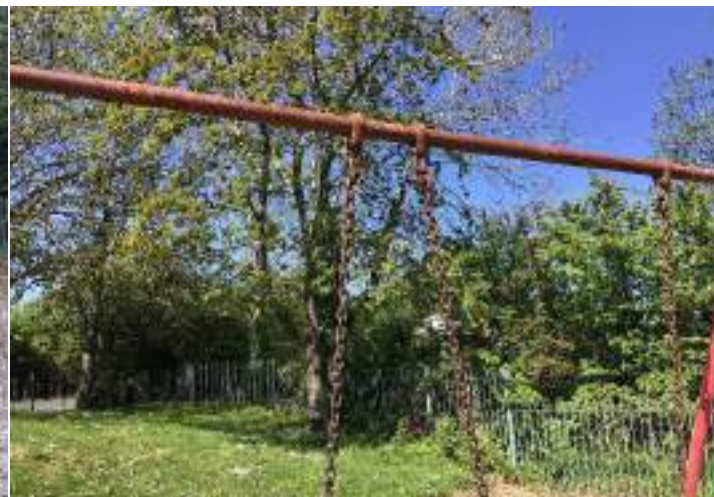
**Finding:** There is surface corrosion present on the item

**Action:** Consider treating and repainting the item

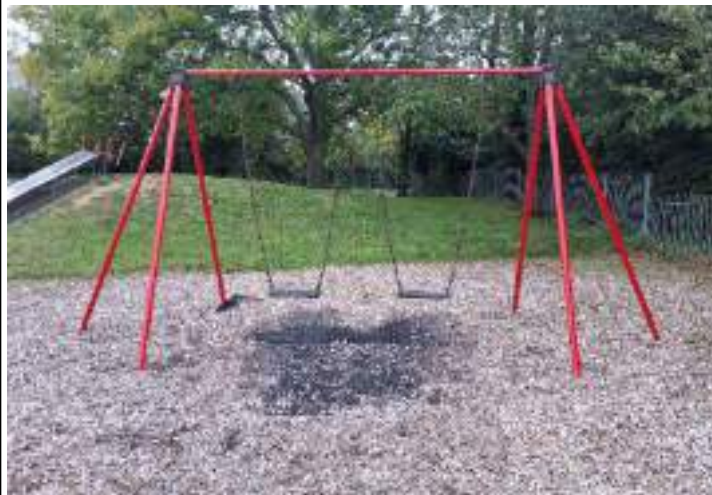
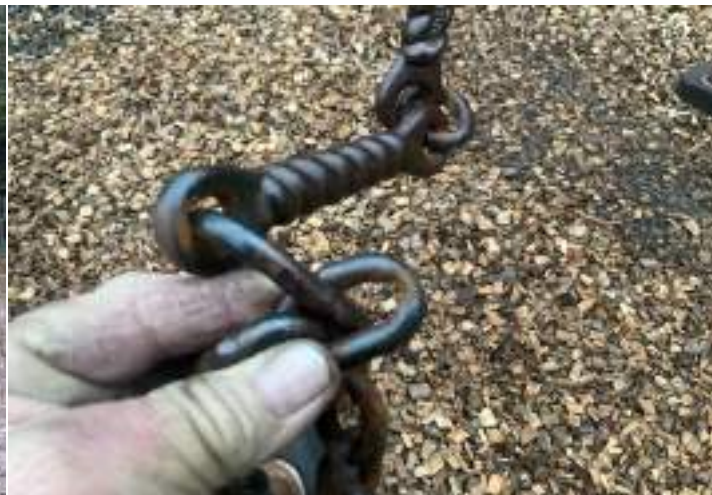
**Finding:** The chain links are worn in excess of 50% and require renewing on both swings

**Action:** Replace worn chains 2x sets of chains

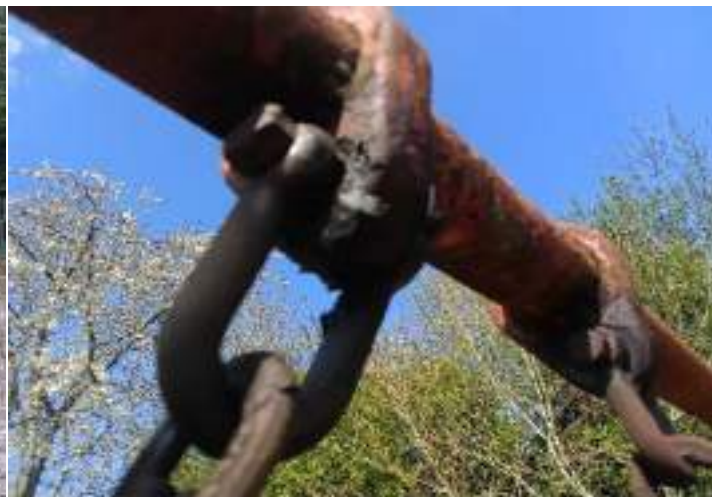
**Finding:** The bushes are worn or missing

**Action:** Replace worn or missing bushes

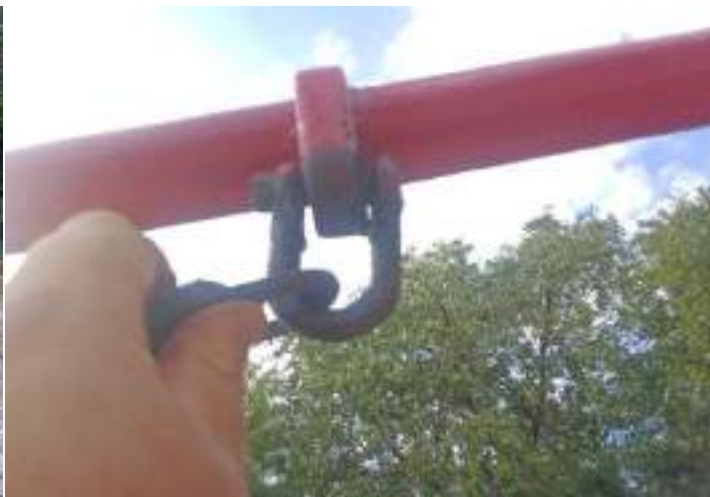
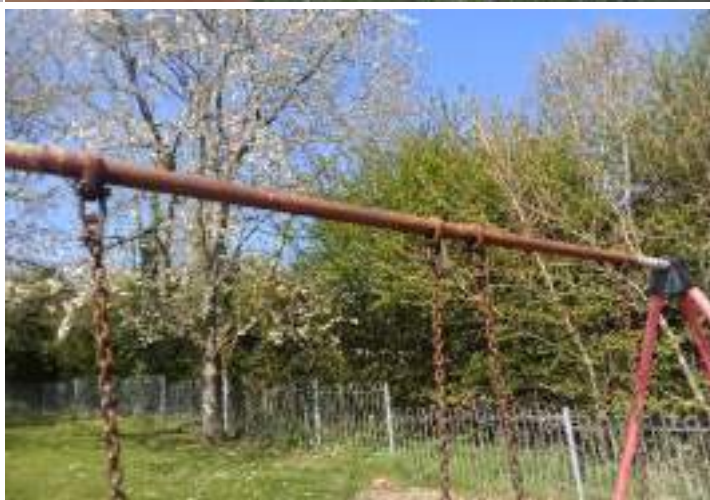
**Finding:** There is some wear to the shackles.

**Action:** Monitor for any further deterioration and replace when 40% worn

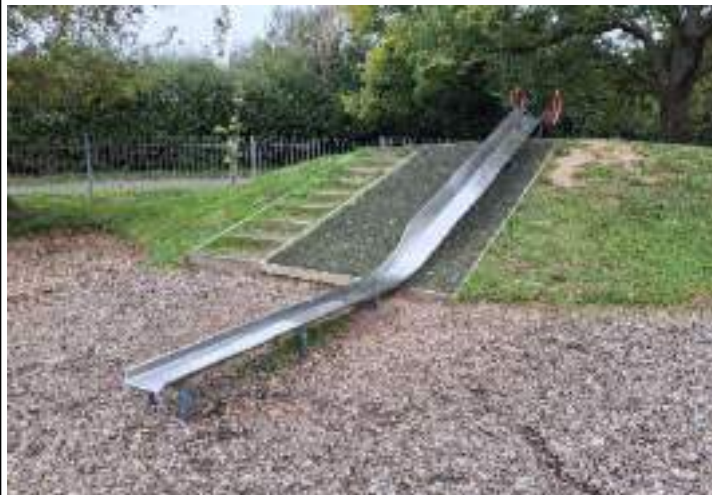
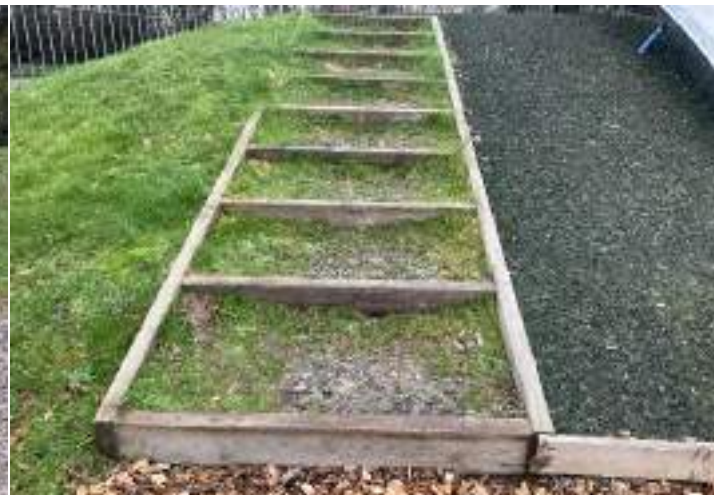
**Finding:** The area around the item has eroded / trip hazards **Action:** Reinstate eroded area on the steps which can lead to falls down bank/steps

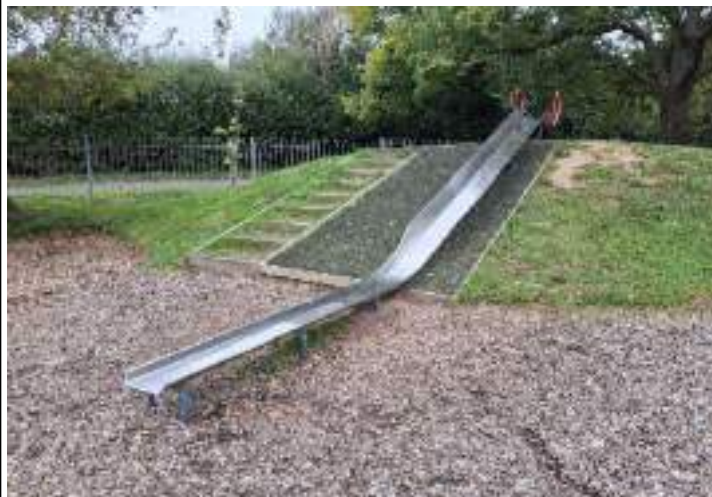
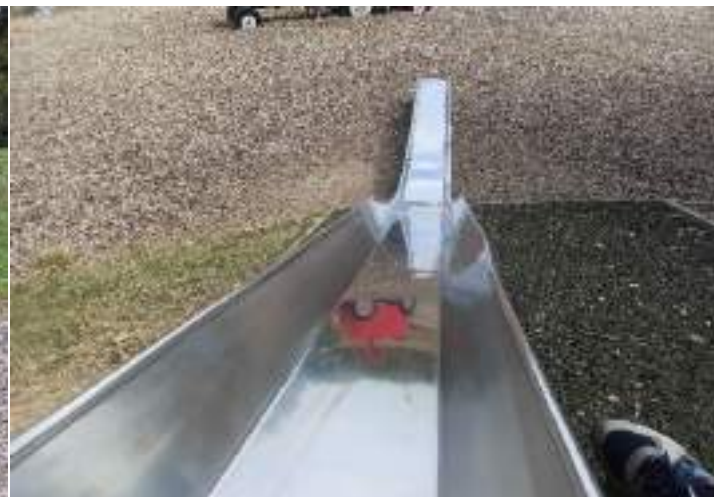
**Finding:** There are a number of dents in the slide surface

**Action:** Monitor for any further deterioration and repair as required

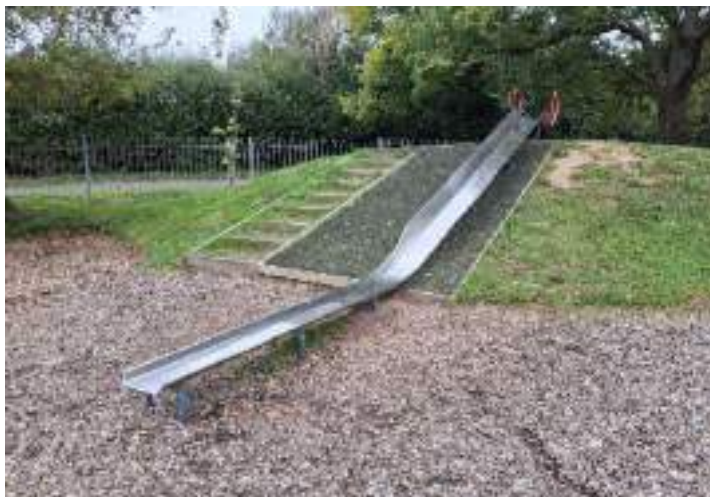
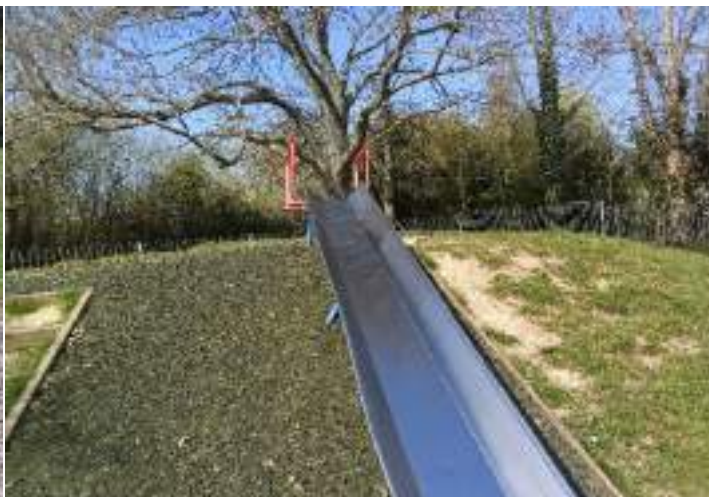
**Finding:** Top of the slide is twisted

**Action:** Monitor and reset if required

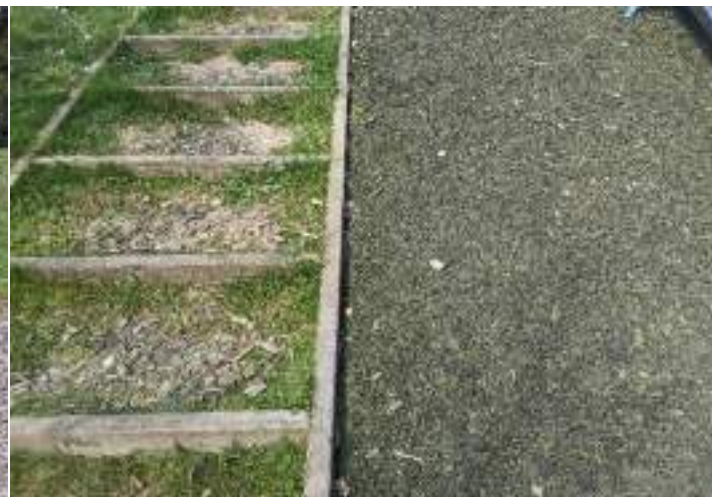
**Finding:** There are gaps opening between the surfacing and the edging surround or between the joints in the surfacing- approximately 6 lin m  
**Action:** Monitor for any further deterioration and repair as required

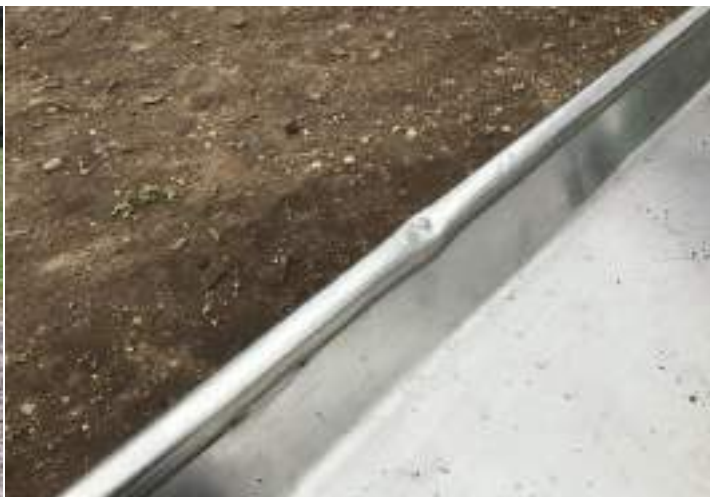
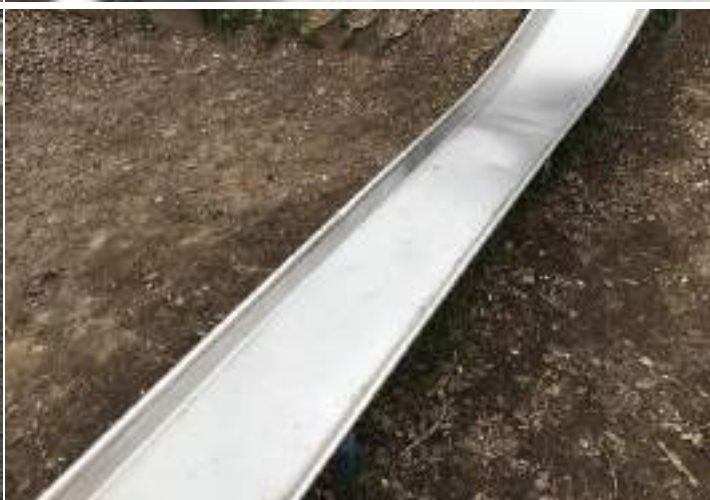
**Finding:** The side of the slide is damaged

**Action:** Monitor for any further deterioration and repair as required
