## **Westbourne Parish Council, 10 September 2026**

## Operational Inspection

Westbourne Parish Council

## Inspection Scope for RPII Annual Inspectors

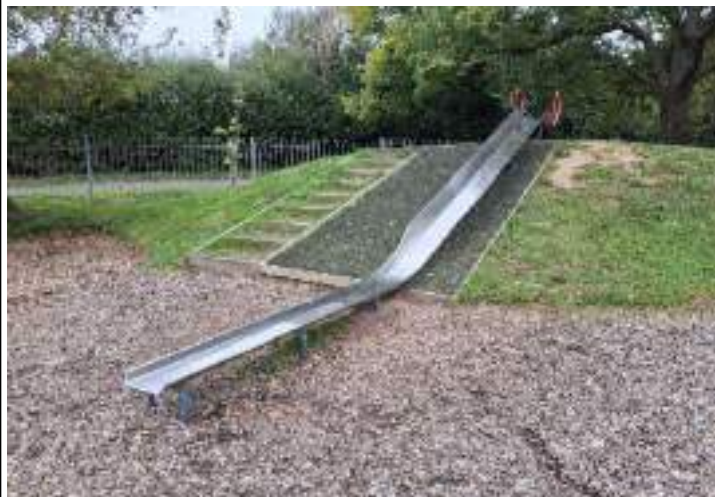
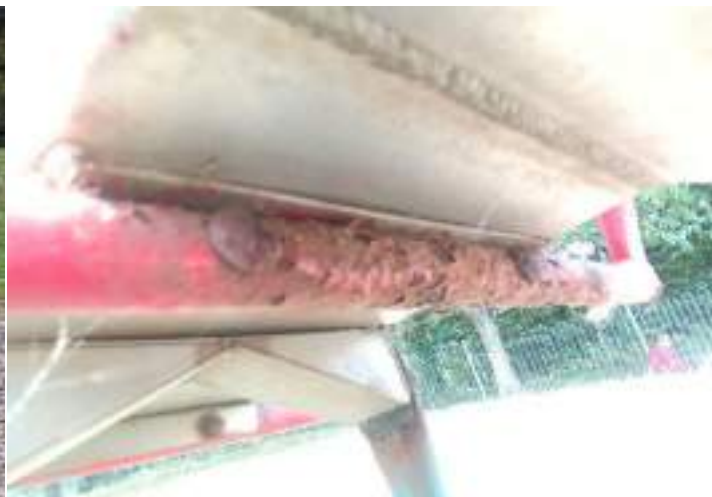
**Finding:** There is surface corrosion / rust present on the item

**Action:** Consider treating the item

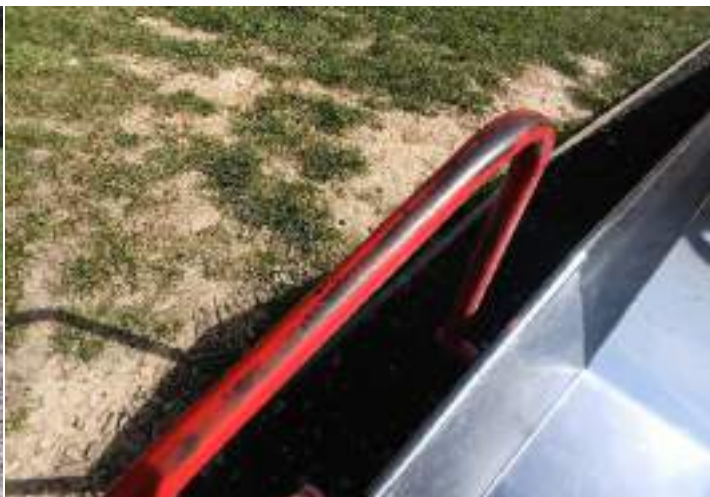
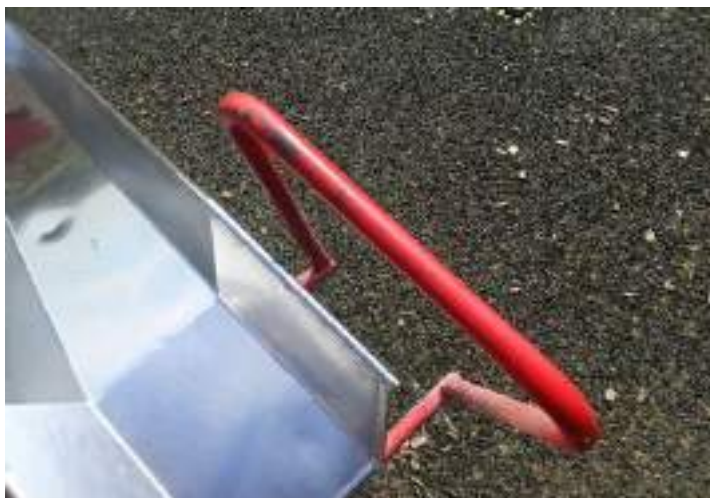
**Finding:** There is surface corrosion / rust present on the item

**Action:** Consider treating the item

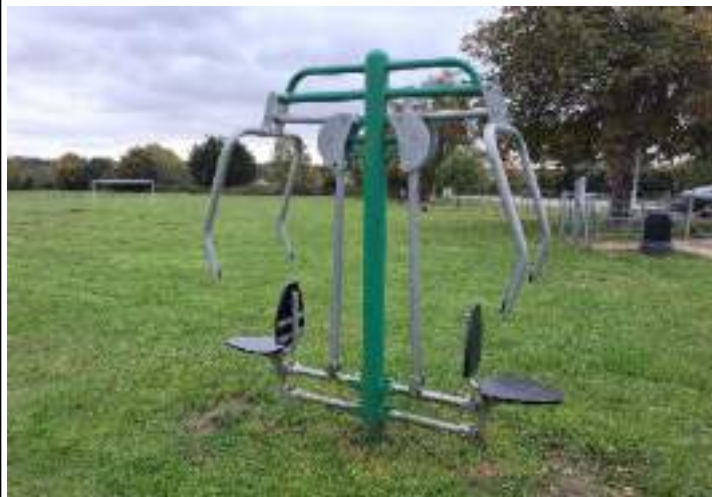
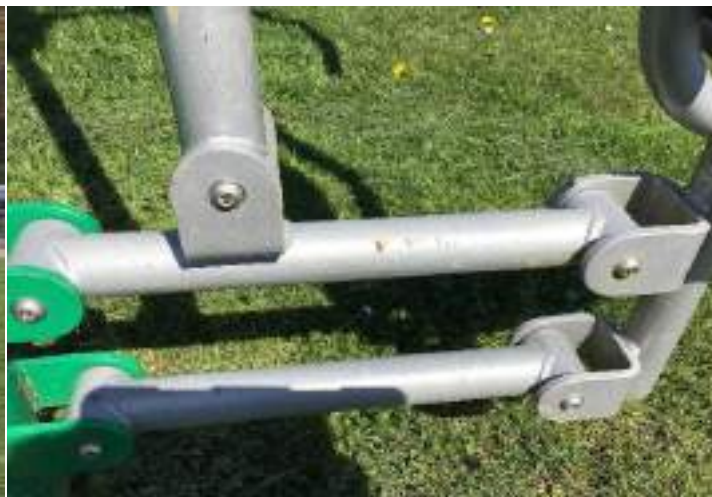
**Item:** Outdoor Fitness Equipment - Chest Press  
**Manufacturer:** Hags

**Risk Level:** L - Low Risk  
**Surface:** Grass Matrix Tiles

**Finding:** The paintwork on this item has been damaged or worn exposing the metal underneath which is rusting

**Action:** Treat any rusting components and repaint

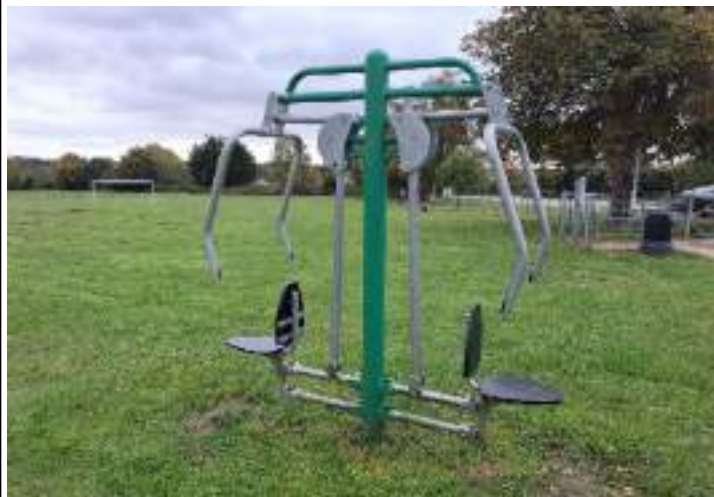
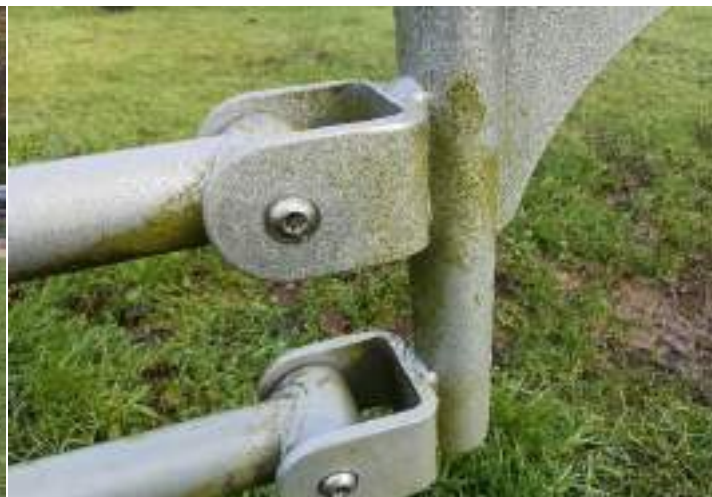
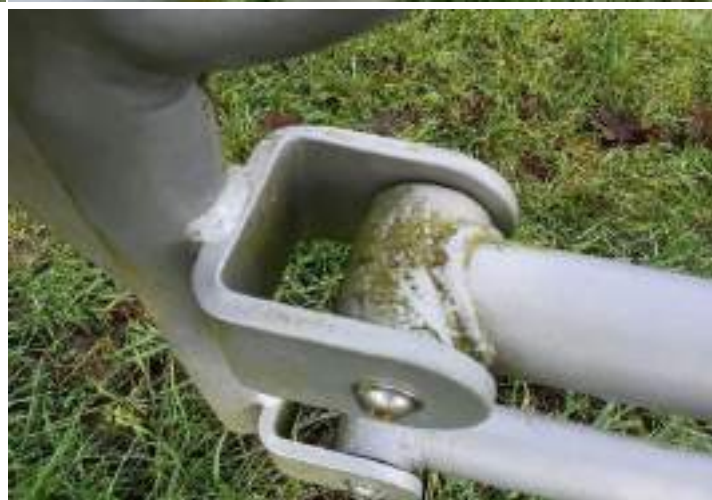
**Item:** Outdoor Fitness Equipment - Chest Press  
**Manufacturer:** Hags

**Risk Level:** V - Very Low Risk  
**Surface:** Grass Matrix Tiles

**Finding:** Algae/moss on the surface of the equipment

**Action:** Clean

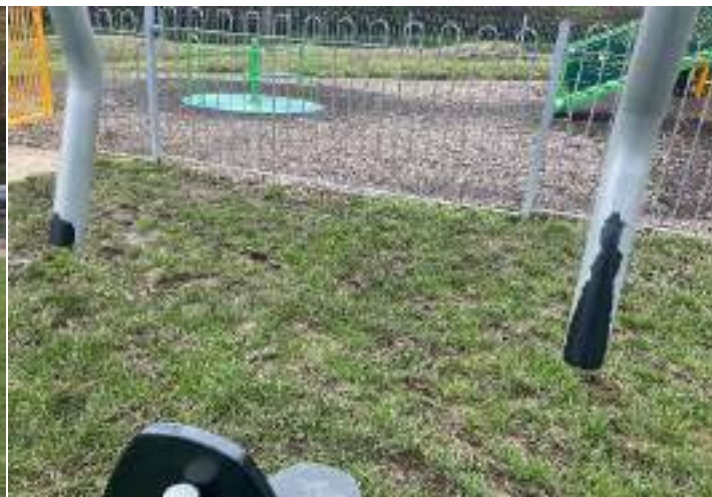
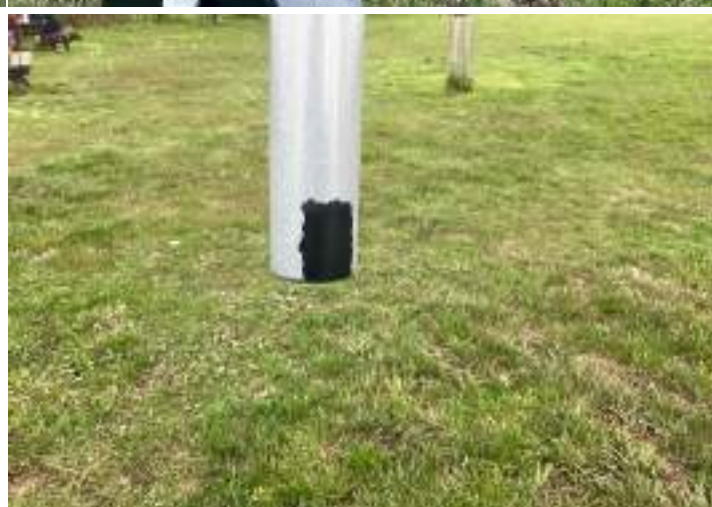
**Item:** Outdoor Fitness Equipment - Chest Press  
**Manufacturer:** Hags

**Risk Level:** L - Low Risk  
**Surface:** Grass Matrix Tiles

**Finding:** The paint is flaking off the metalwork

**Action:** Rub down and re-paint

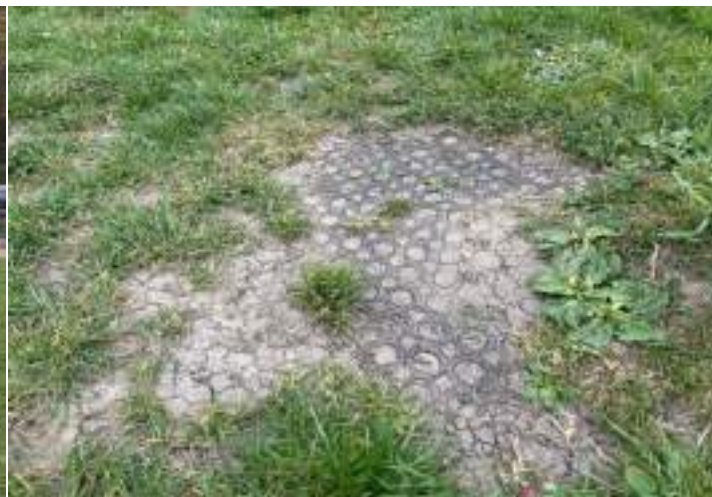
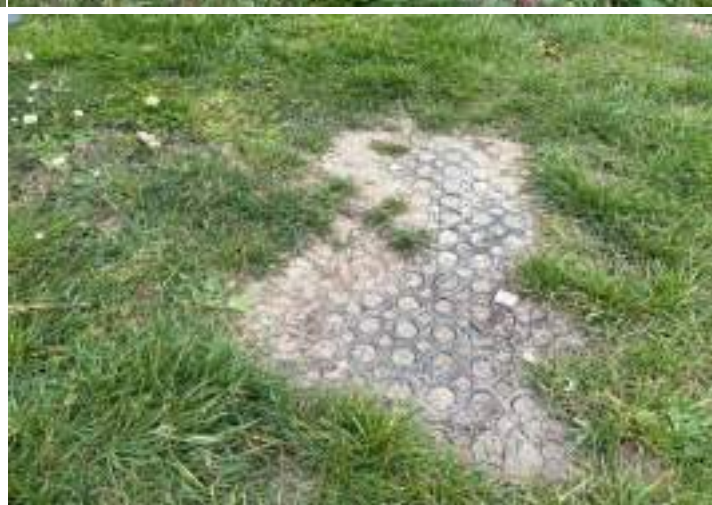
**Item:** Outdoor Fitness Equipment - Chest Press  
**Manufacturer:** Hags

**Risk Level:** L - Low Risk  
**Surface:** Grass Matrix Tiles

**Finding:** The grass mats are silted up, the soil is compacted and the area will become very slippery when the soil is wet. **Action:** Reinstate as required

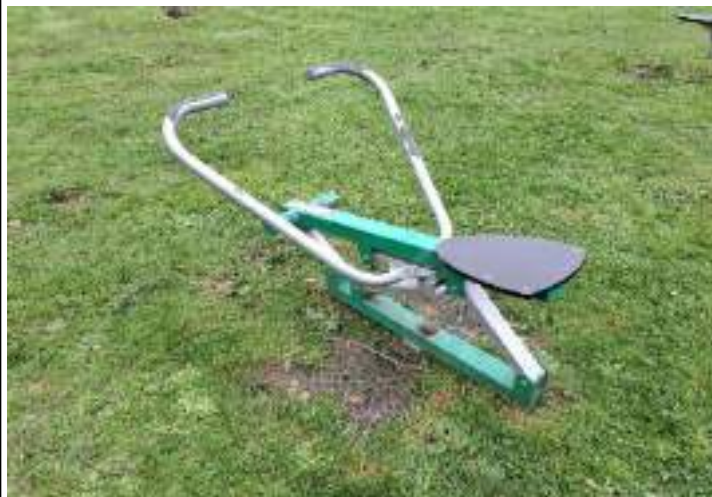
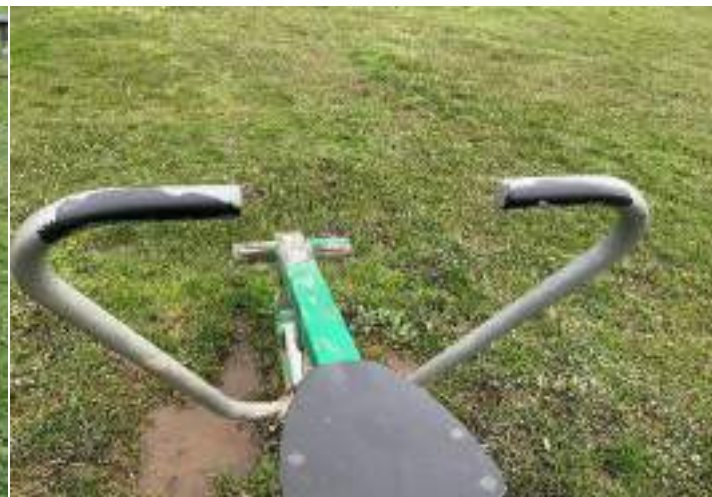
**Item:** Outdoor Fitness Equipment - Handle Boat  
**Manufacturer:** Hags

**Risk Level:** L - Low Risk  
**Surface:** Grass Matrix Tiles

**Finding:** The paint is flaking off the metalwork

**Action:** Rub down and re-paint

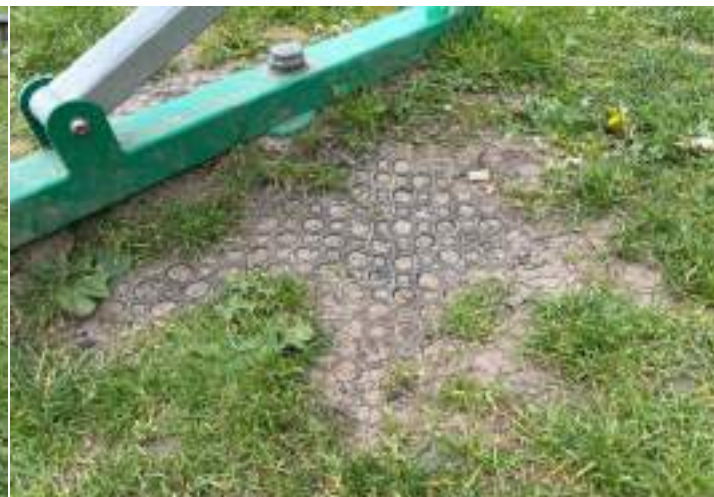
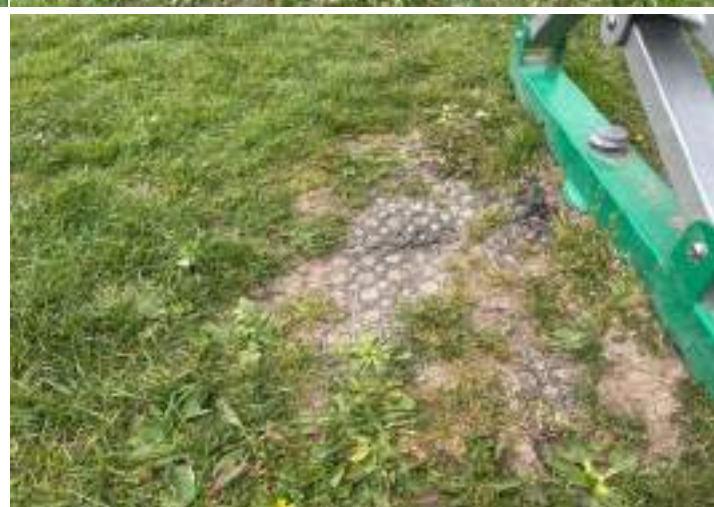
**Item:** Outdoor Fitness Equipment - Handle Boat  
**Manufacturer:** Hags

**Risk Level:** L - Low Risk  
**Surface:** Grass Matrix Tiles

**Finding:** The grass mats are silted up, the soil is compacted and the area will become very slippery when the soil is wet. **Action:** Reinstate as required

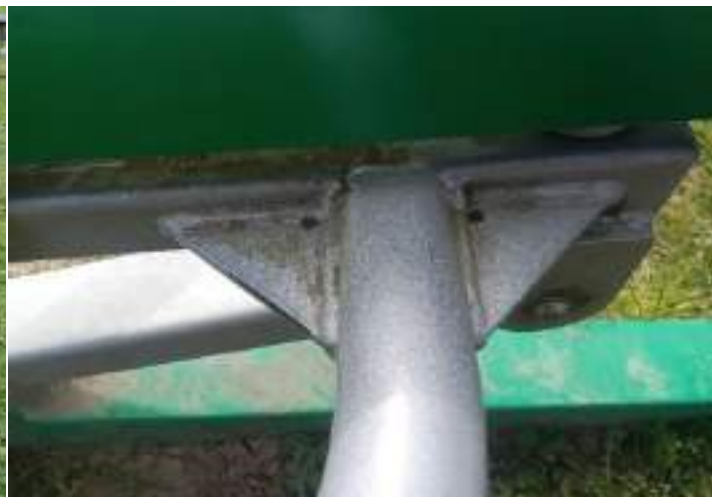
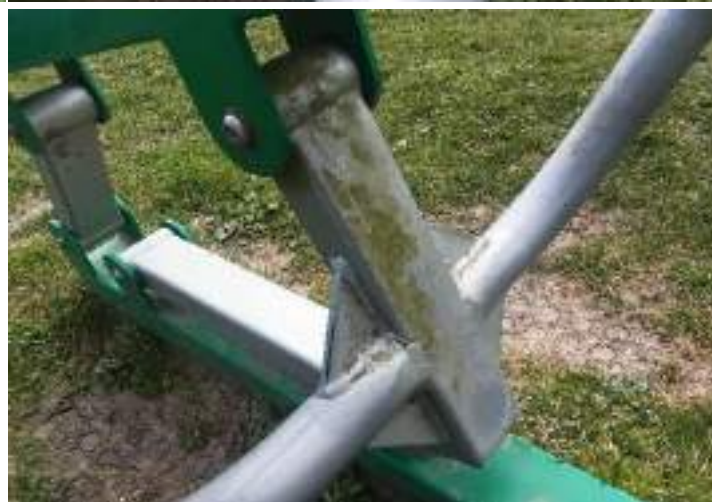
**Item:** Outdoor Fitness Equipment - Handle Boat  
**Manufacturer:** Hags

**Risk Level:** V - Very Low Risk  
**Surface:** Grass Matrix Tiles

**Finding:** Algae on the surface of the equipment

**Action:** Clean and treat

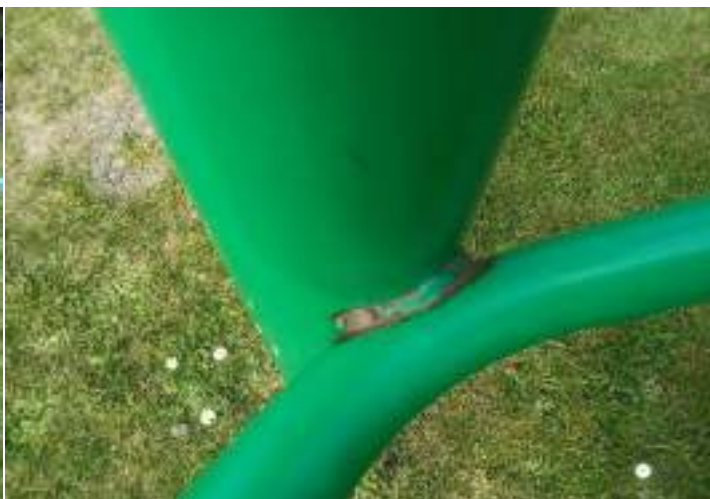
**Manufacturer:** Hags

**Surface:** Grass Matrix Tiles

**Finding:** The paintwork on this item has been damaged or worn exposing the metal underneath which is rusting

**Action:** Treat any rusting components and repaint

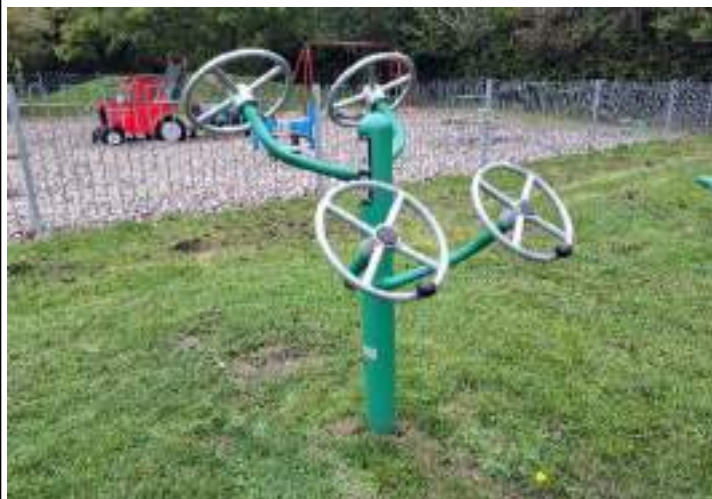
**Item:** Outdoor Fitness Equipment - Tai Chi Wheels  
**Manufacturer:** Hags

**Risk Level:** L - Low Risk  
**Surface:** Grass Matrix Tiles

**Finding:** The bearing is showing signs of wear

**Action:** Monitor for any further deterioration and replace as required

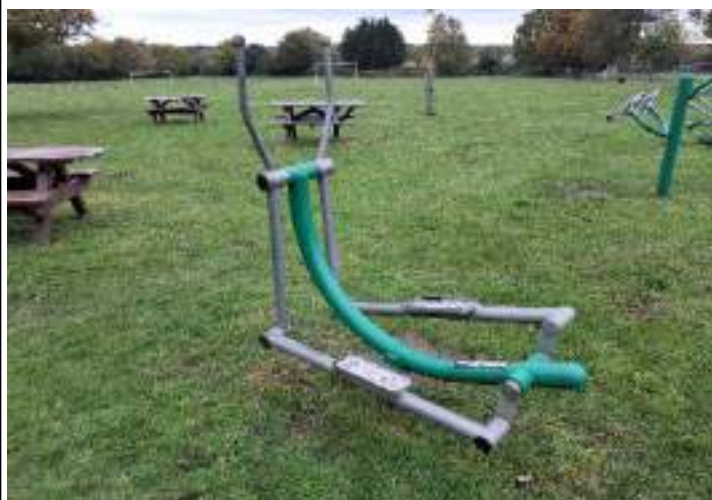
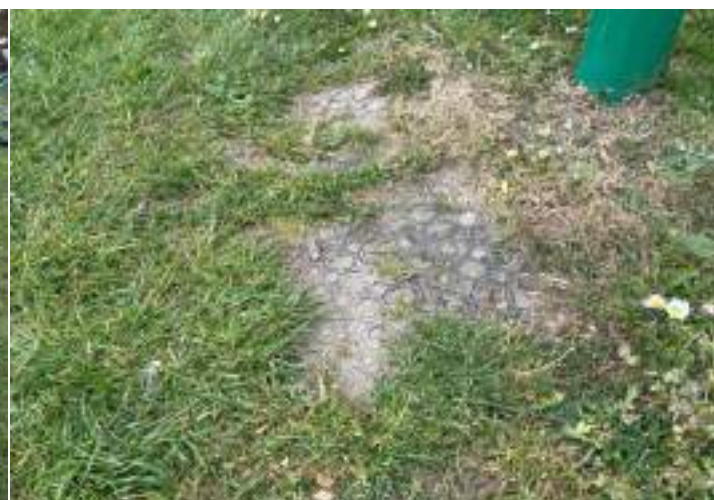
**Item:** Outdoor Fitness Equipment - Cross Trainer  
**Manufacturer:** Hags

**Risk Level:** L - Low Risk  
**Surface:** Grass Matrix Tiles

**Finding:** The grass mats are silted up, the soil is compacted and the area will become very slippery when the soil is wet.

**Action:** Reinststate as required

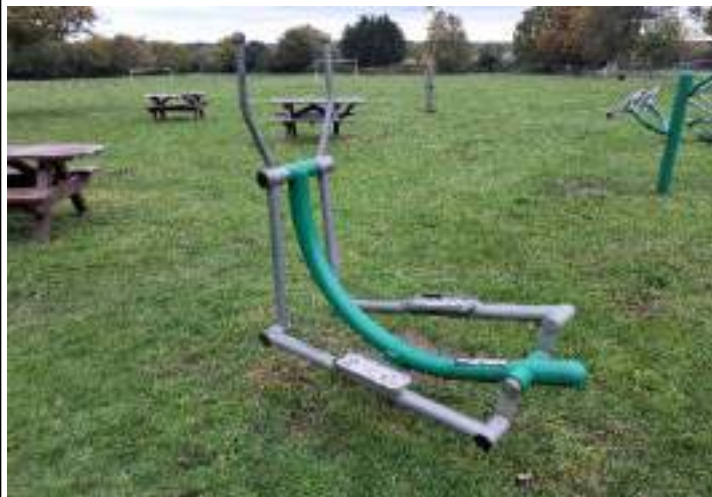
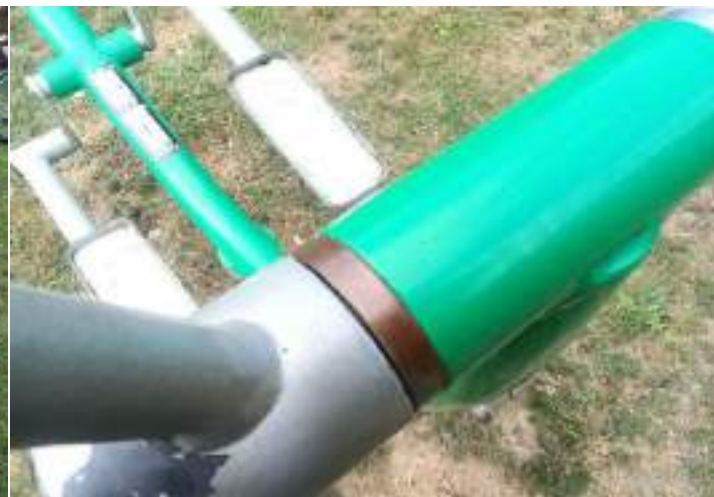
**Item:** Outdoor Fitness Equipment - Cross Trainer **Risk Level:** L - Low Risk  
**Manufacturer:** Hags **Surface:** Grass Matrix Tiles

**Finding:** There is surface corrosion present on the item

**Action:** Consider treating and repainting the item

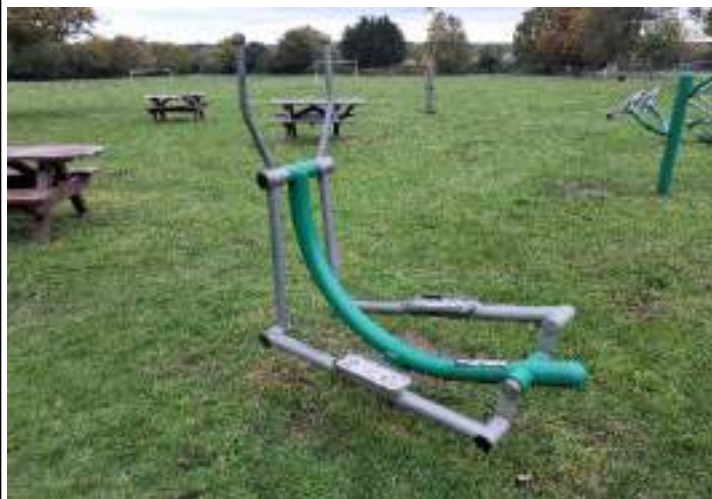
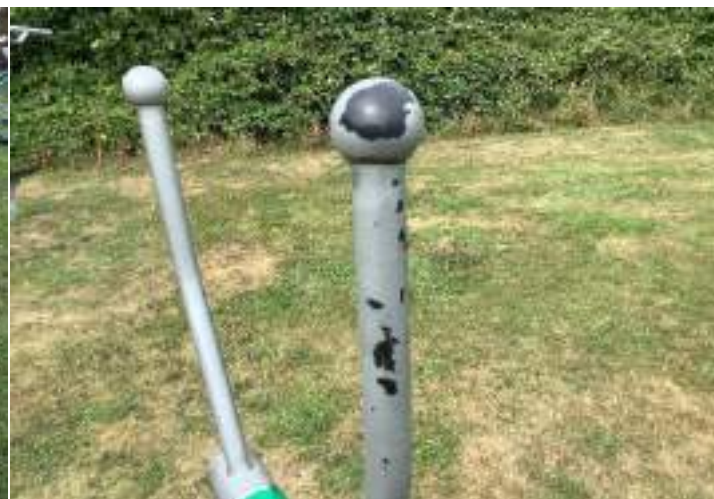
**Item:** Outdoor Fitness Equipment - Cross Trainer **Risk Level:** L - Low Risk  
**Manufacturer:** Hags **Surface:** Grass Matrix Tiles

**Finding:** The paint is flaking off the metalwork

**Action:** Rub down and re-paint

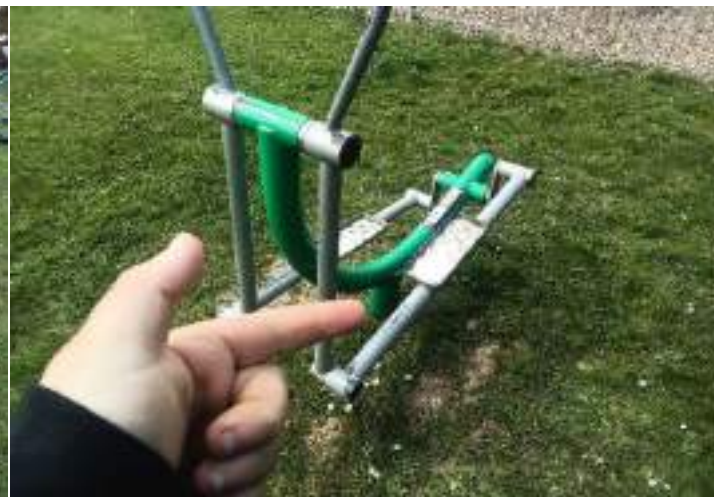
**Item:** Outdoor Fitness Equipment - Cross Trainer  
**Manufacturer:** Hags  
**Risk Level:** L - Low Risk  
**Surface:** Grass Matrix Tiles

**Finding:** The item is slightly loose in its foundations

**Action:** Monitor for any further deterioration and repair as required

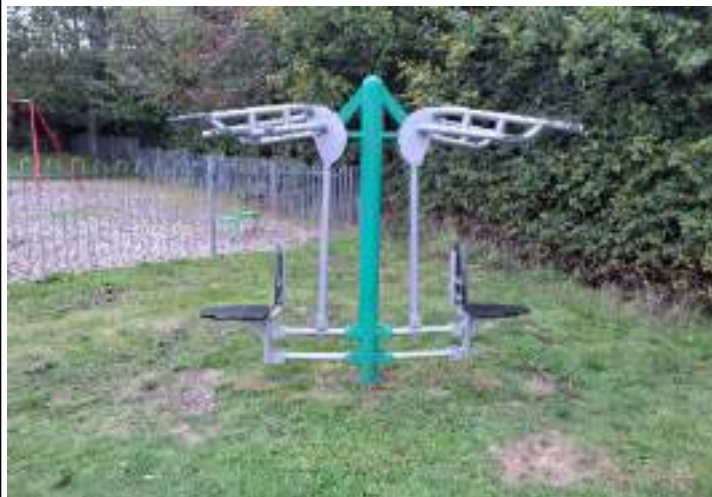
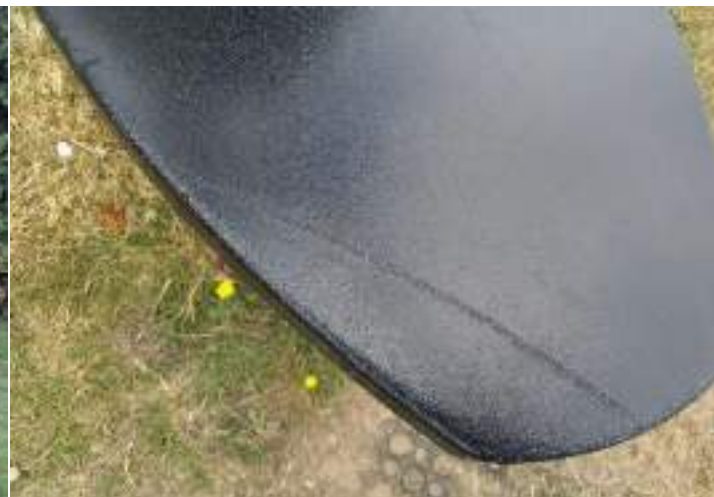
**Item:** Outdoor Fitness Equipment - Pull Down Challenger  
**Manufacturer:** Hags  
**Risk Level:** V - Very Low Risk  
**Surface:** Grass Matrix Tiles

**Finding:** The item has been slightly damaged (Seat)

**Action:** Monitor for any further deterioration and replace as required

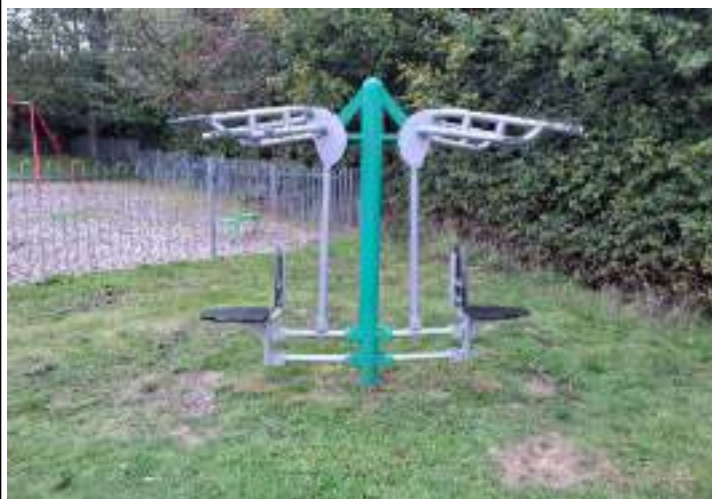
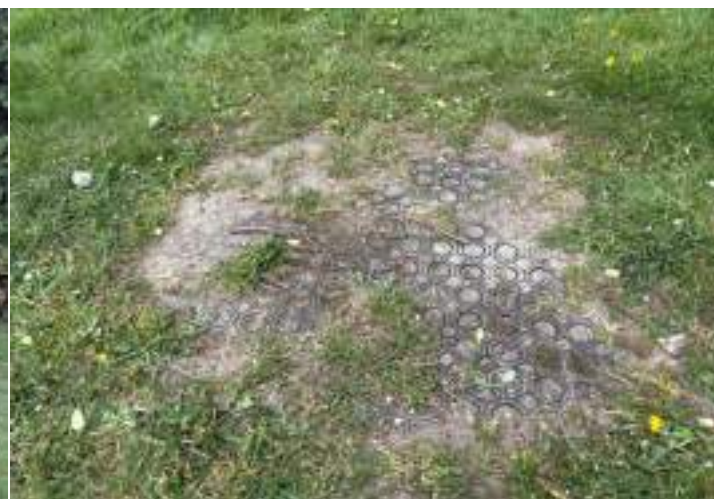
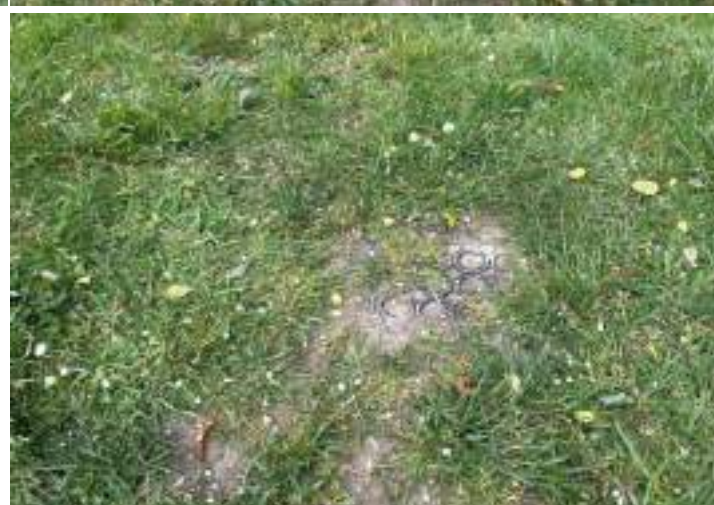
**Item:** Outdoor Fitness Equipment - Pull Down Challenger  
**Manufacturer:** Hags

**Risk Level:** L - Low Risk  
**Surface:** Grass Matrix Tiles

**Finding:** The grass mats are silted up, the soil is compacted and the area will become very slippery when the soil is wet. **Action:** Reinstate as required

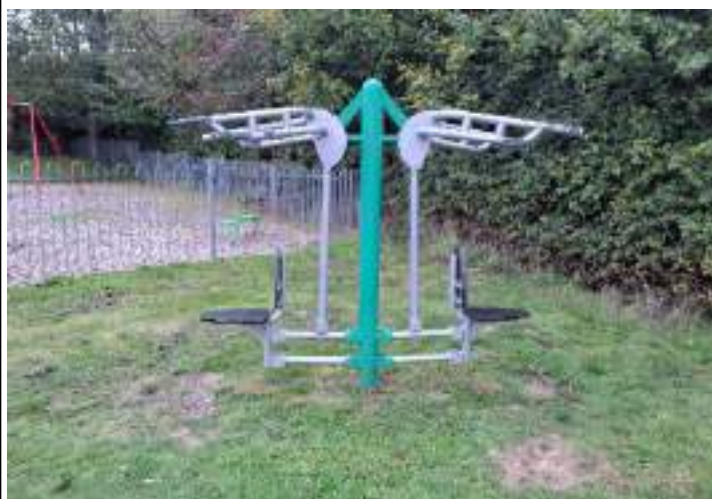
**Item:** Outdoor Fitness Equipment - Pull Down Challenger  
**Manufacturer:** Hags

**Risk Level:** L - Low Risk  
**Surface:** Grass Matrix Tiles

**Finding:** The buffers are wearing

**Action:** Monitor for any further deterioration and replace as required

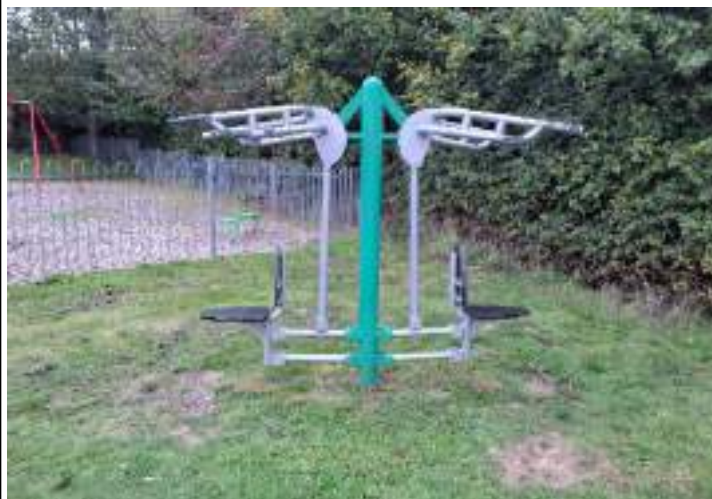
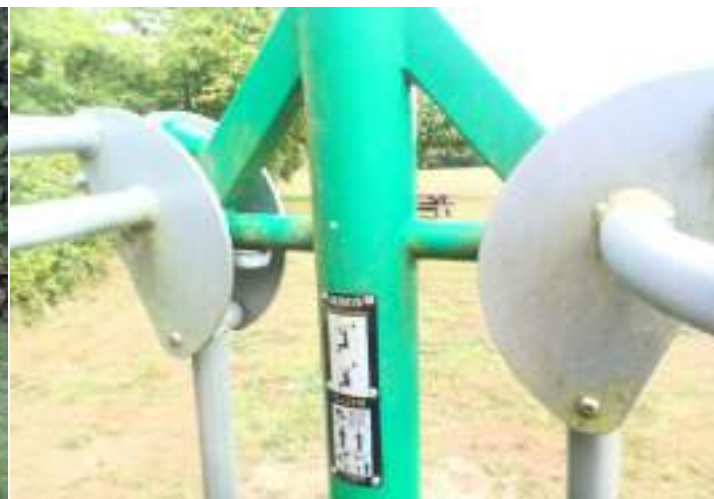
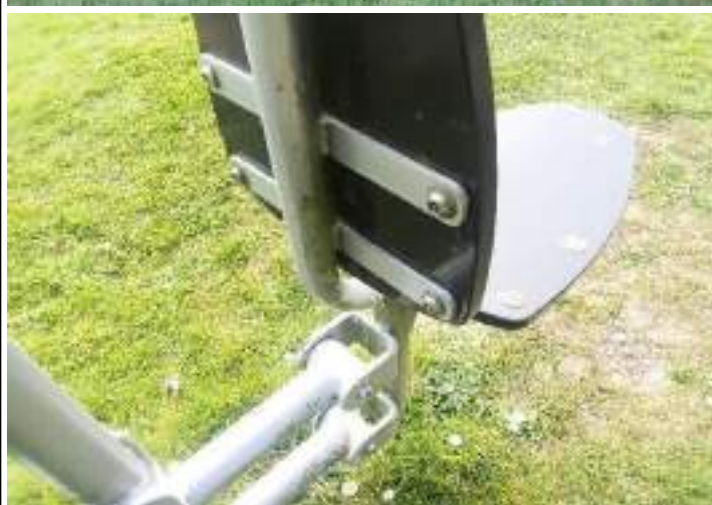
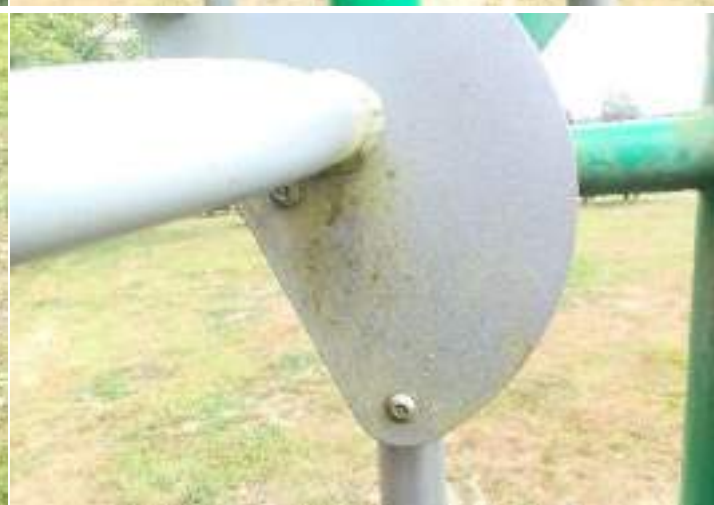
**Item:** Outdoor Fitness Equipment - Pull Down Challenger  
**Manufacturer:** Hags

**Risk Level:** V - Very Low Risk  
**Surface:** Grass Matrix Tiles

**Finding:** There is algae or moss on the surface of the equipment

**Action:** Clean and treat appropriately

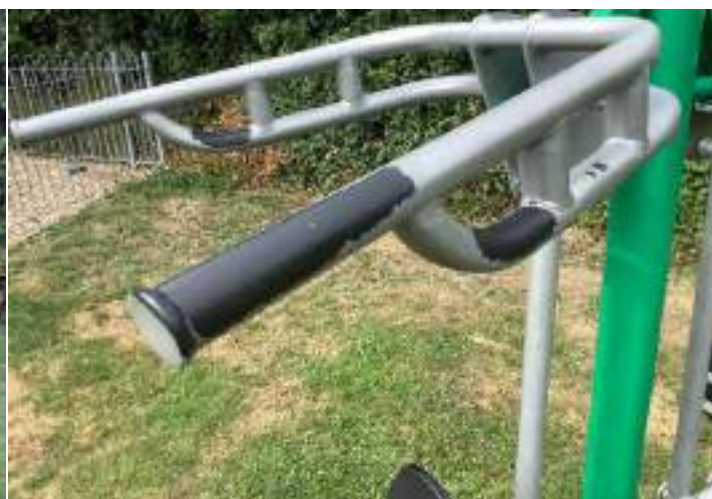
**Item:** Outdoor Fitness Equipment - Pull Down Challenger  
**Manufacturer:** Hags

**Risk Level:** L - Low Risk  
**Surface:** Grass Matrix Tiles

**Finding:** The paint is flaking off the metalwork

**Action:** Rub down and re-paint

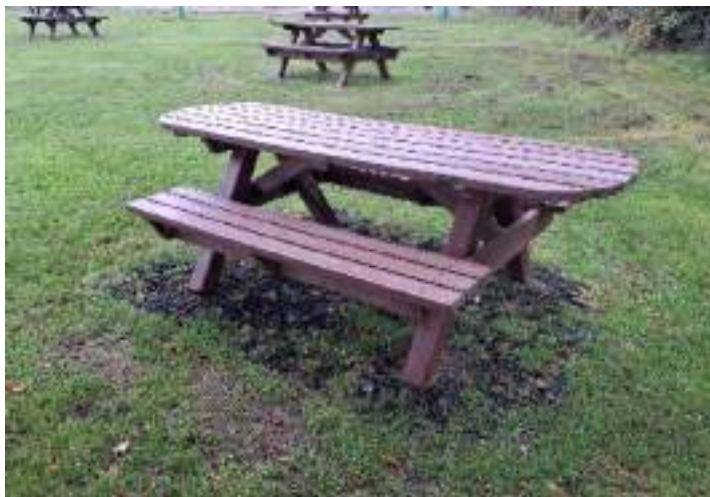
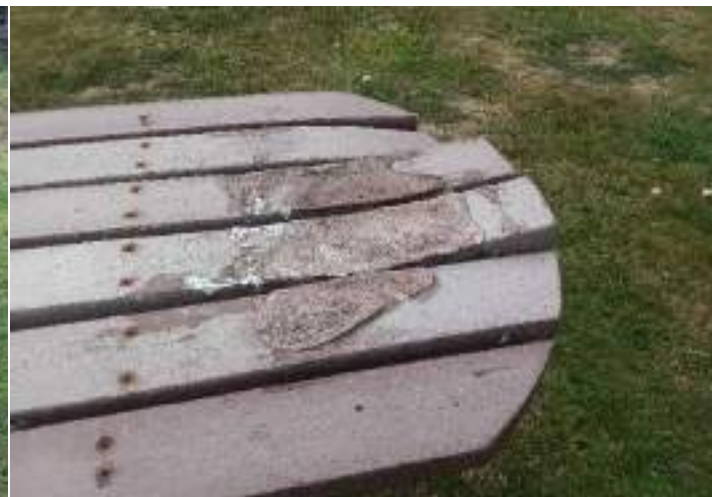
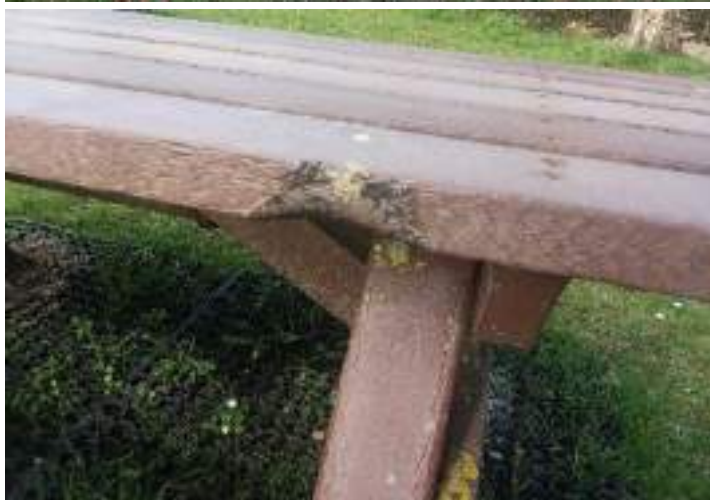
**Item:** Ancillary Items - Picnic Table  
**Manufacturer:** Marmax Products Ltd

**Risk Level:** L - Low Risk  
**Surface:** Grass

**Finding:** There is some evidence of fire damage to the item **Action:** Monitor for any further deterioration and repair as required

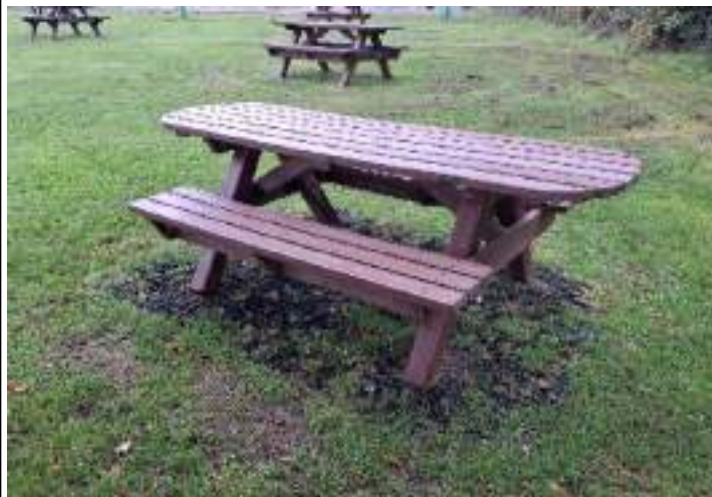
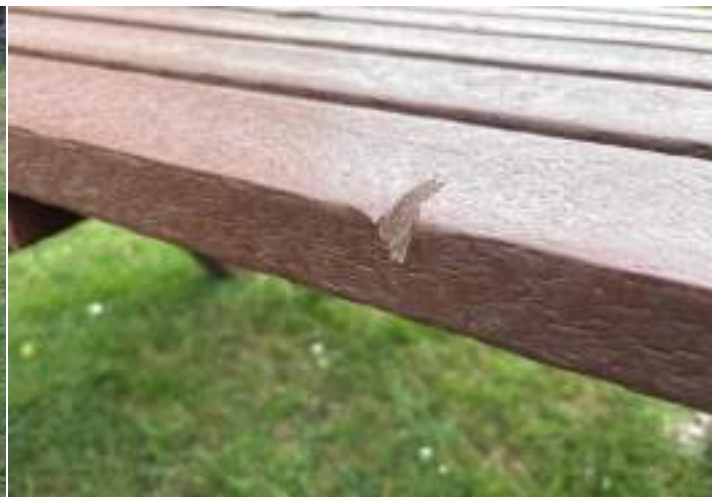
**Item:** Ancillary Items - Picnic Table  
**Manufacturer:** Marmax Products Ltd

**Finding:** There is some damage to the item

**Action:** Monitor for any further deterioration and repair as required

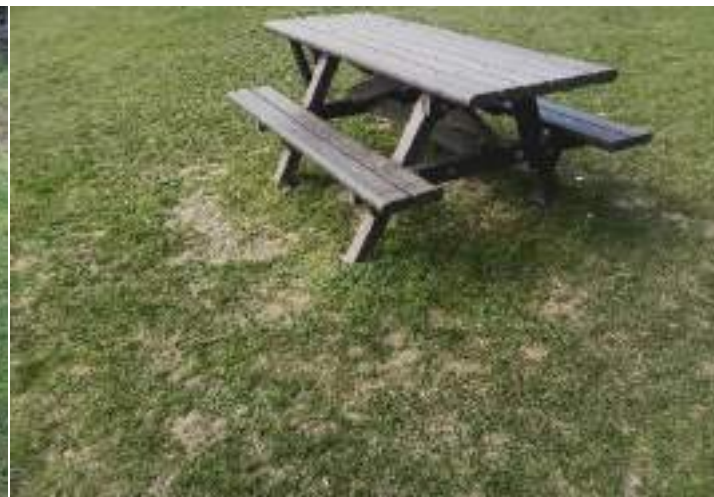
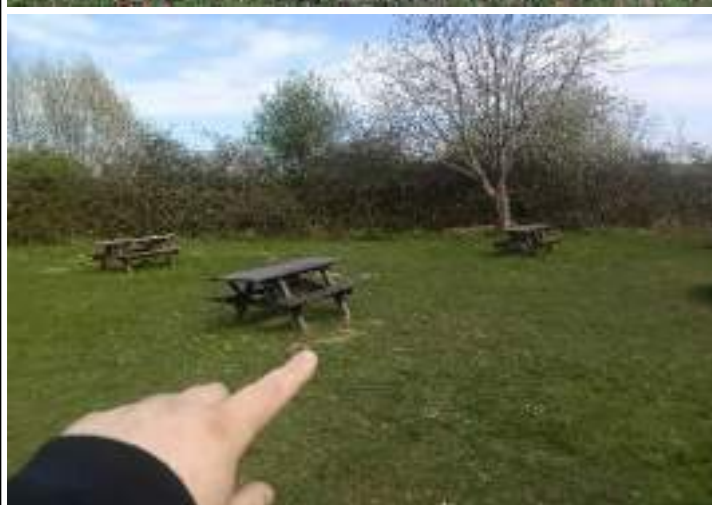
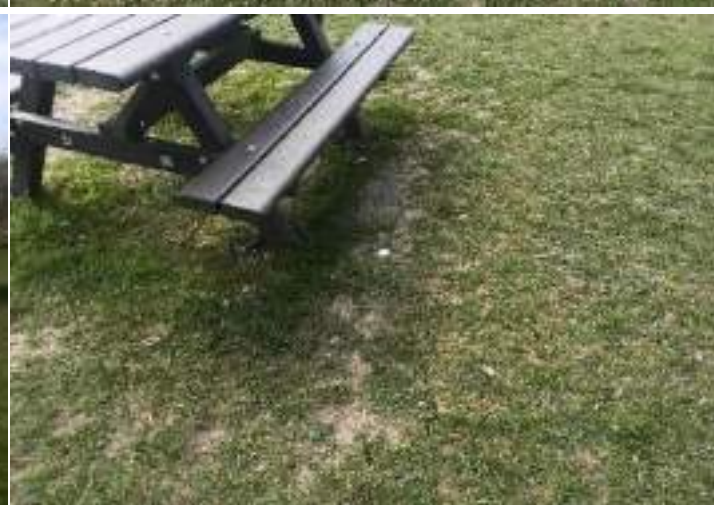
**Item:** Ancillary Items - Picnic Table  
**Manufacturer:** Marmax Products Ltd

**Finding:** The surface has eroded in some areas

**Action:** Reinstate the surface

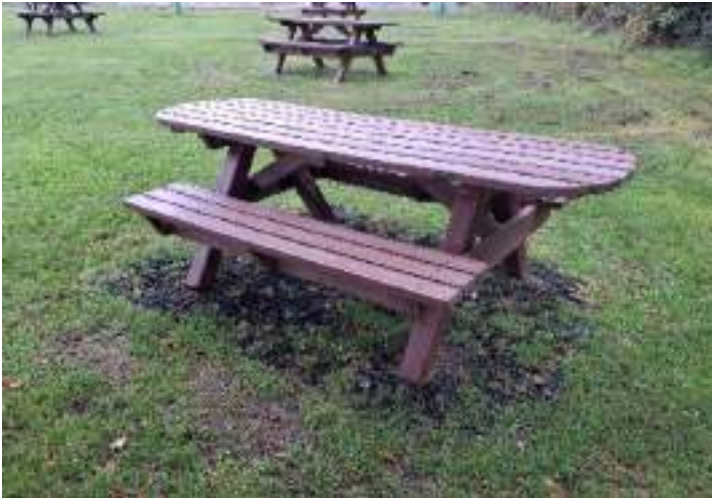
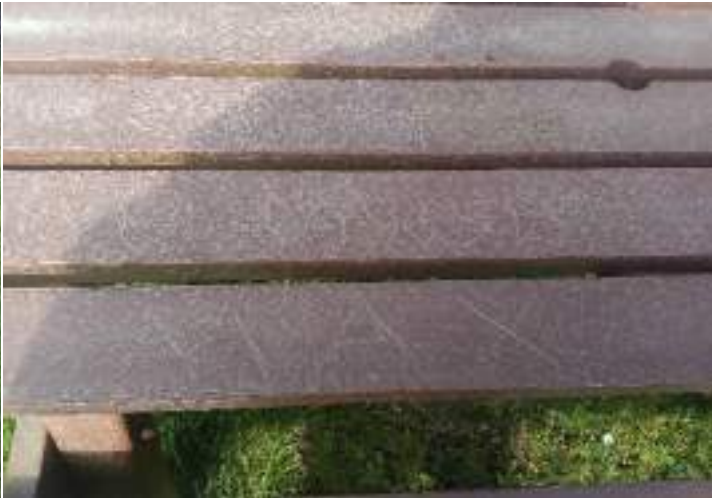
| 2 - Very Low Risk (Finding 4) | | | |
|---|---|---|---|
| <b>Item:</b> | Ancillary Items - Picnic Table | <b>Risk Level:</b> | V - Very Low Risk |
| <b>Finding:</b> There is some graffiti present | | <b>Action:</b> Remove the graffiti | |

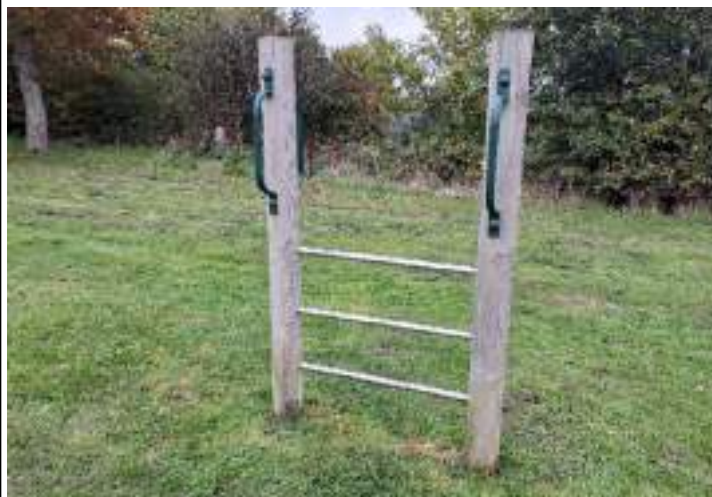
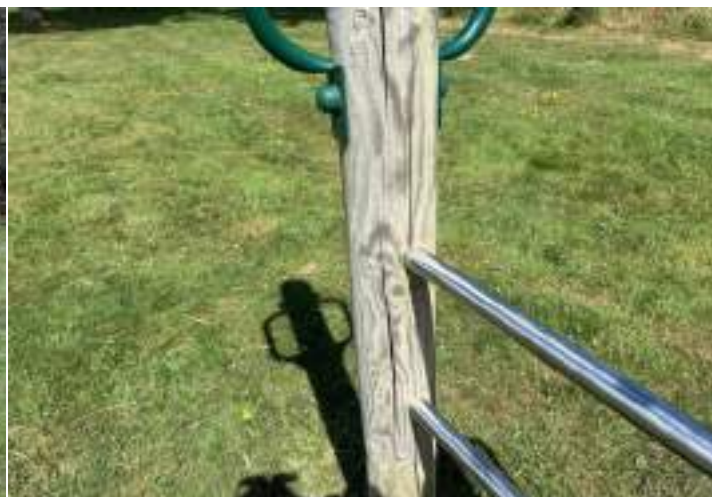
**Finding:** The timber has a number of splits/shakes or air cracks and this may affect the stability or allow water ingress which will accelerate the rotting process

**Action:** Monitor to ensure the splits do not cross through fixing points of the structure and/or cause any instability

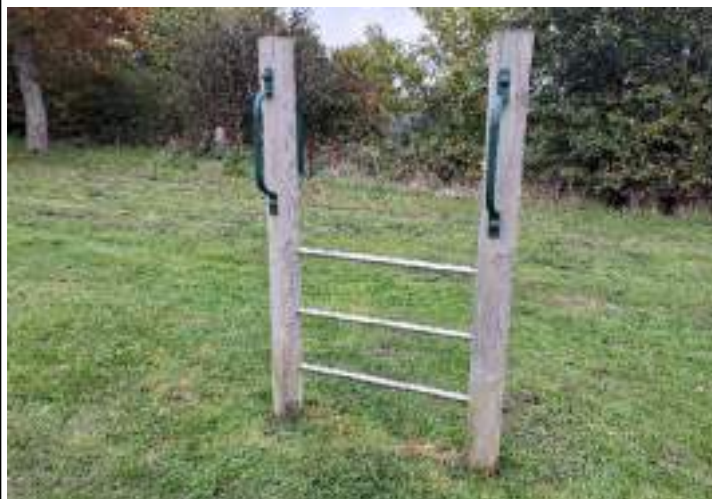
**Item:** Outdoor Fitness Equipment - Step Up Station  
**Manufacturer:** Sovereign Leisure

**Finding:** There are areas or parts of the timber on the structure that have rotted

**Action:** Replace all affected timbers

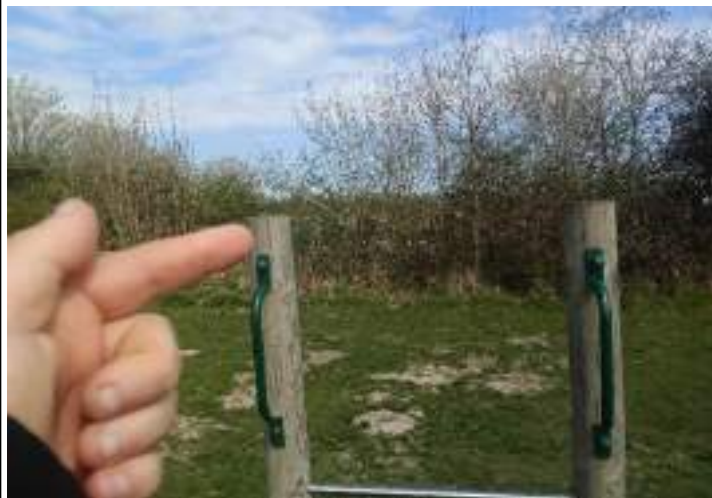
**Item:** Outdoor Fitness Equipment - Step Up Station  
**Manufacturer:** Sovereign Leisure

**Finding:** There is some damage to the item

**Action:** Monitor for any further deterioration and repair as required

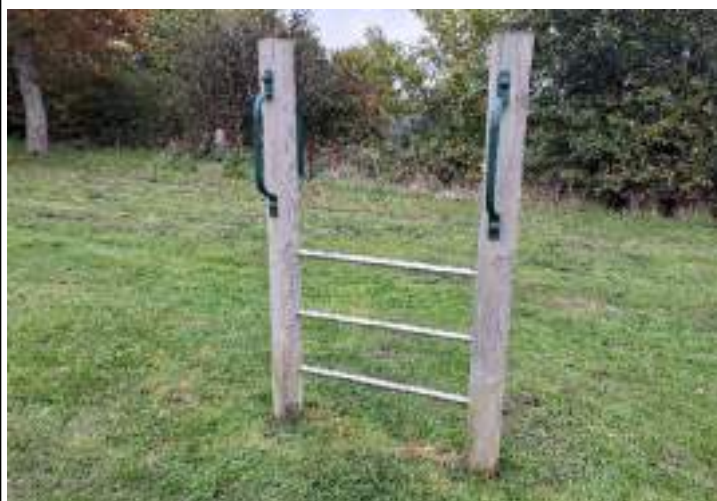
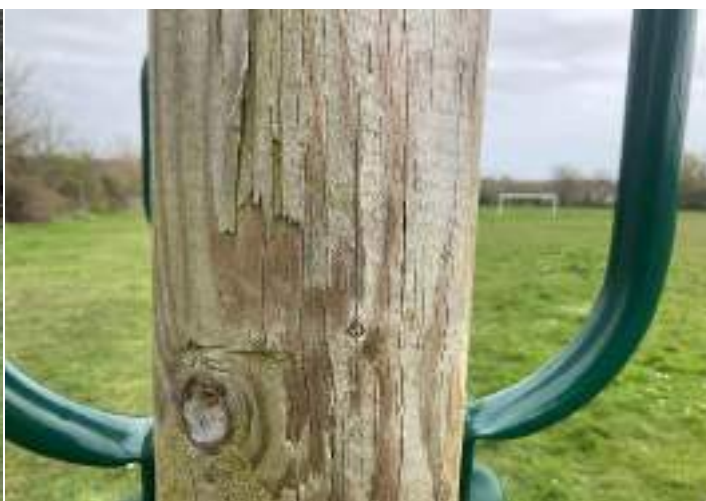
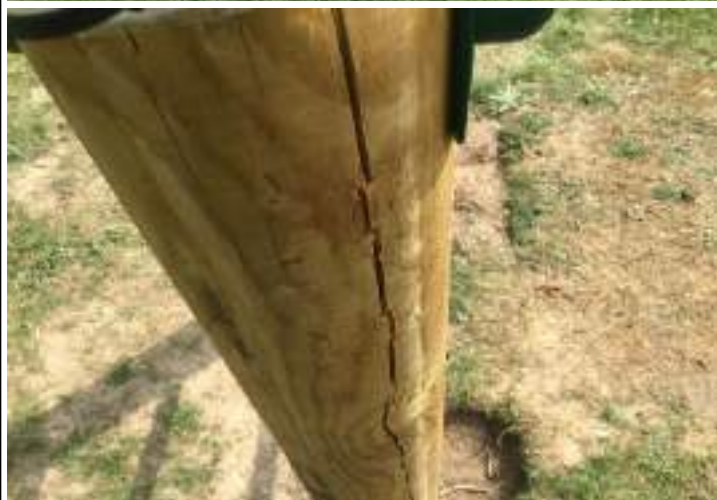
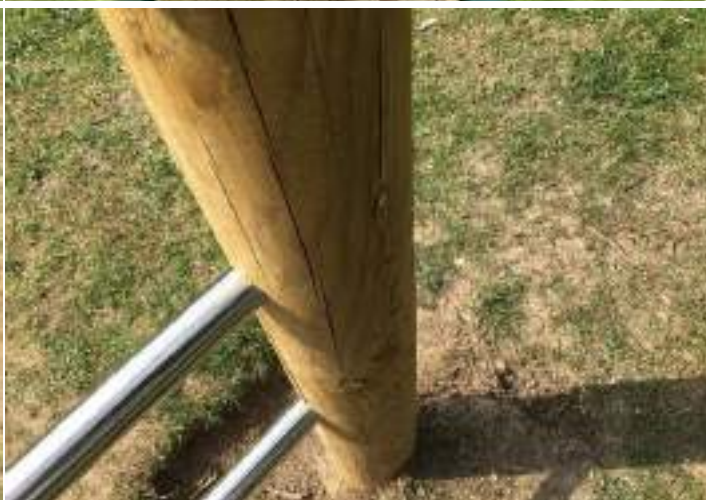
**Finding:** Parts of the timber are rough or splintered

**Action:** Remove all rough or sharp edges

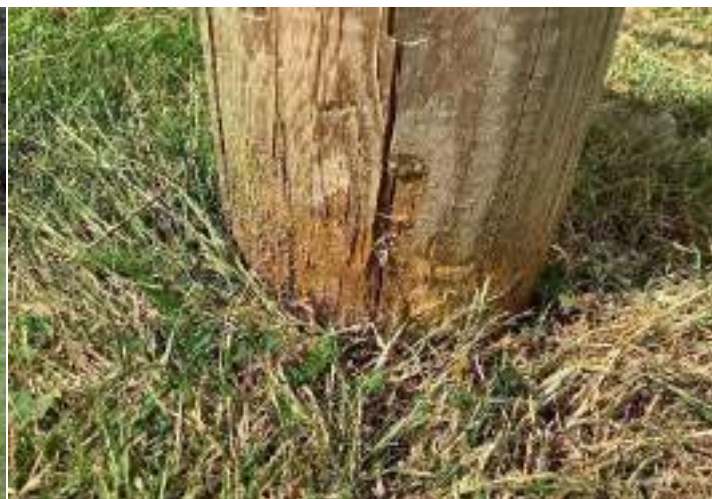
**Finding:** There is some strimmer / machinery damage apparent on the posts, this can penetrate the preservative applied to the timber and accelerate the rotting process

**Action:** Monitor for any deterioration (rot) and replace as required

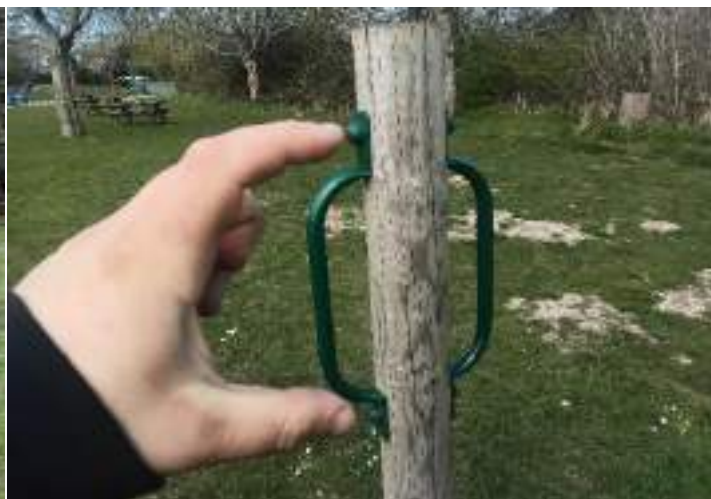
**Finding:** A number of fixing(s) have worked loose-inaccessible

**Action:** Secure all loose fixings
