## **Westbourne Parish Council, 10 September 2026**

## Operational Inspection

Westbourne Parish Council

## Inspection Scope for RPII Annual Inspectors

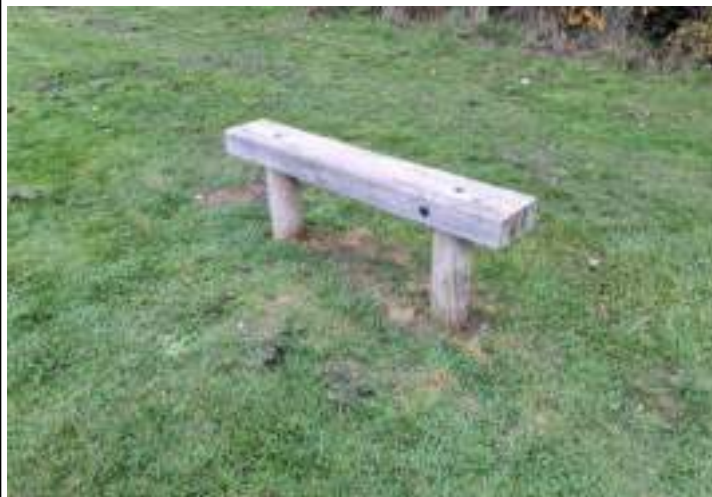
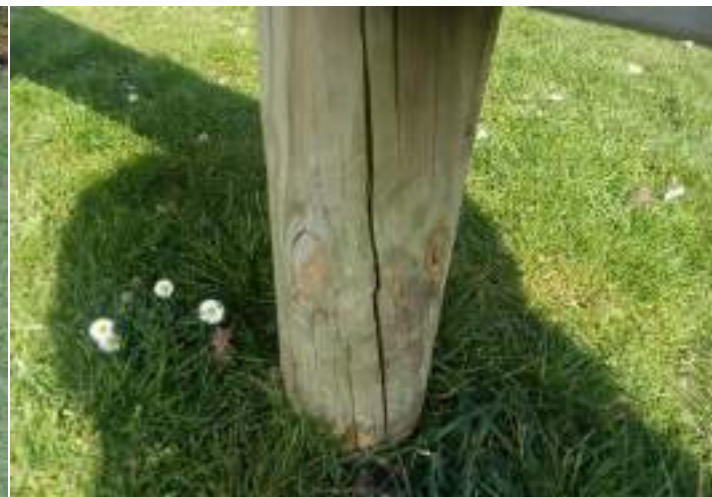
**Item:** Ancillary Items - Bench  
**Manufacturer:** Not Identified

**Finding:** The timber has a number of splits/shakes or air cracks and this may affect the stability or allow water ingress fixing points of the structure and/or cause any instability which will accelerate the rotting process

**Action:** Monitor to ensure the splits do not cross through

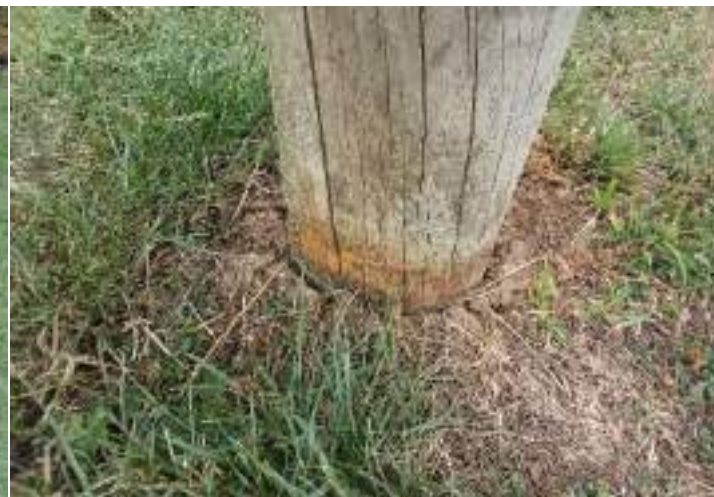
**Item:** Ancillary Items - Bench  
**Manufacturer:** Not Identified

**Finding:** There is some strimmer / machinery damage apparent on the posts, this can penetrate the preservative applied to the timber and accelerate the rotting process

**Action:** Monitor for any deterioration (rot) and replace as required

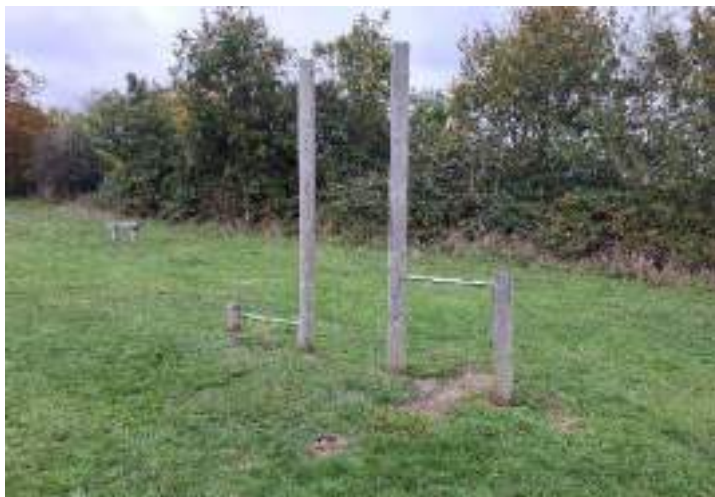
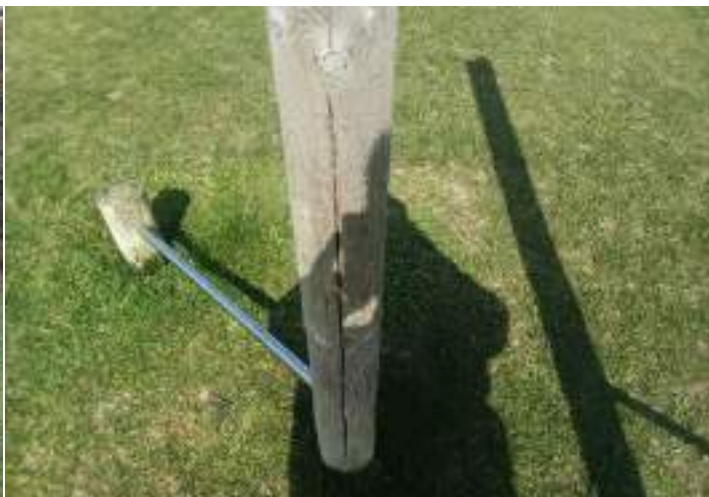
**Item:** Outdoor Fitness Equipment - Fit Point  
**Manufacturer:** Sovereign Leisure

**Finding:** The timber has a number of splits/shakes or air cracks and this may affect the stability or allow water ingress which will accelerate the rotting process

**Action:** Monitor to ensure the splits do not cross through fixing points of the structure and/or cause any instability

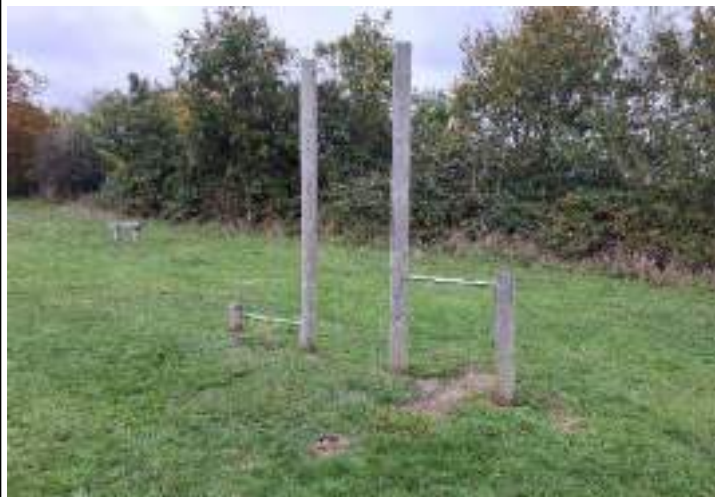
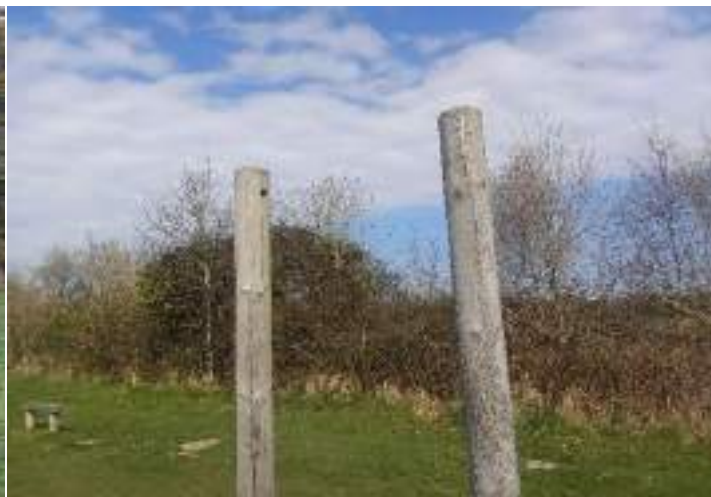
**Item:** Outdoor Fitness Equipment - Fit Point  
**Manufacturer:** Sovereign Leisure

**Finding:** The item has missing component(s) - top bar missing

**Action:** Consider replacing missing components

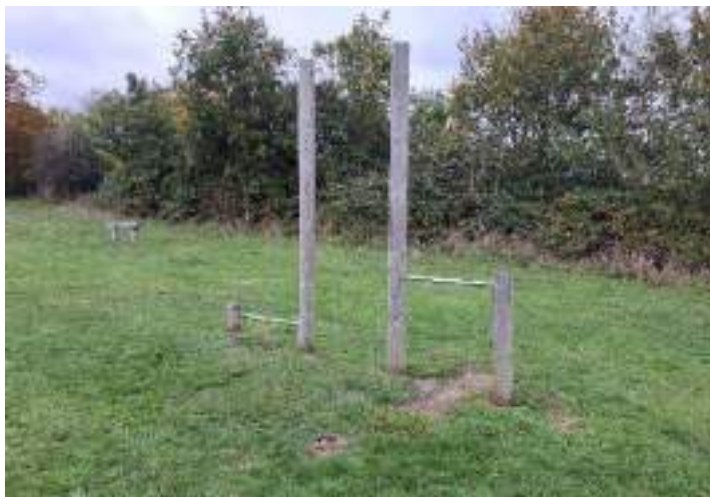
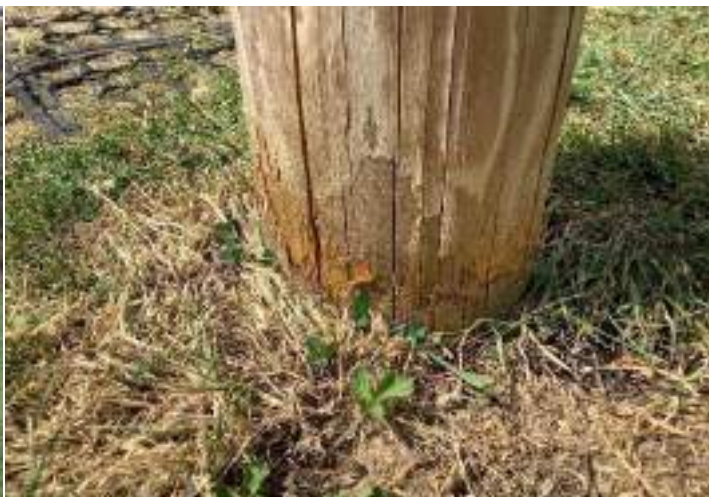
**Item:** Outdoor Fitness Equipment - Fit Point  
**Manufacturer:** Sovereign Leisure

**Finding:** There is some strimmer / machinery damage apparent on the posts, this can penetrate the preservative applied to the timber and accelerate the rotting process

**Action:** Monitor for any deterioration (rot) and replace as required

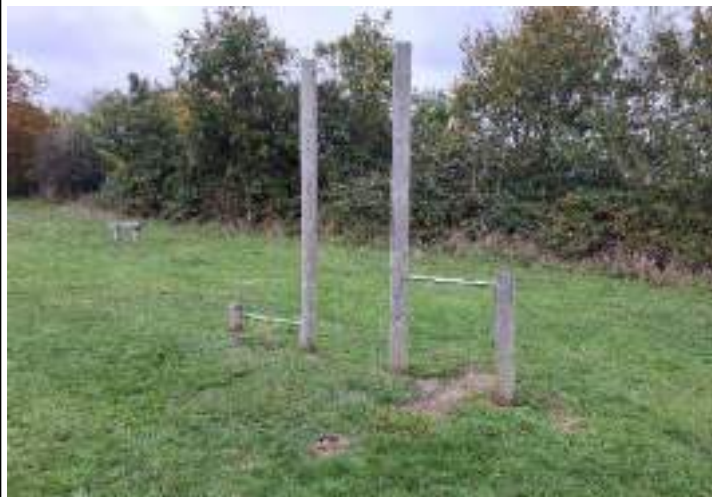
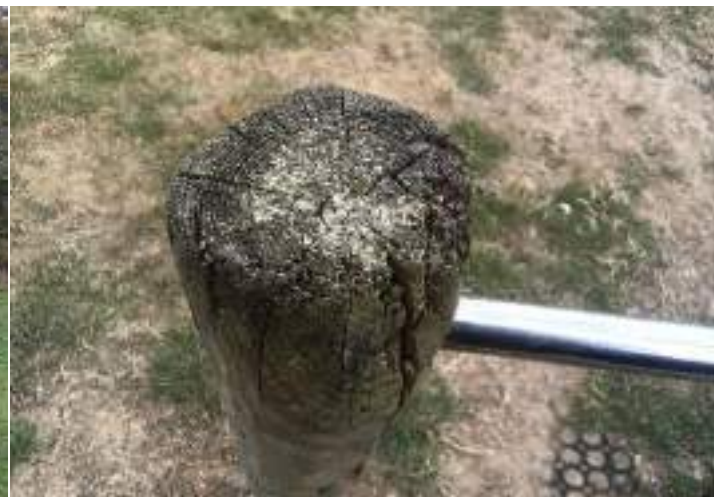
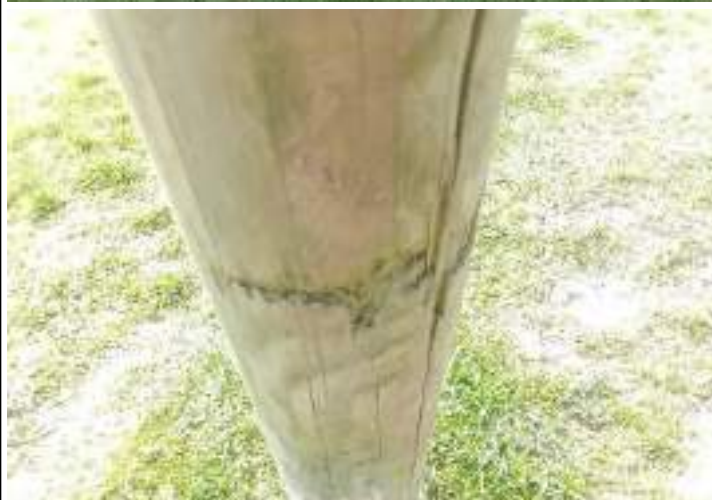
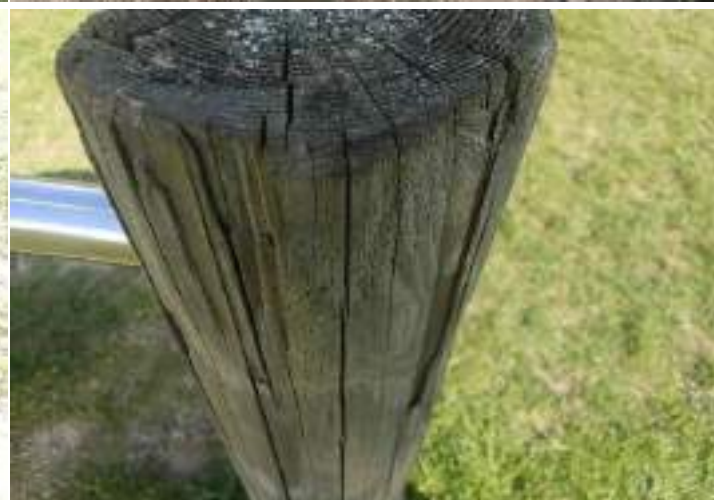
**Item:** Outdoor Fitness Equipment - Fit Point  
**Manufacturer:** Sovereign Leisure

**Finding:** Parts of the timber are rough or splintered

**Action:** Remove all rough or sharp edges

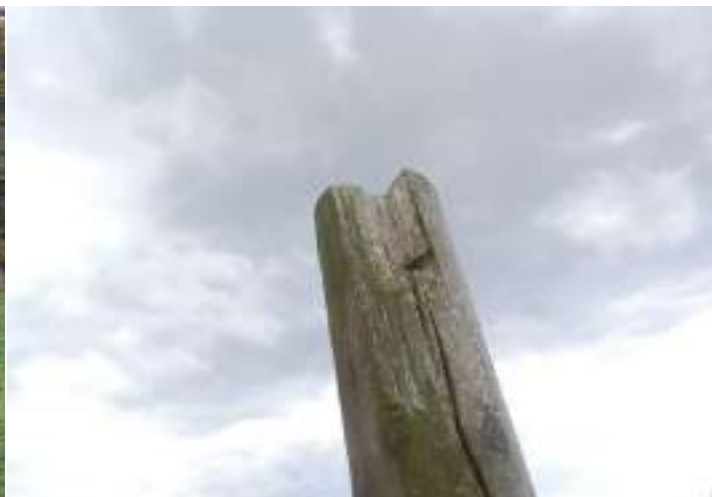
**Item:** Outdoor Fitness Equipment - Fit Point  
**Manufacturer:** Sovereign Leisure

**Finding:** The item has been severely damaged

**Action:** Replace item

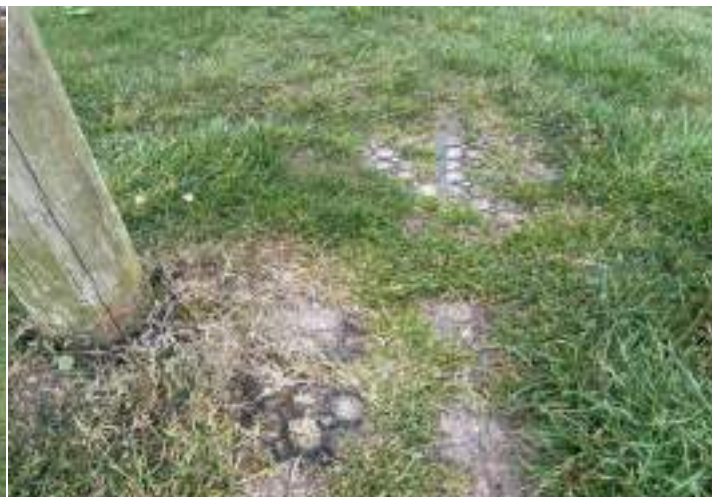
**Item:** Outdoor Fitness Equipment - Fit Point  
**Manufacturer:** Sovereign Leisure

**Finding:** The grass mats are silted up, the soil is compacted and the area will become very slippery when the soil is wet. **Action:** Reinststate as required

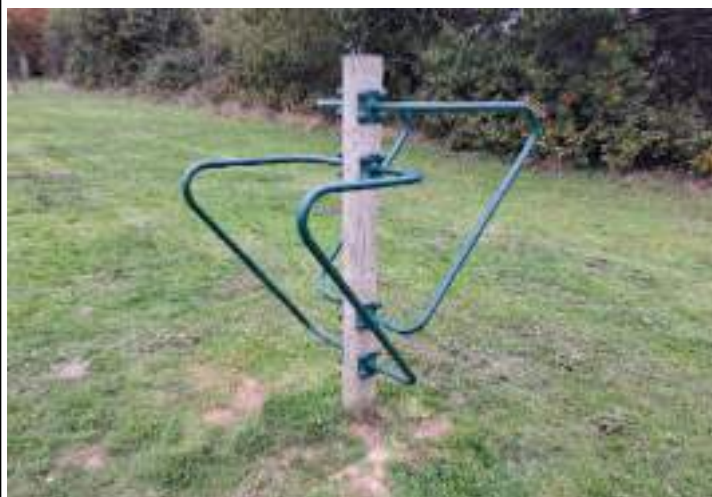
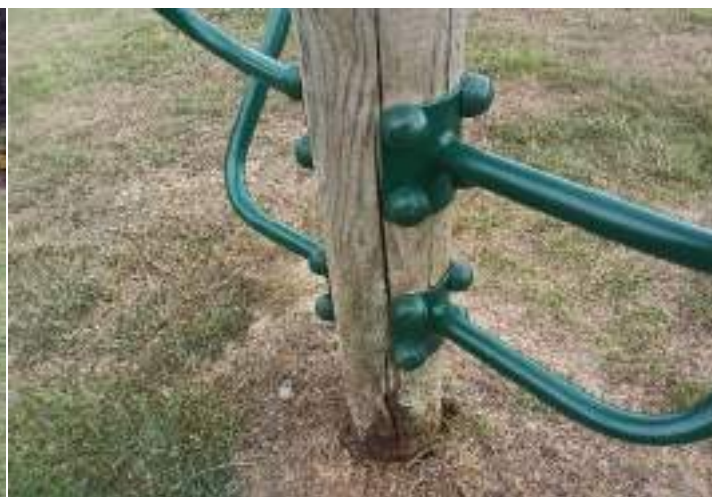
**Item:** Outdoor Fitness Equipment - Dip Station  
**Manufacturer:** Sovereign Leisure

**Finding:** Parts of the timber are rough or splintered **Action:** Remove all rough or sharp edges

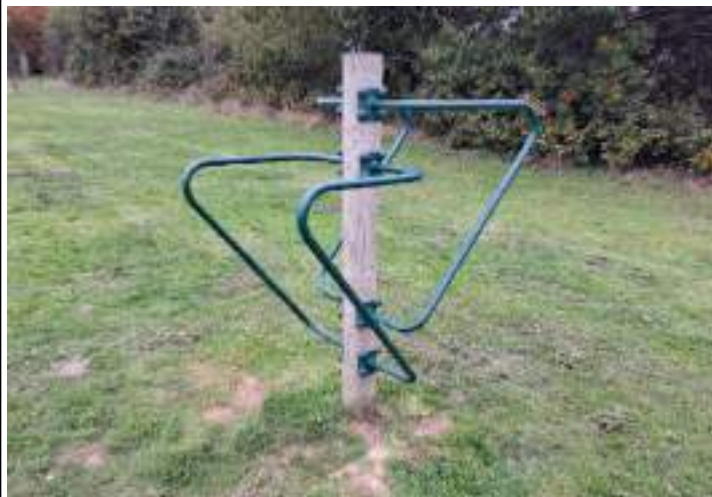
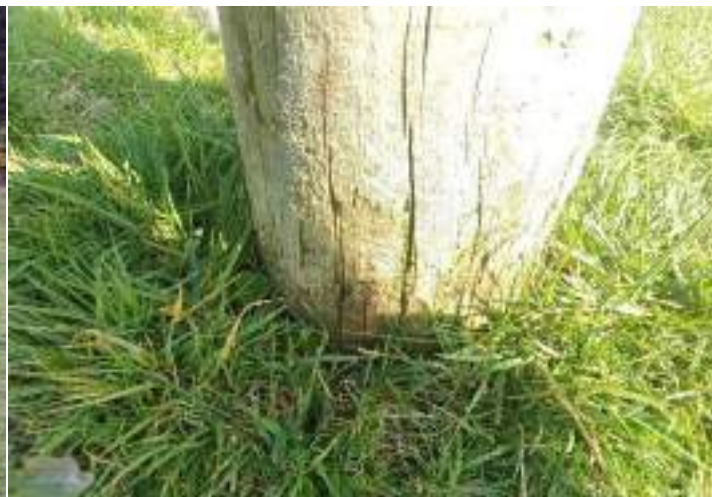
**Item:** Outdoor Fitness Equipment - Dip Station  
**Manufacturer:** Sovereign Leisure

**Finding:** There is some strimmer / machinery damage apparent on the posts, this can penetrate the preservative applied to the timber and accelerate the rotting process

**Action:** Monitor for any deterioration (rot) and replace as required

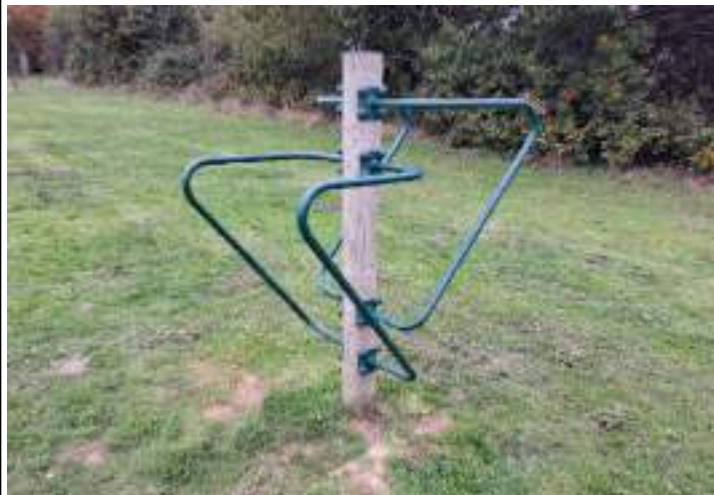
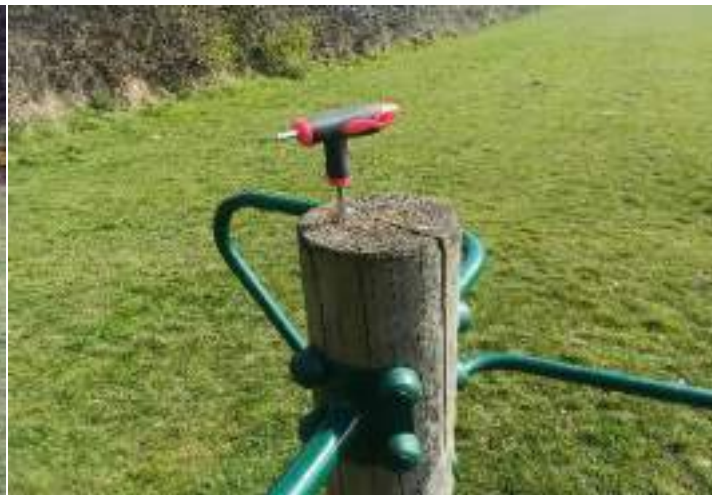
**Item:** Outdoor Fitness Equipment - Dip Station  
**Manufacturer:** Sovereign Leisure

**Finding:** There are areas or parts of the timber on the structure that have rotted above ground measurement approximately 1.4 m

**Action:** Replace all affected timbers

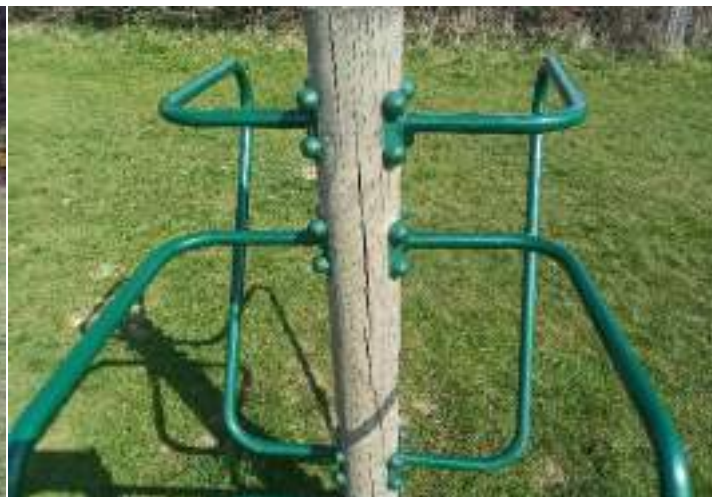
**Item:** Outdoor Fitness Equipment - Dip Station  
**Manufacturer:** Sovereign Leisure

**Finding:** The timber has a number of splits/shakes or air cracks and this may affect the stability or allow water ingress which will accelerate the rotting process

**Action:** Monitor to ensure the splits do not cross through fixing points of the structure and/or cause any instability

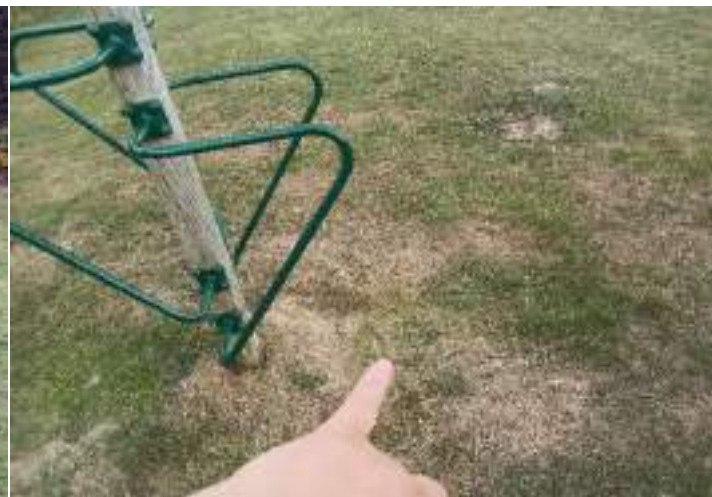
**Item:** Outdoor Fitness Equipment - Dip Station  
**Manufacturer:** Sovereign Leisure

**Finding:** The surface has subsided in some areas

**Action:** Monitor for any further deterioration and repair as required

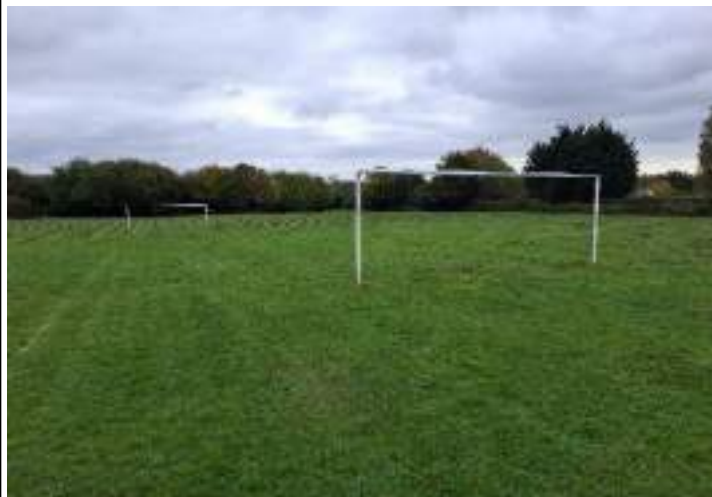
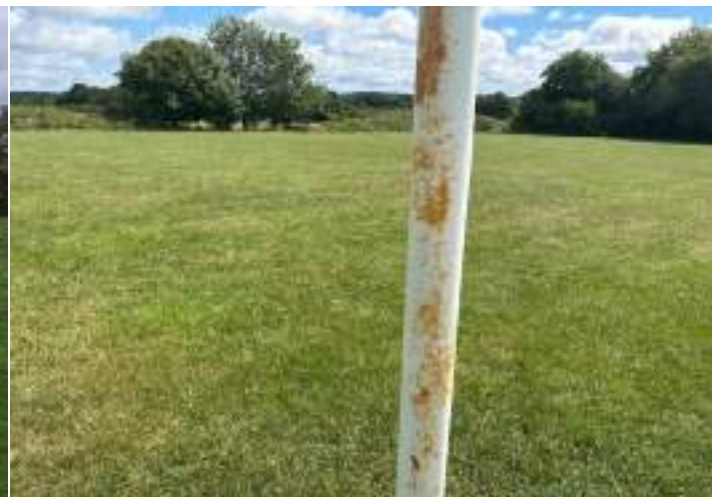
**Item:** Multi Use Games Area - Football Goal  
**Manufacturer:** Not Identified

**Finding:** There is surface corrosion / rust present on the item

**Action:** Consider treating the item

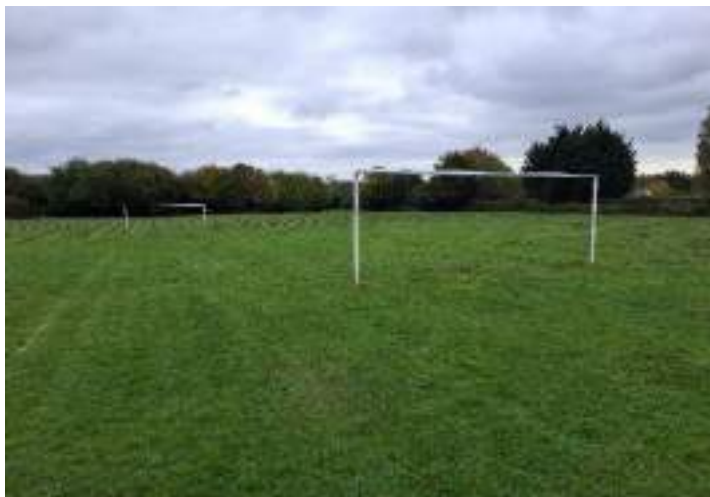
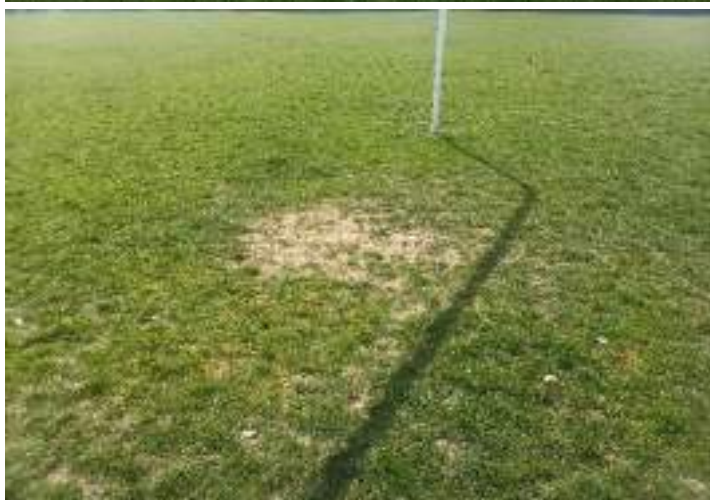
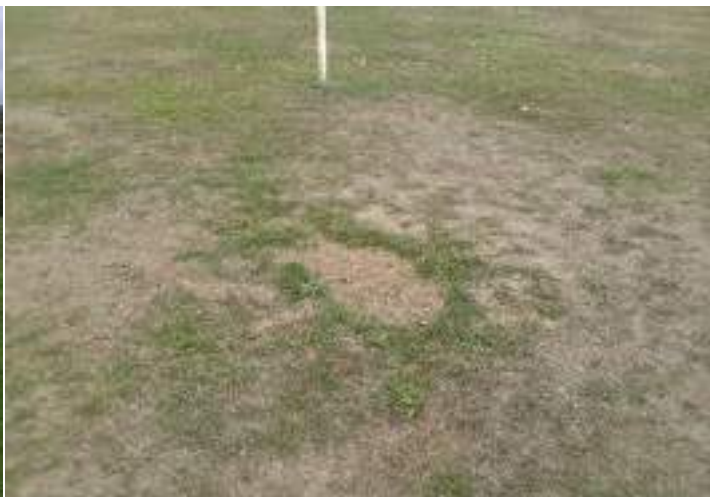
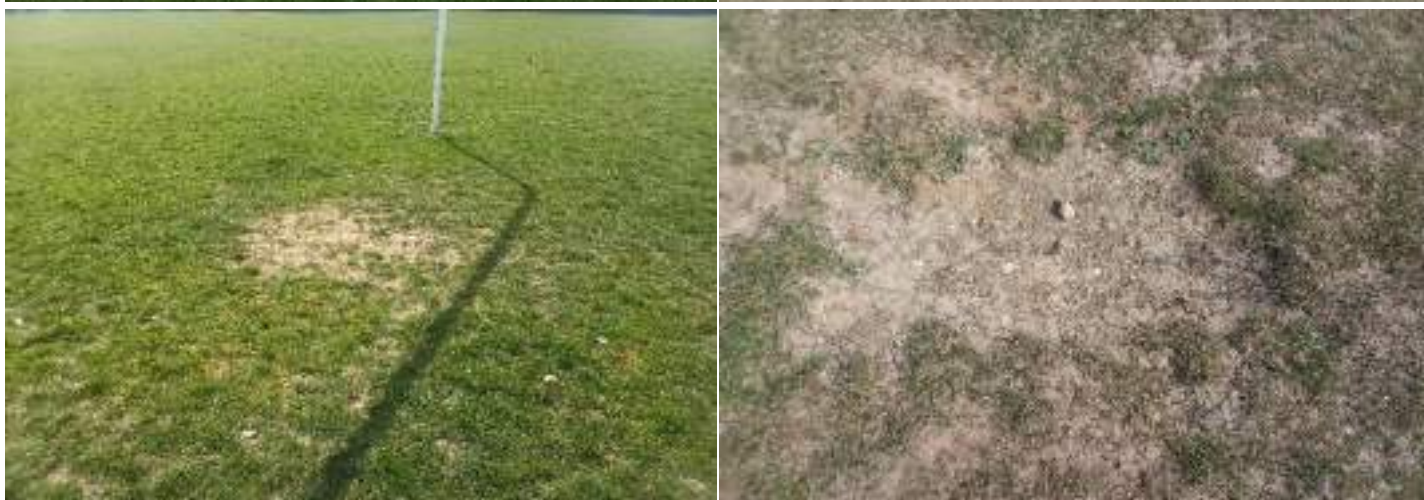
**Item:** Multi Use Games Area - Football Goal  
**Manufacturer:** Not Identified

**Finding:** The surface has eroded in some areas

**Action:** Reinstate the surface

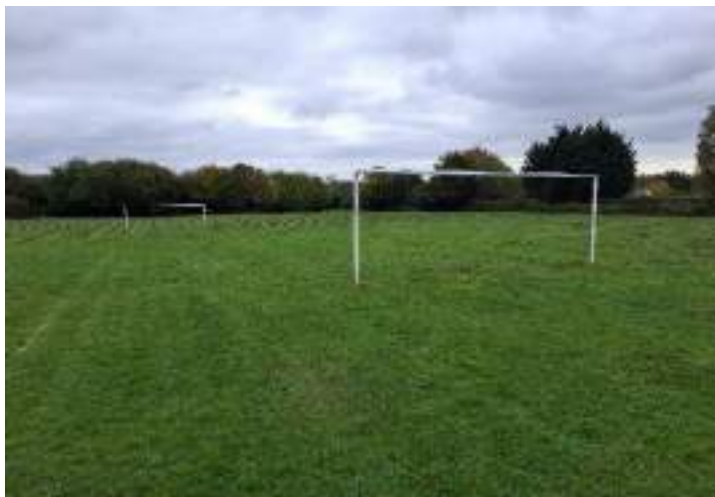
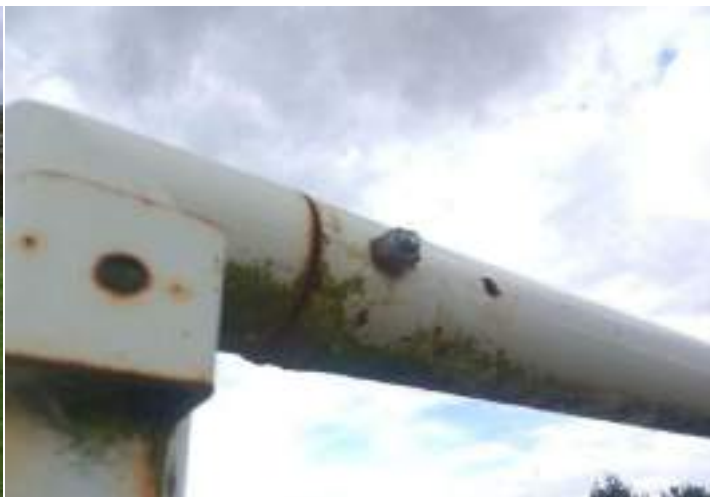
**Item:** Multi Use Games Area - Football Goal  
**Manufacturer:** Not Identified

**Finding:** There is/are bolt cap covers missing or damaged on the item

**Action:** Replace missing or damaged bolt cap covers

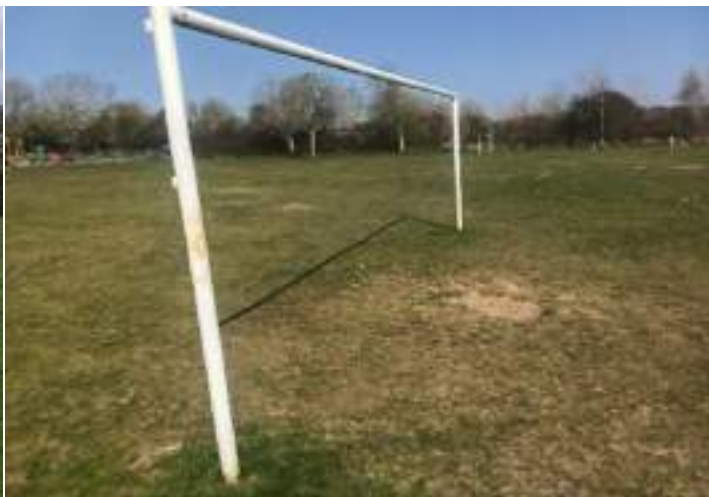
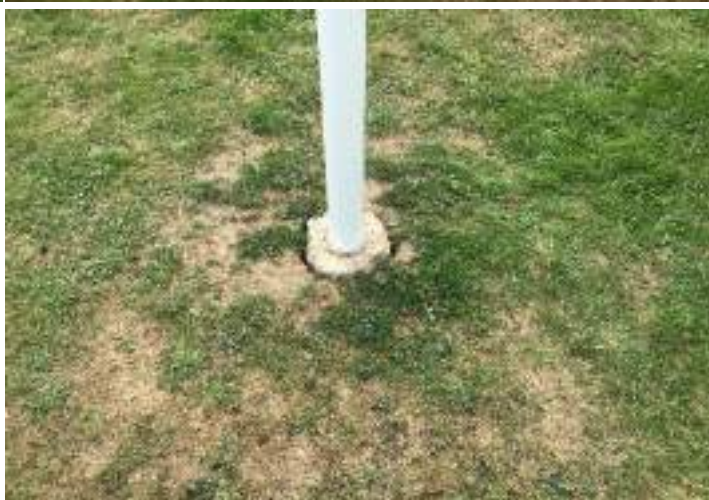
**Item:** Multi Use Games Area - Football Goal  
**Manufacturer:** Not Identified

**Finding:** The item is loose in its foundations

**Action:** Reinstall item to secure

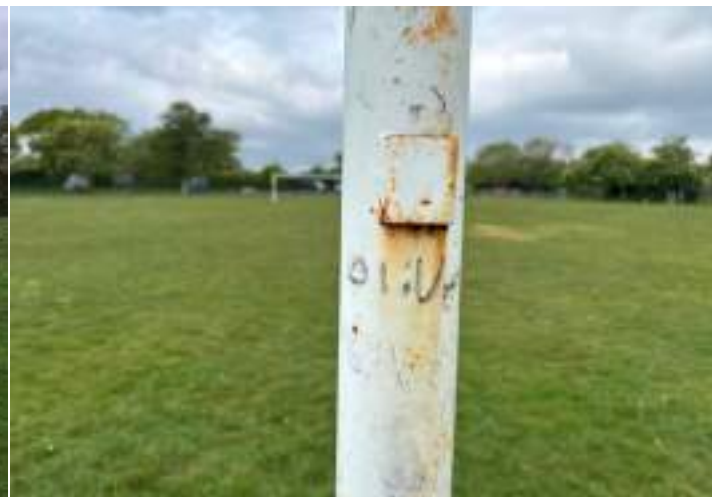
**Item:** Multi Use Games Area - Football Goal  
**Manufacturer:** Not Identified

**Finding:** There is some graffiti present

**Action:** Remove the graffiti

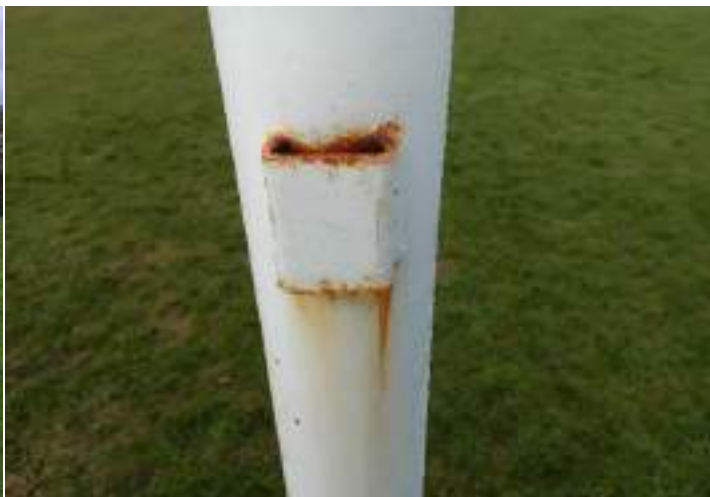
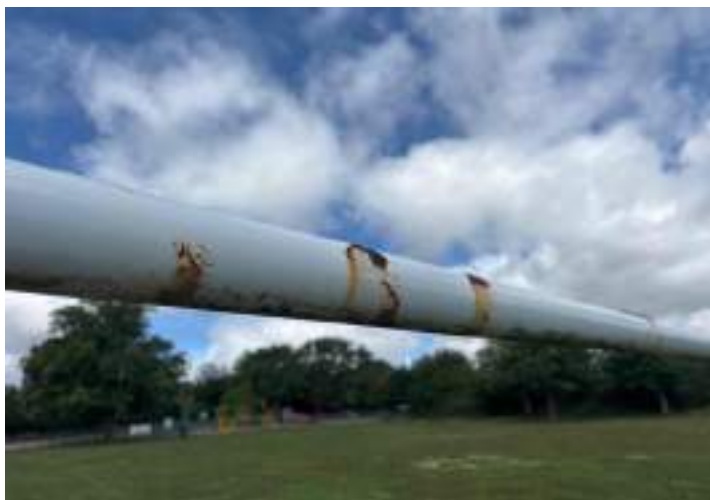
**Item:** Multi Use Games Area - Football Goal  
**Manufacturer:** Not Identified

**Finding:** The paintwork on this item has been damaged or worn exposing the metal underneath which is rusting / corroding

**Action:** Treat affected areas and repaint

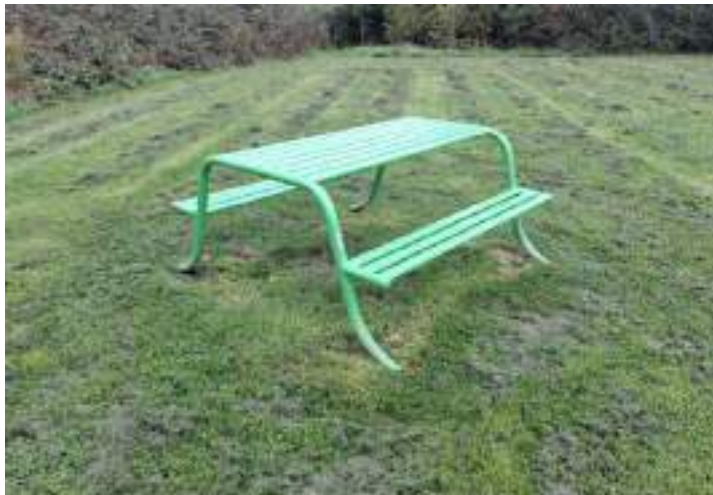
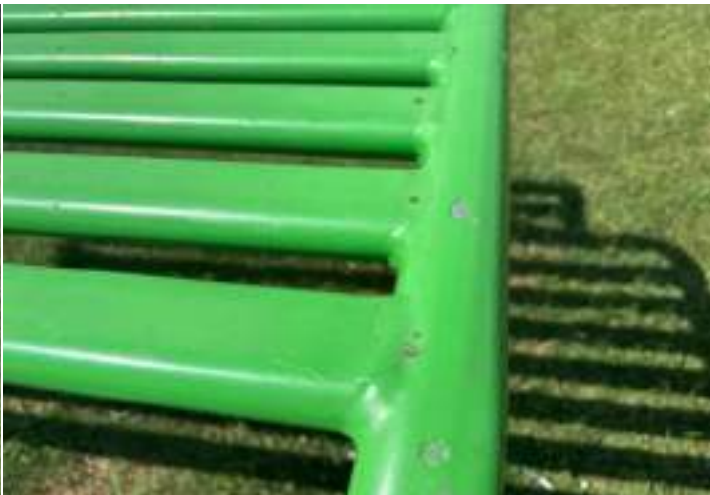
| 6 - Low Risk (Finding 1) | | | |
|---|---|---|---|
| <b>Item:</b> | Ancillary Items - Picnic Table | <b>Risk Level:</b> | L - Low Risk |

| 6 - Low Risk (Finding 1) | | | |
|---|---|---|---|
| <b>Finding:</b> The paint is flaking off the metalwork | | <b>Action:</b> Rub down and re-paint | |

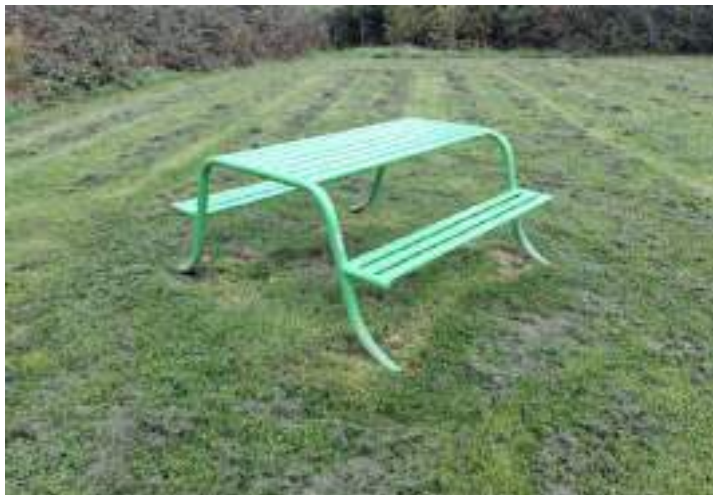
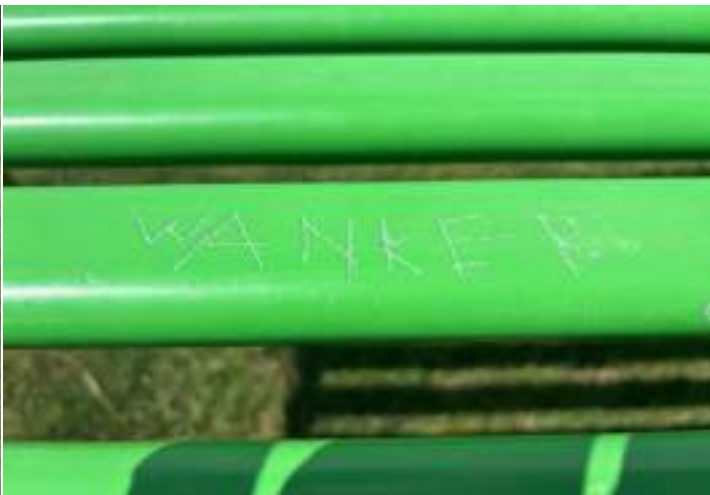
| 0 - Risk Assessment not Undertaken (Finding 2) | | | |
|---|---|---|---|
| <b>Item:</b> | Ancillary Items - Picnic Table | <b>Risk Level:</b> | N - Risk Assessment not Undertaken |

| 0 - Risk Assessment not Undertaken (Finding 2) | | | |
|---|---|---|---|
| <b>Finding:</b> There is offensive graffiti present | | <b>Action:</b> Remove as soon as practicable | |
